1993 Mercury Sable Wagon Rear Shock Absorber Replacement

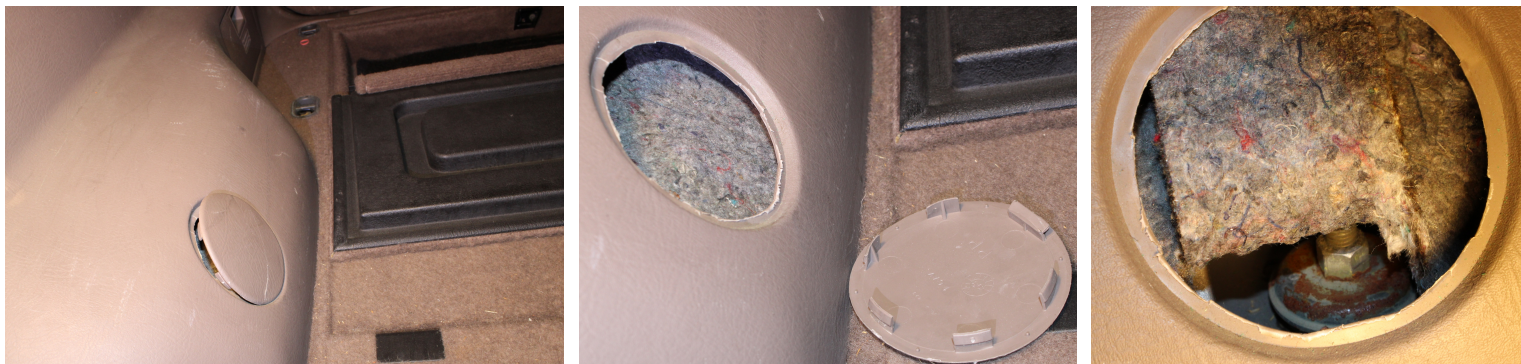
Shock absorber top nut access hole

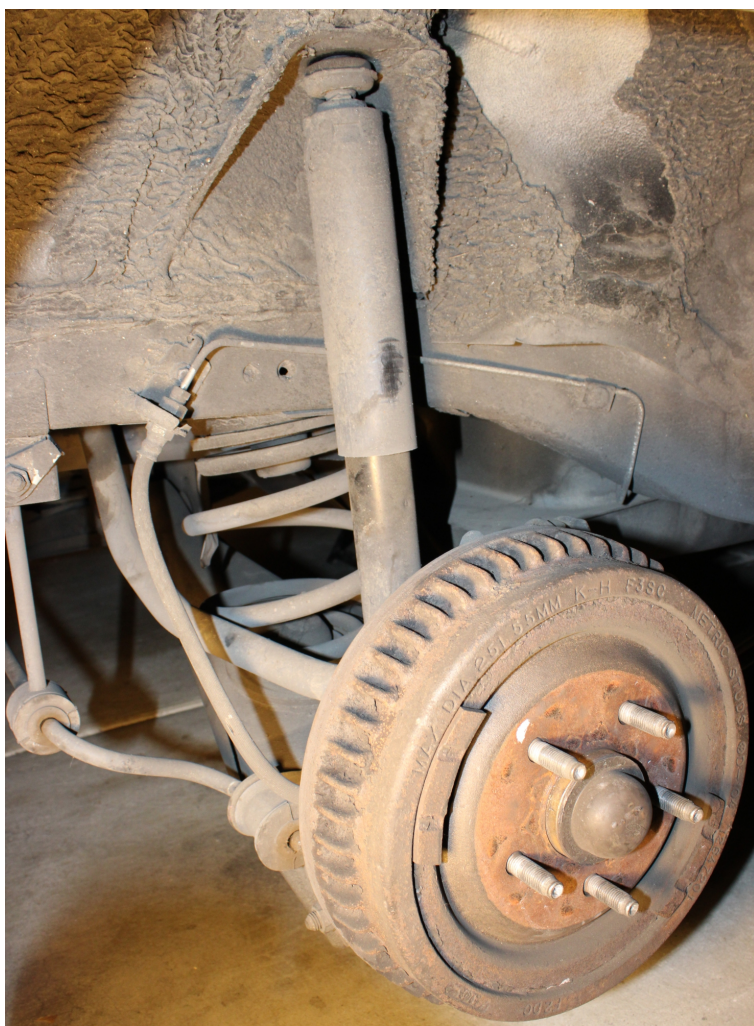
Coil spring & shock absorber independently assembled

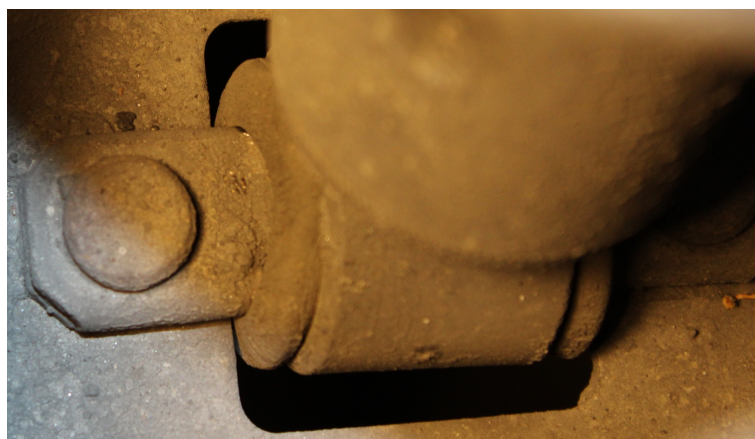
Assembly bolts at bottom

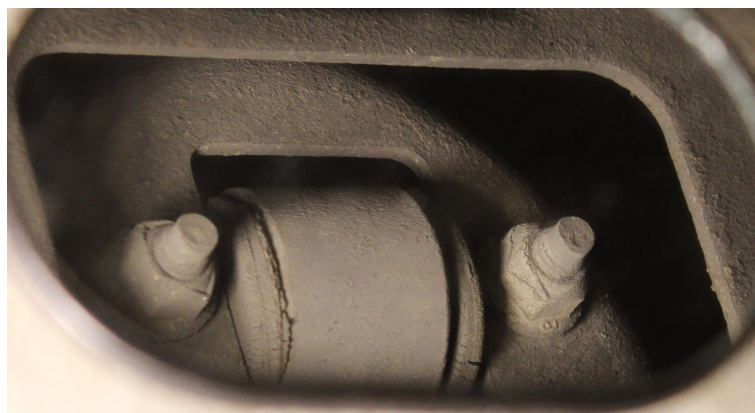
Assembly nuts at bottom

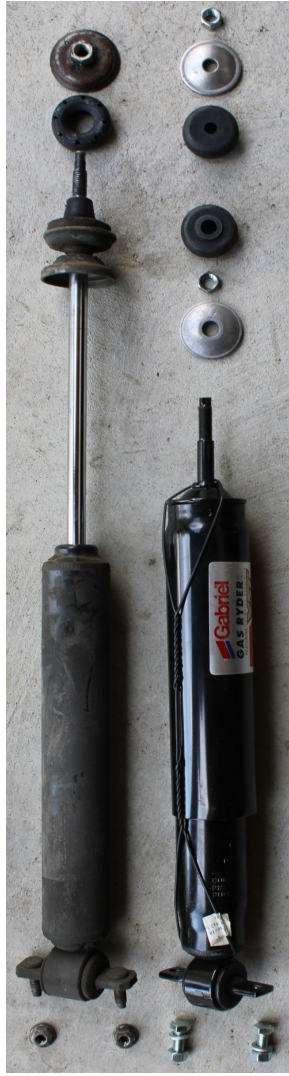
Old & New shock absorber (cut wire when assemble)
