1999 Toyota Avalon ECM (Engine Control Module) Replacement

ECM started throwing faulty DTCs (Diagnostic Trouble Codes) and all reactions taken were ineffective because ECM threw faulty diagnosis results.

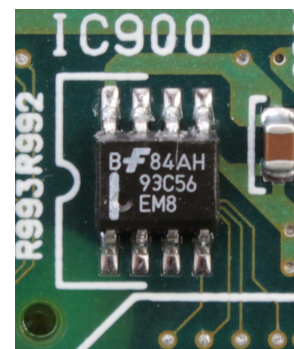
FM93C56 (IC900)

When ECM is replaced, engine never starts due to the immobilizer installed on Avalon throwing DTC of "B2795 (A key with unregistered key code in ECU is inserted into ignition key cylinder)" because ECM key codes stored in 8 pin 2k bit serial EEPROM (FM93C56 tagged as IC900) do not match with ignition keys. In this case, when key is inserted, slight clicking sound generates. The purpose of immobilizer is to guard from car theft using ignition keys mechanically duplicated.

(A) Replacing an 8 pin serial flash memory ("FM93C56", parts tag "IC900"), from old ECM to new ECM.

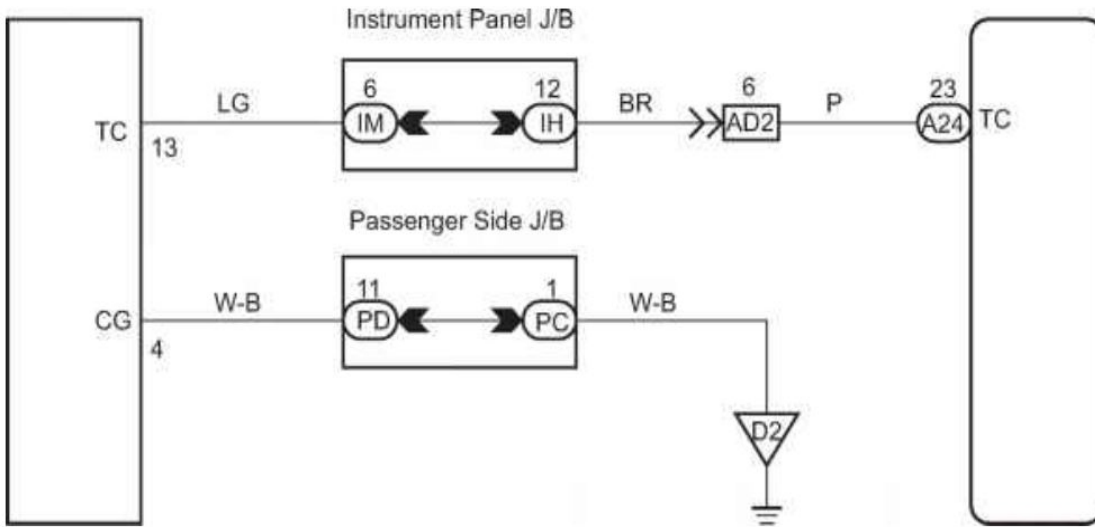
The way did not work because there was no metal female tab to vendor option pin 13 (TC). (See photo below)

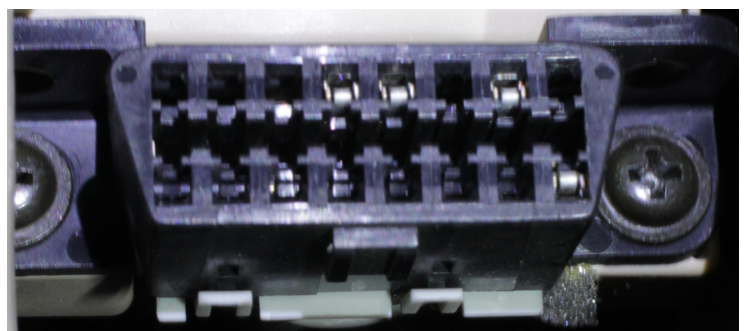
OBD2 Connector on Avalon (P13 has no female tab)

(1) Short pin 4 (CG; Chassis Ground) & 13 (TC) of OBD2 (DLC3) connector (Using OBD2 extension cable with male and female plugs is recommended because some pins of OBD2 plug installed on Avalon may not have been fully installed contact metals in surface).

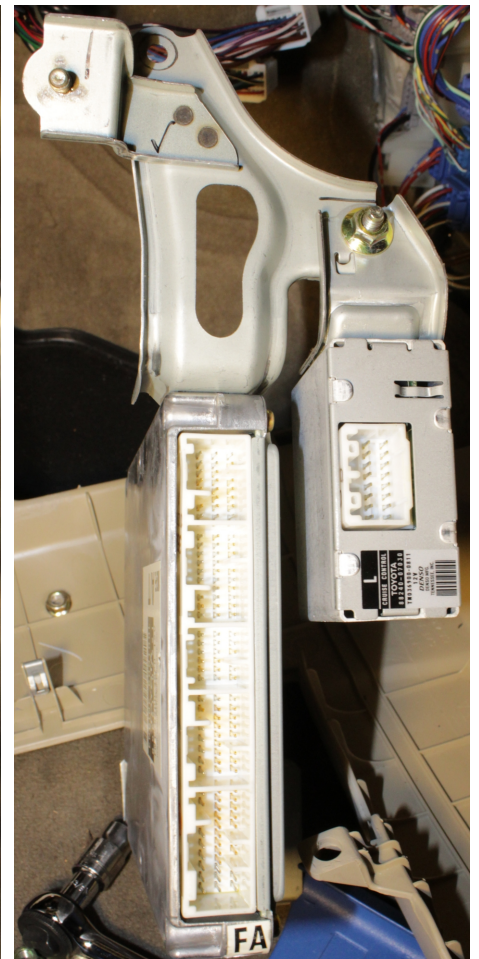
Old ECM (Left) Removed

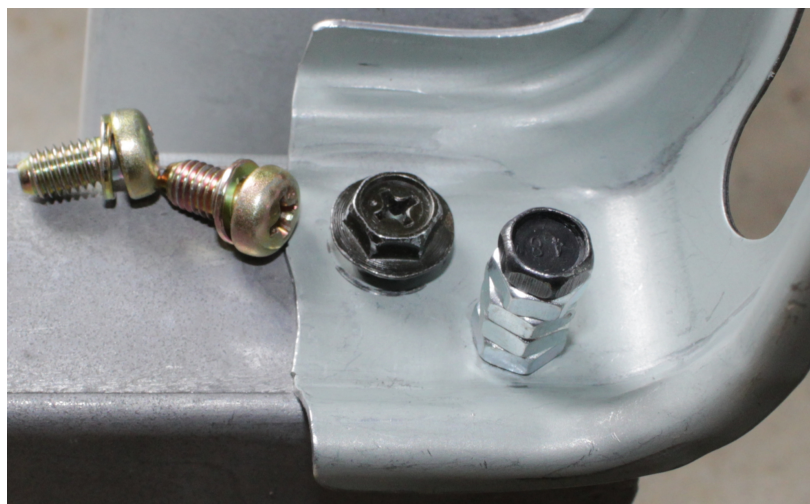
Hex bolts replaced Philips head bolts factory used to make it easy detaching/attaching ECM next time

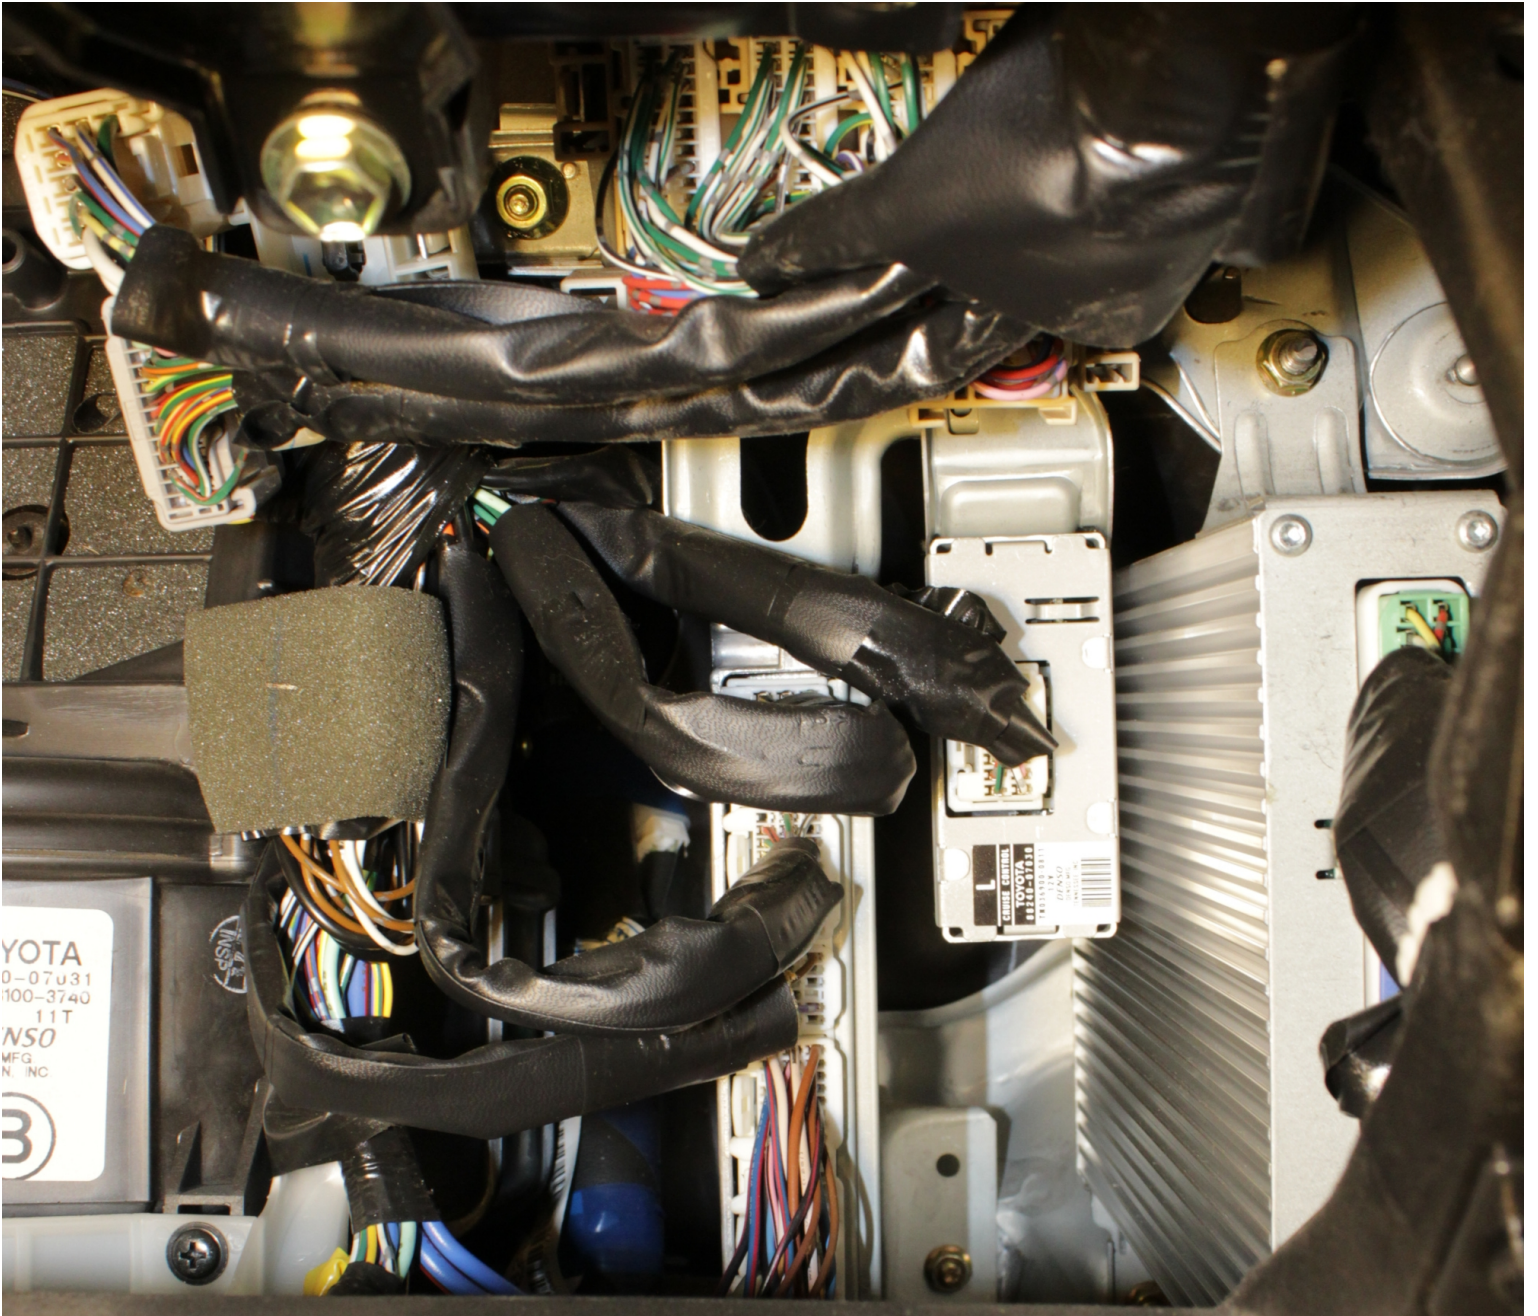
New ECM Reinstalled

- (1) Remove FM93C56 (#1) from original ECM.
- (2) Remove FM93C56 (#2) from new ECM.
- (3) Solder FM93C56 (#1) on new ECM.

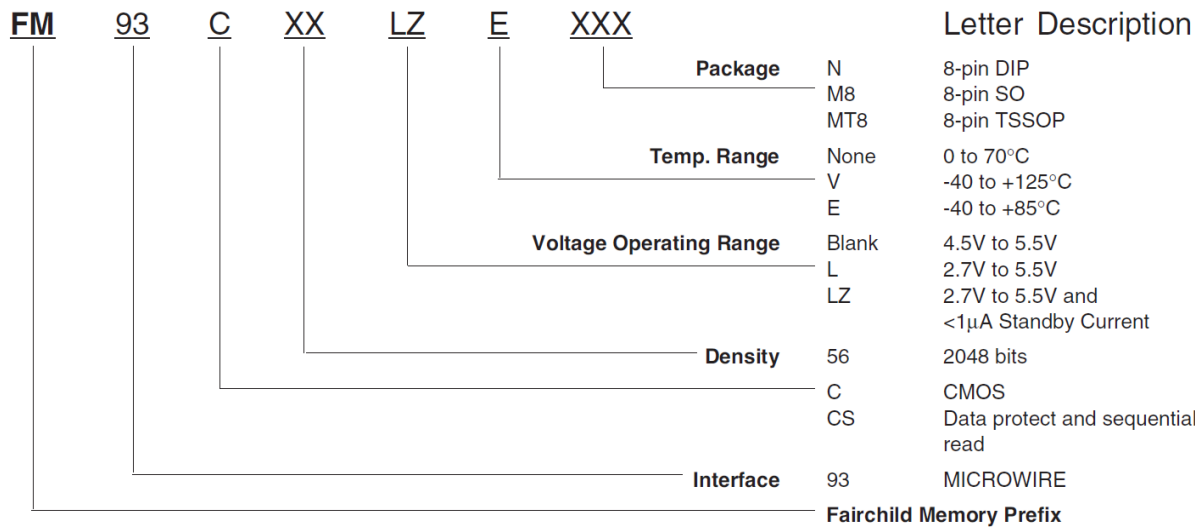
FM93C56 data sheet claims "Wide Vcc 2.7V – 5.5V" at page 1 although maximum 1 MHz clock frequency is guaranteed only at Vcc = 5V, not 2.7V.

However, product name printed on surface, "FM93C56 EM8", specifies the Voltage Operating Range "4.5V to 5.5V".

This is a sort of gimmick. Be aware of it.

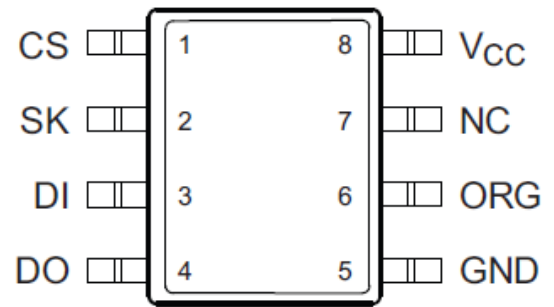
AT93C56B data sheet claims "Wide Vcc 1.7V - 5.5V" at page 1 boasting wider Vcc range than FM93C56 although maximum 2 MHz clock frequency is guaranteed only at Vcc = 5V, not 1.7V.

Furthermore, "ORG" pin functional specification is ambiguous ("If the ORG pin is left unconnected and"). When "ORG" is left unconnected, 128 x 16 configuration does not work. It had to be connected to 5V. This is a sort of gimmick. Be aware of it.

Atmel AT93C56 seems trying to hide its incompatibility with FM93C56.

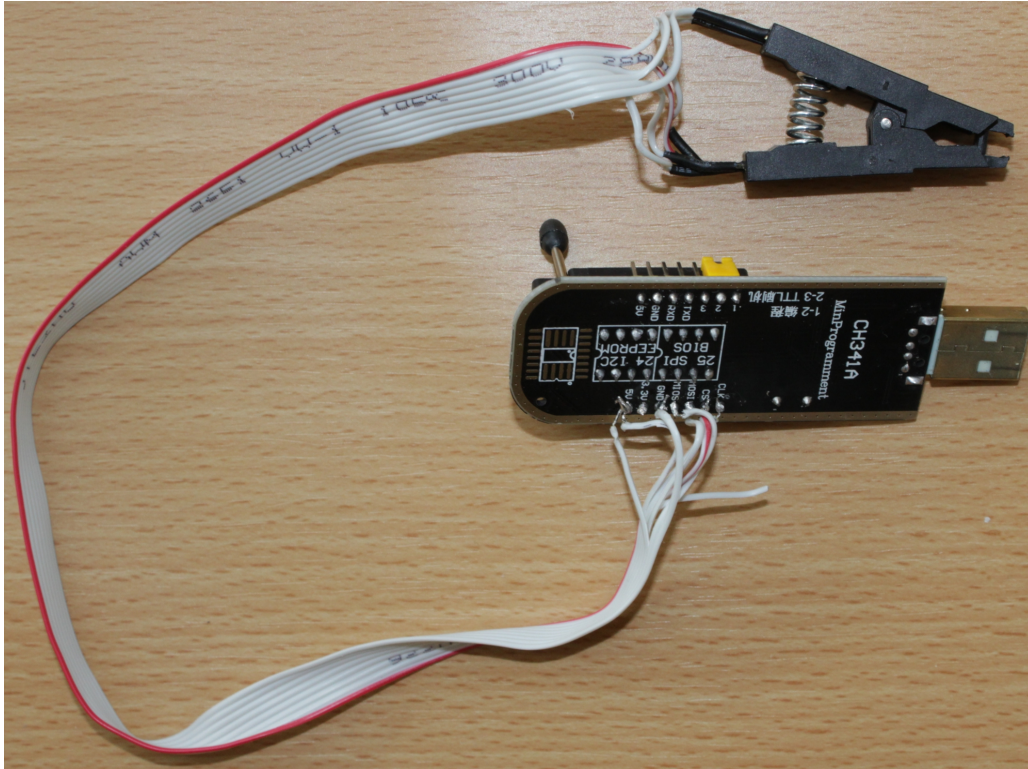
Wiring between FM93C56 and CH341A

In-circuit programming does not work because IC clip cannot perfectly clip on-board FM93C56, and etc.. Remove FM93C56 from ECM all the time, clip it by IC clip, and read/program by CH341A programmer.

- (1) Solder 6 wires to test pins on CH341A using flat cable with 8 pin SOIC IC clip attached other end.
- (2) Pin 6 is NC in FM93C56 implemented on Denso ECM but needs to be connected to 5V in Atmel AT93C56.
- (3) Remove FM93C56 from ECM and carefully clip it by IC clip making sure the contacts are all intact.
