Gen 2 Prius Instrument Cluster Lights

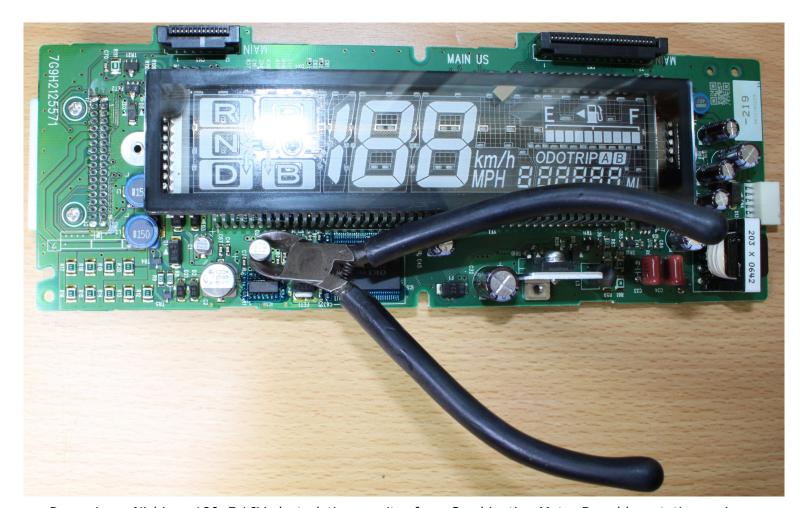
Removing a Nichicon 100µF 16V electrolytic capacitor from Combination Meter Board by rotating a nipper

It is easy to detach the capacitor as wrenching off human being's head because the surface mount soldering is much looser than through-hole soldering. Surface-mount should not be applied for vehicle-mounted electrolytic capacitors that get much gravity and acceleration from various directions and strength swaying the parts. Charging gravity and acceleration to baby's neck is presumable as dangerous act.

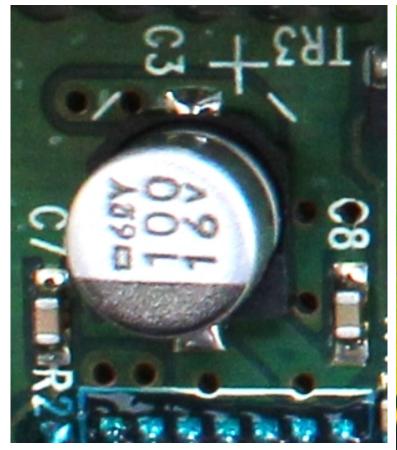
Before Removal of an 100µF 16V electrolytic capacitor

Presumably from the lot number ("6IY''), the $100\mu F$ 16V capacitor seemed to be picked up from aging parts stock which deteriorated already.

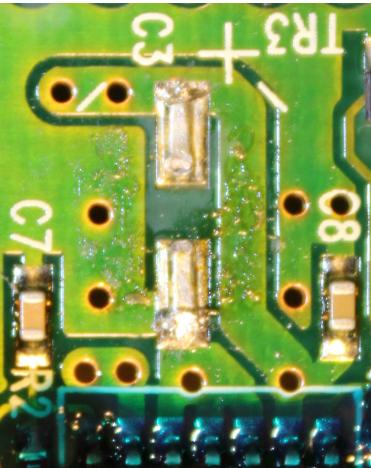
After Removal (Electrolyte leaked is sticking on board)

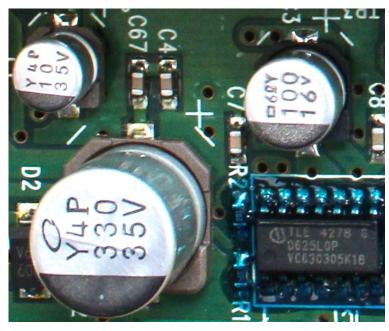
10μF 35V (Upper left), 330μF 35V (Lower left) 100μF 16V ("Culprit", Upper right)

Infineon TLE4278G 5V voltage regulator (Lower right) All electrolytic capacitors are soldered by surface mount

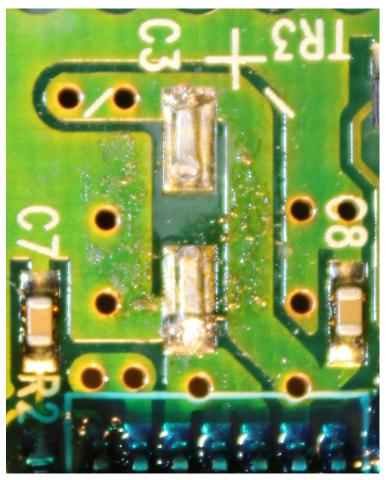
The principal cause was deterioration (leaking electrolyte which is just about the same of battery) of a <u>Nichicon 100µF 16V aluminum electrolytic capacitor</u> connected between VQ (+5V) and GND outputs of <u>Infineon TLE4278G 5V voltage regulator</u> applied for the purpose of DC voltage smoothing.

VQ (pin 9) and GND (pin 10, 11, 12) of Infineon TLE4278G 5V voltage regulator are covered by electrolyte leaked from Nichicon electrolytic capacitor

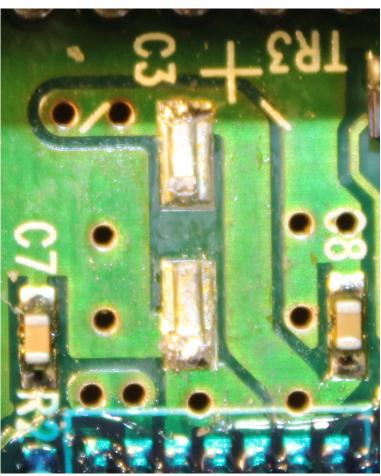
Removed electrolyte, Cleaned pattern (Original space between VQ and GND looks too narrow)
