1989 Toyota Camry "Door not Opened" Repair

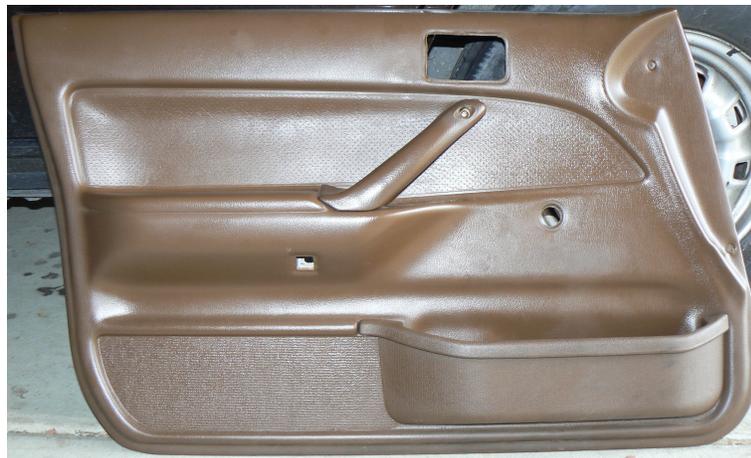
Removed inner door panel

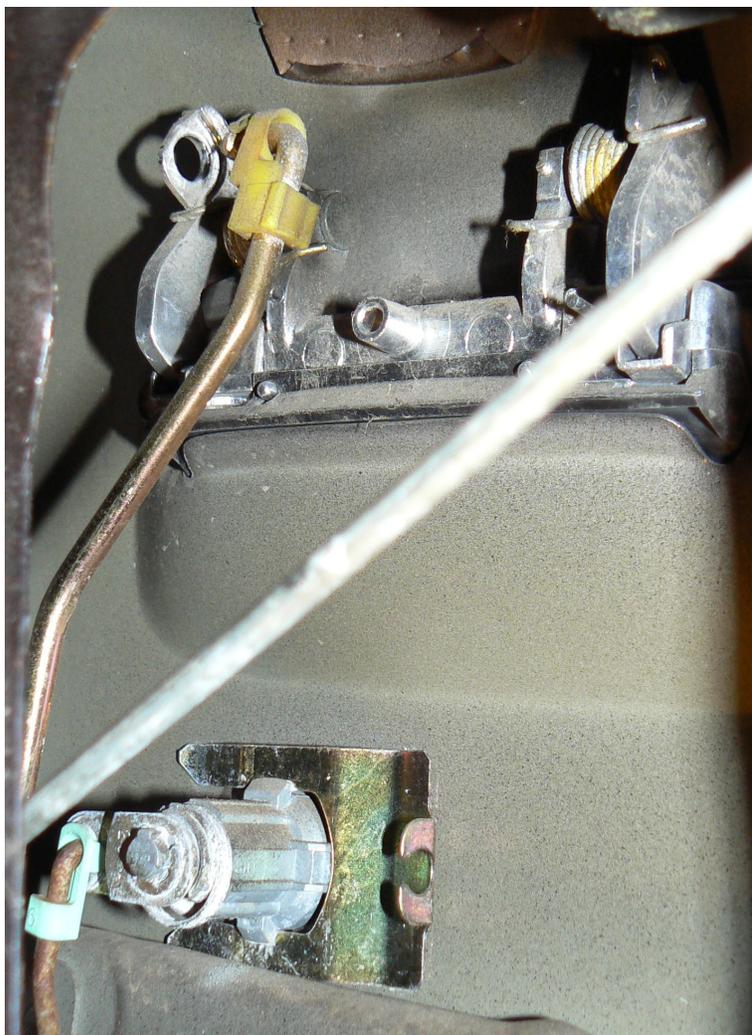
Disengaged door hinge caused "Door not opened"

Yellow plastic clip deteriorates by heat and causes being disengaged door opening mechanism. Then, it results in deactivation of door opening.

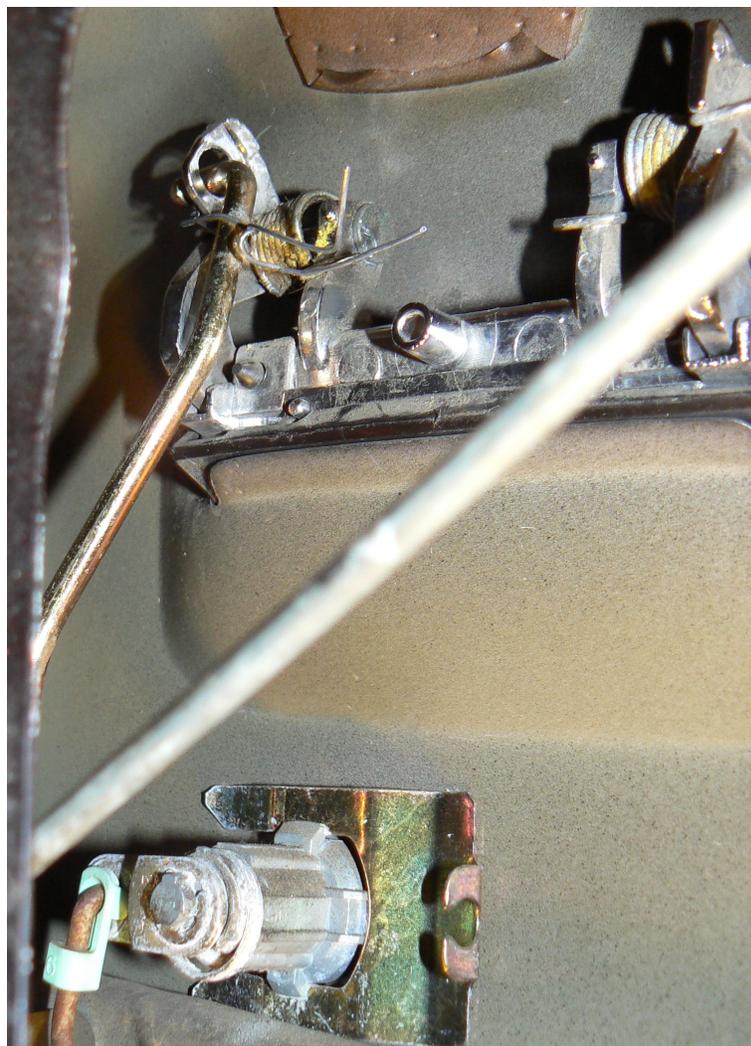
Engaged by wire resulted "Door opened"

Simple wired connection fix works.
