1993 Mercury Sable Wagon Constant Control Relay Module Replacement

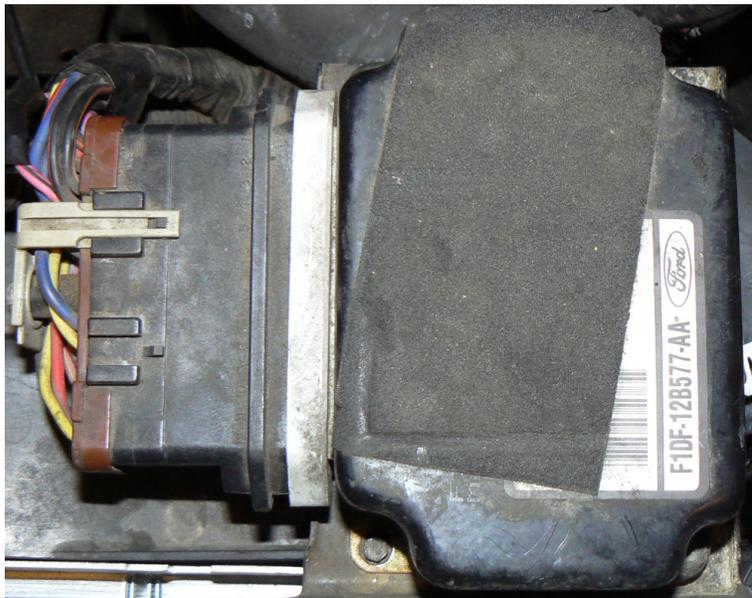
Old Relay Module Installed

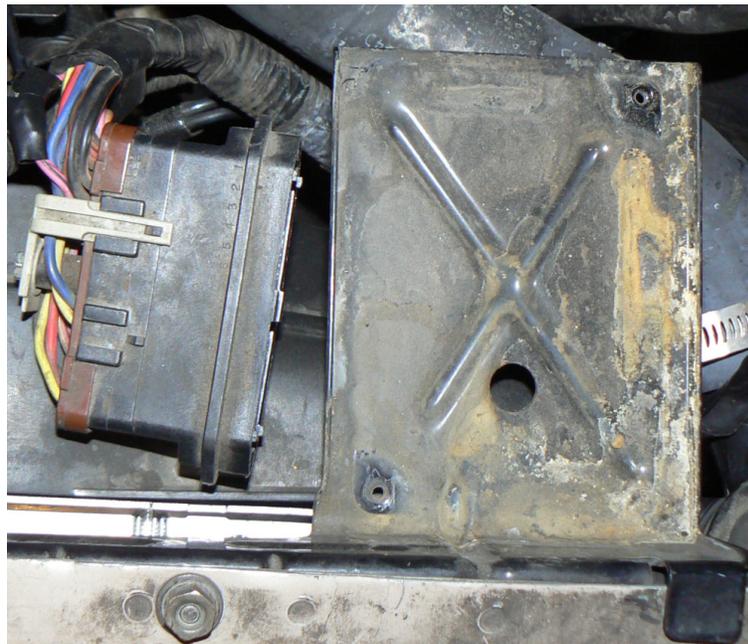
Connector & Bracket

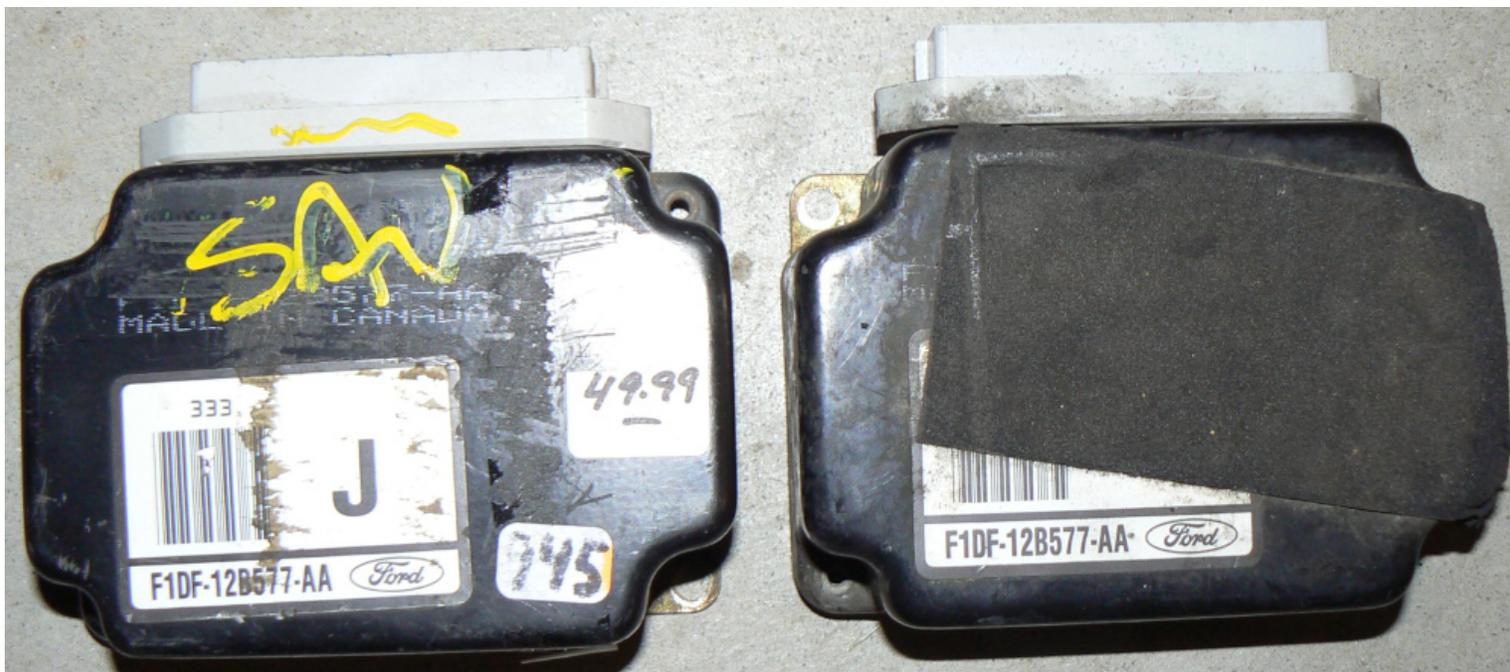
New & Old Constant Control Relay Module

While vehicle is running, engine stall tends to happen.

According to OBDI scanner, the cause was occasional contact failure of fuel pump relay installed in the constant control relay module (one of relays installed).
