1993 Mercury Sable Wagon Power Steering Pump Replacement

Power Steering Pump & Pulley

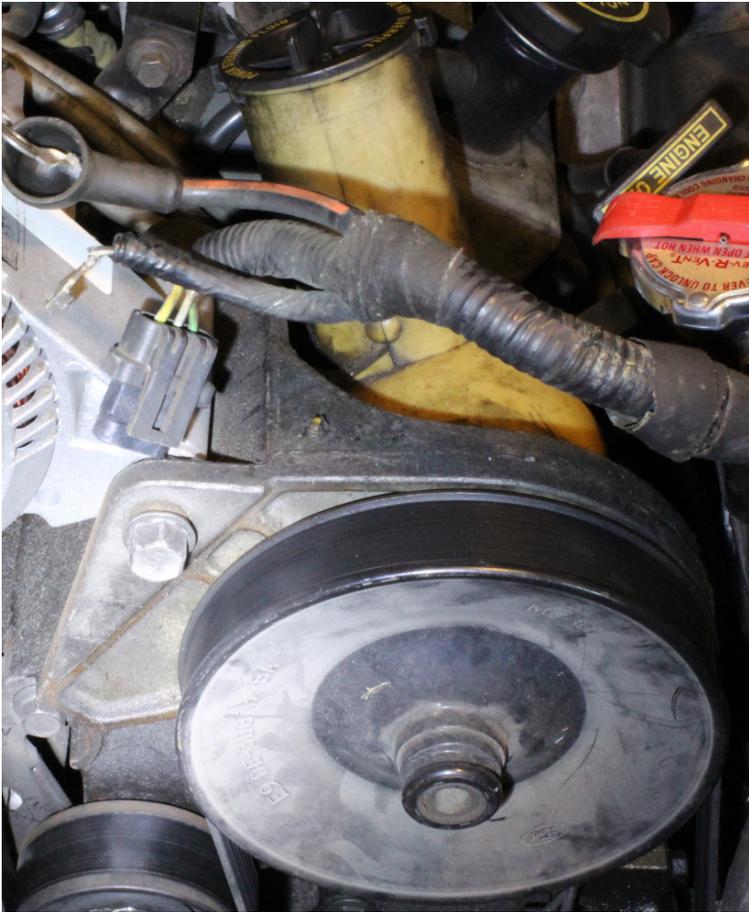
Power steering oil started leaking from cracked plastic reservoir of power steering pump.

Old Power Steering Pump Installed

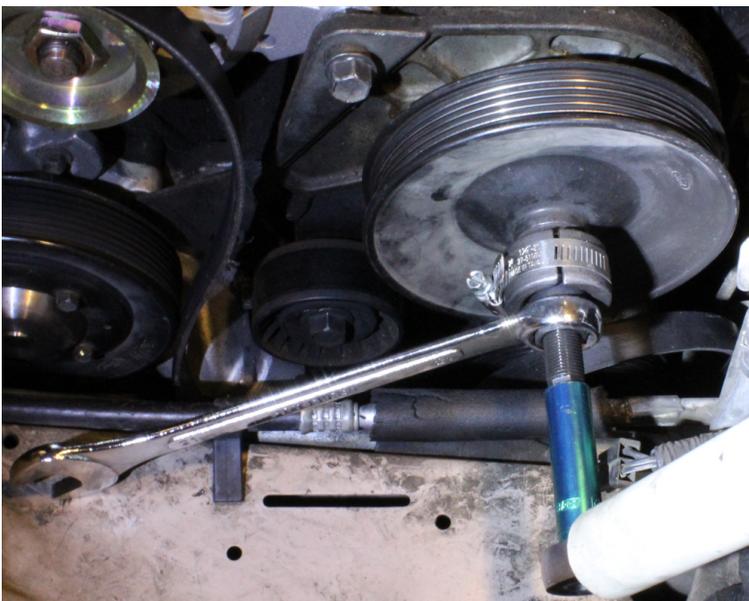
Removing Pulley

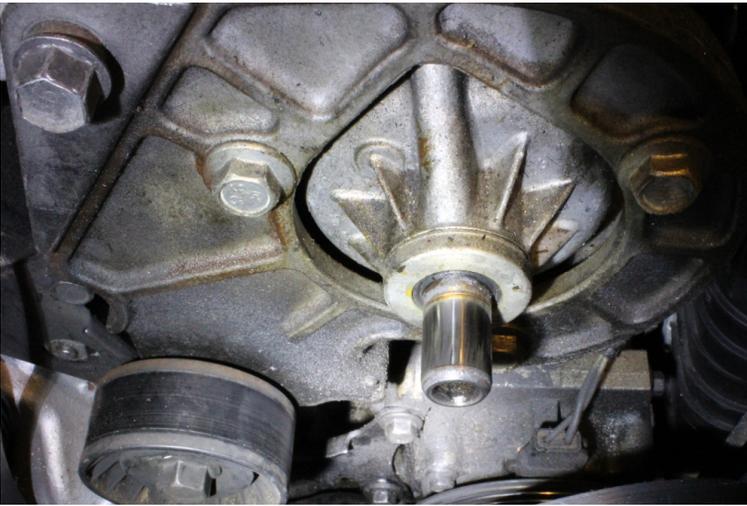
Pulley Removed

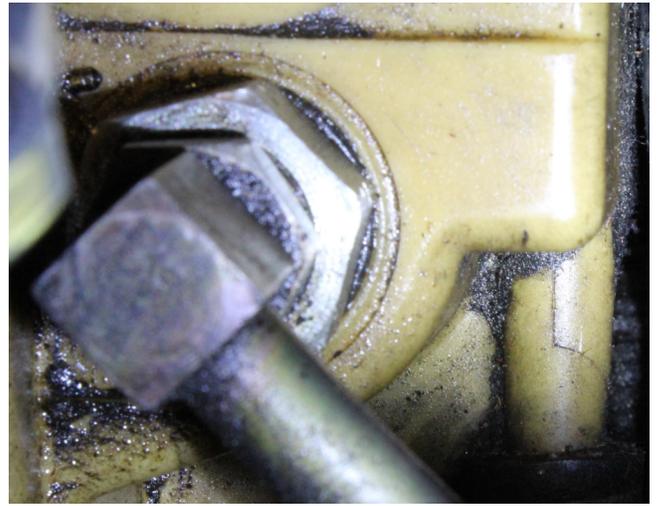
Crack on Plastic Return Hose Inlet (Design Flaw)

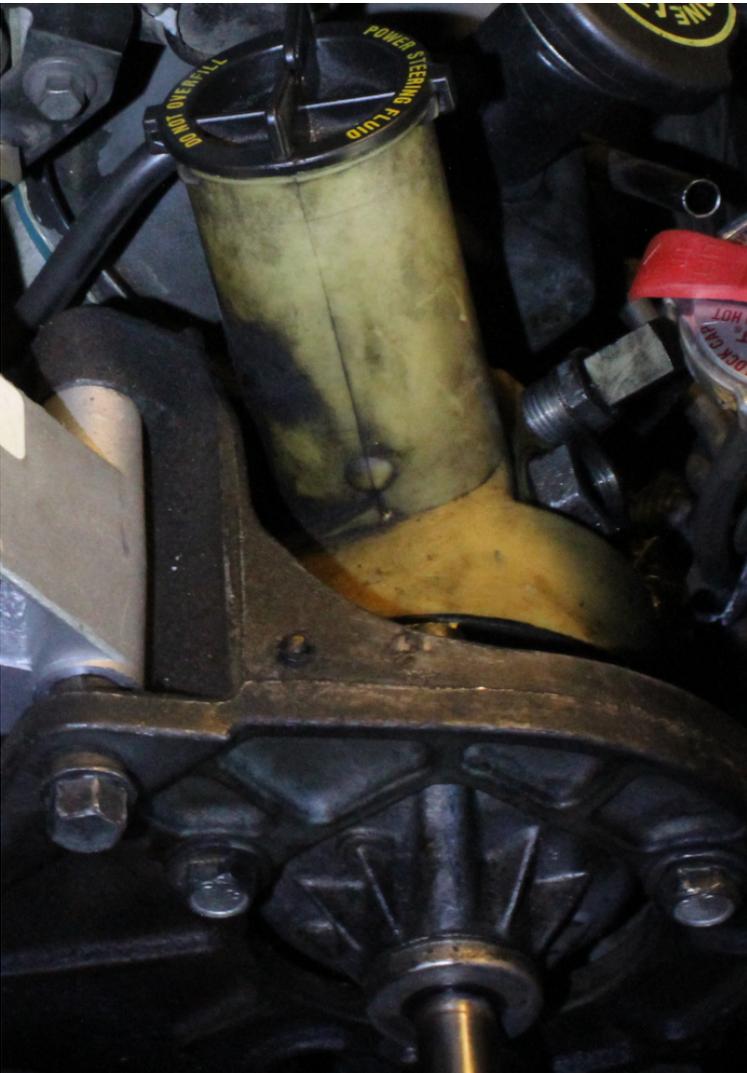
Pressure Hose Disconnected

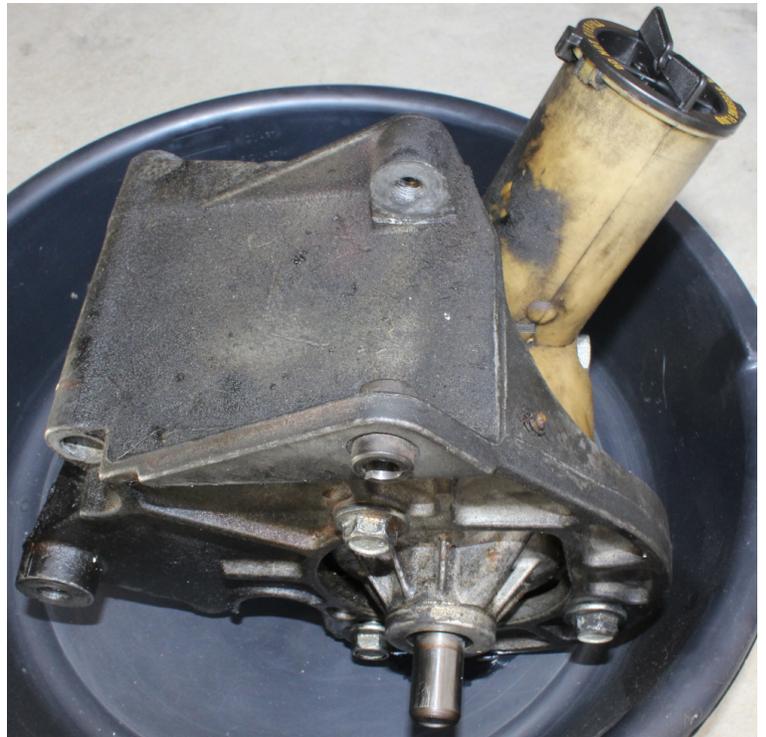
Power Steering Pump Removed (with Bracket)

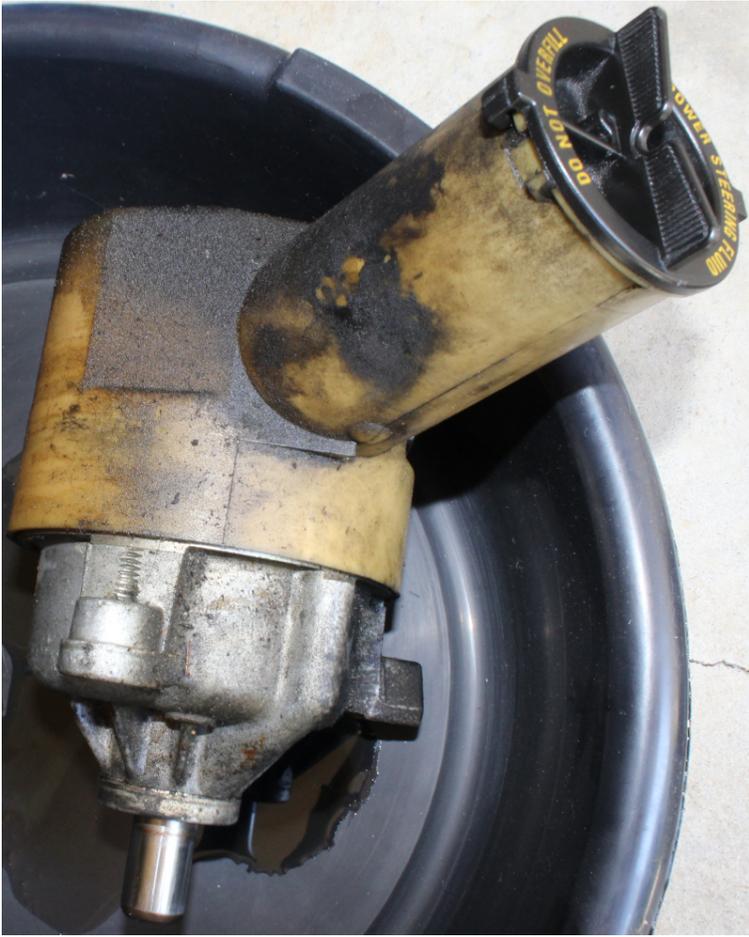
Power Steering Pump Removed (No Bracket)

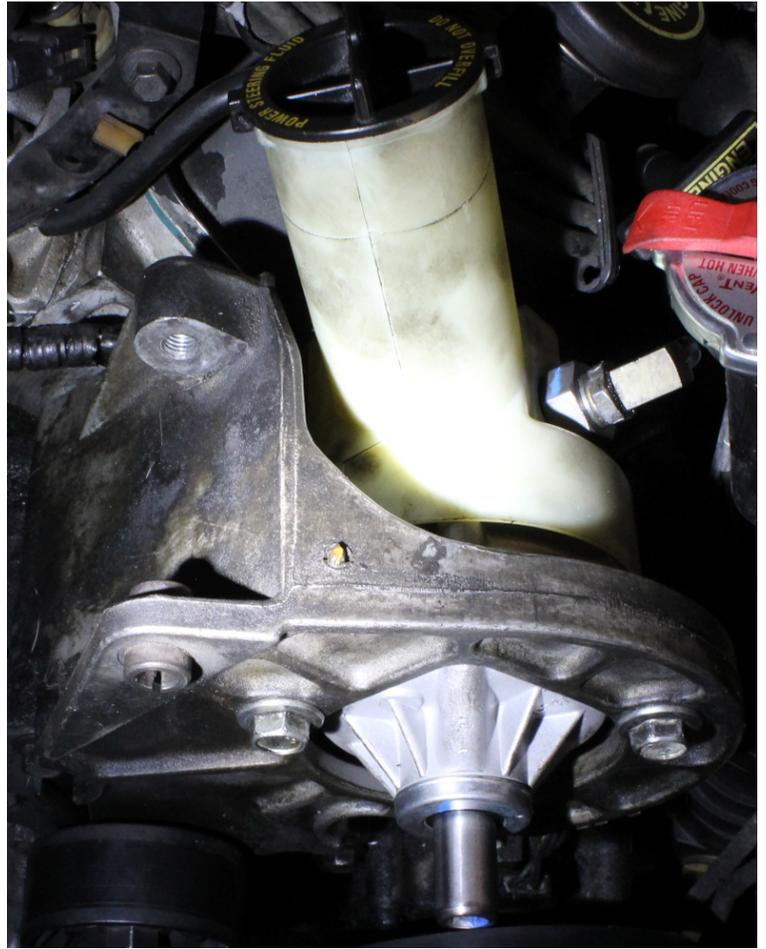
New Power Steering Pump Installed (No Pulley)

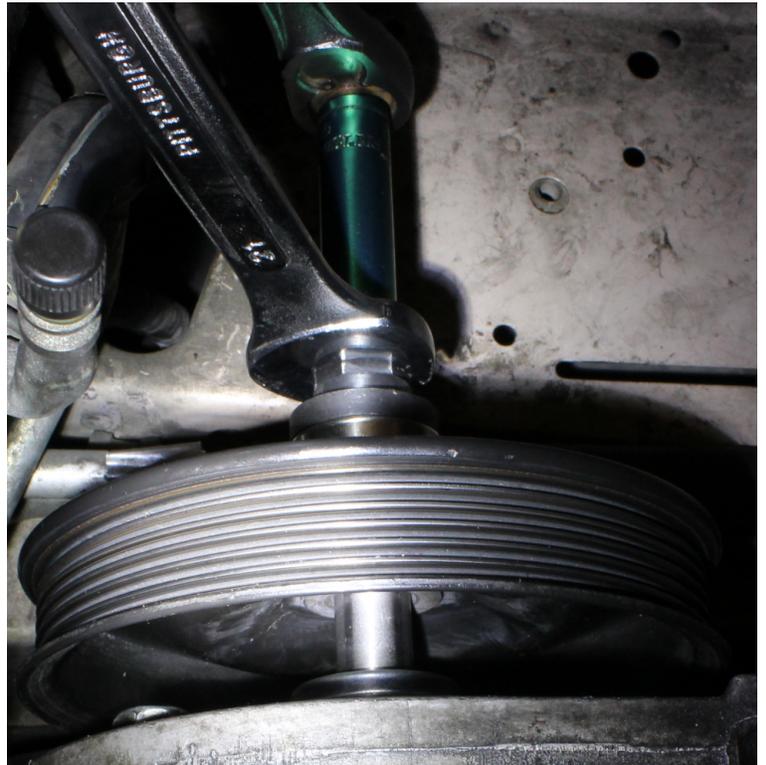
Mounting Pulley

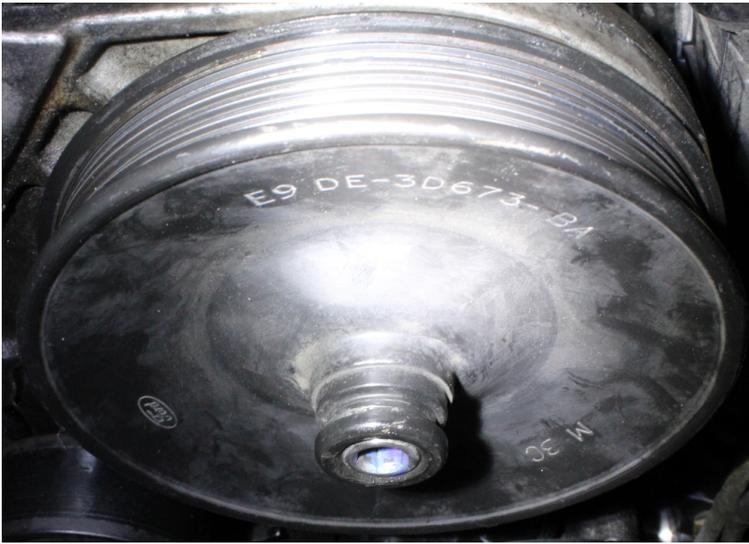
Pulley Mounted
