Zipper Slider Derailed

Actual Repair (Re-Engaging Teeth by a Slider newly Installed)

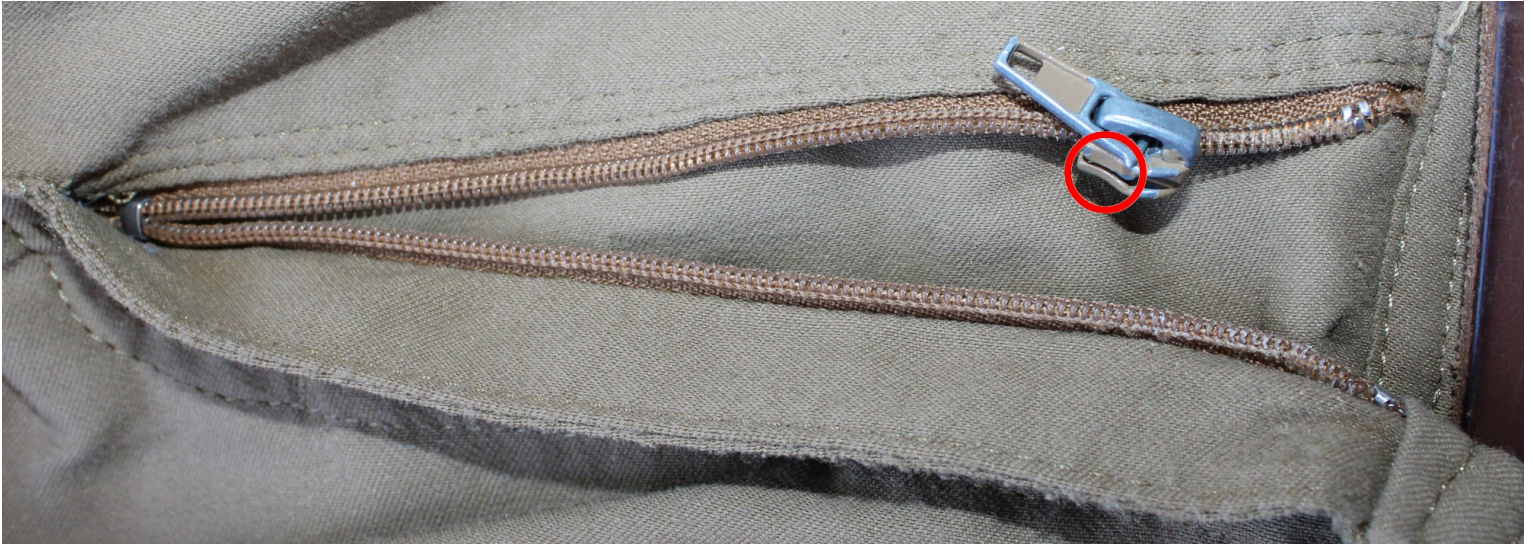
Derailed (Red circle shows the mouse of zipper slider to be widened by a flat head driver with a long-nose plier)

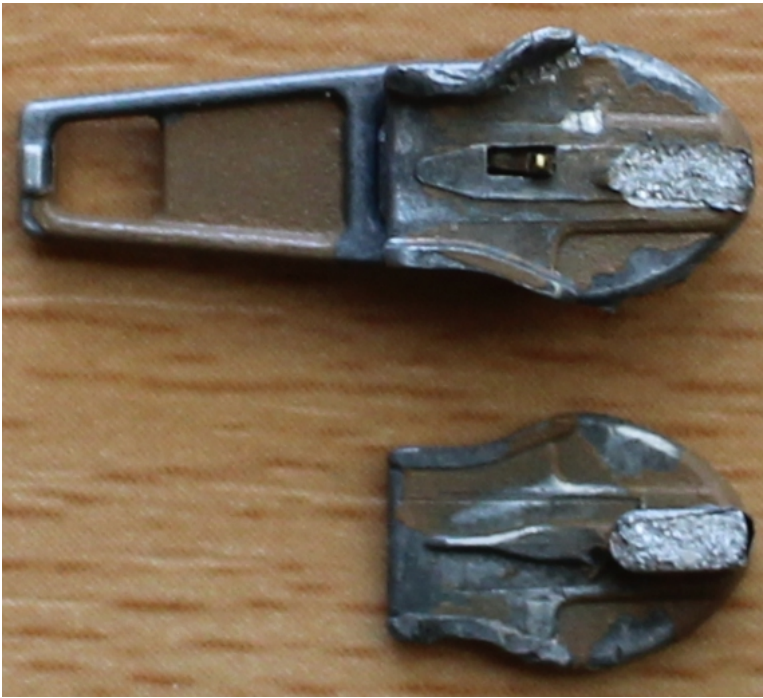
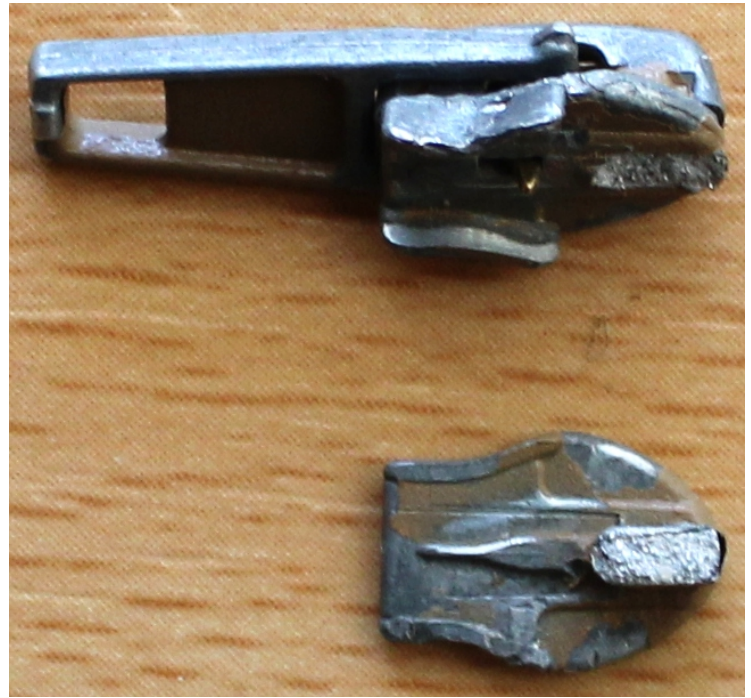
The zipper slider has derailed again. In the middle of second repair using the scheme above, the slider was miserably broken into two pieces due to too much force applied (Diagnosis: Complete jaw dislocation).

Warnings: I do not recommend the way shown above. The optimum way is introduced below.

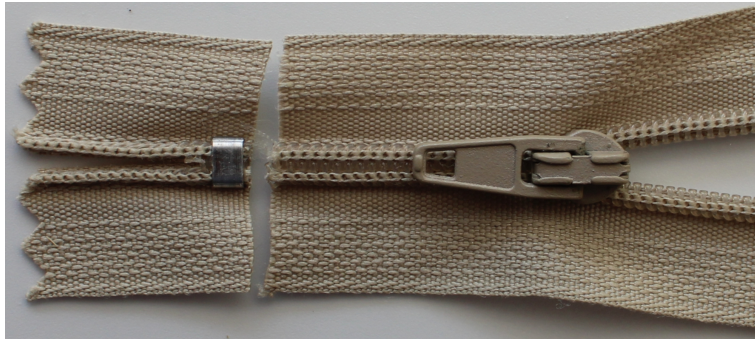
Zipper tape cut

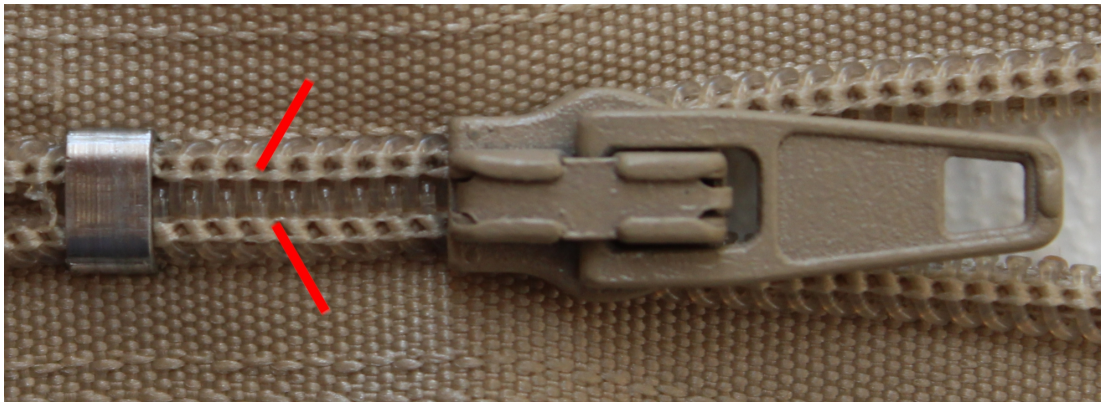
Cut position of zipper tape (between 4th and 5th tooth from bottom stop)

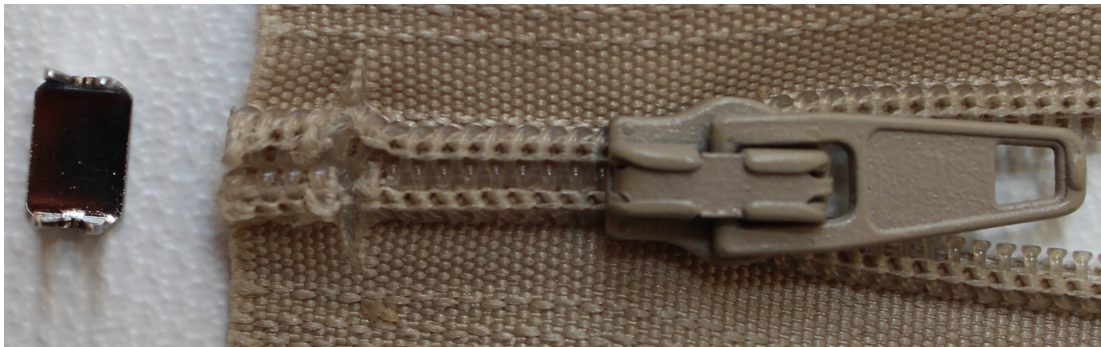
Engaging practice succeeded (A #7 bottom stop for mending the cut)

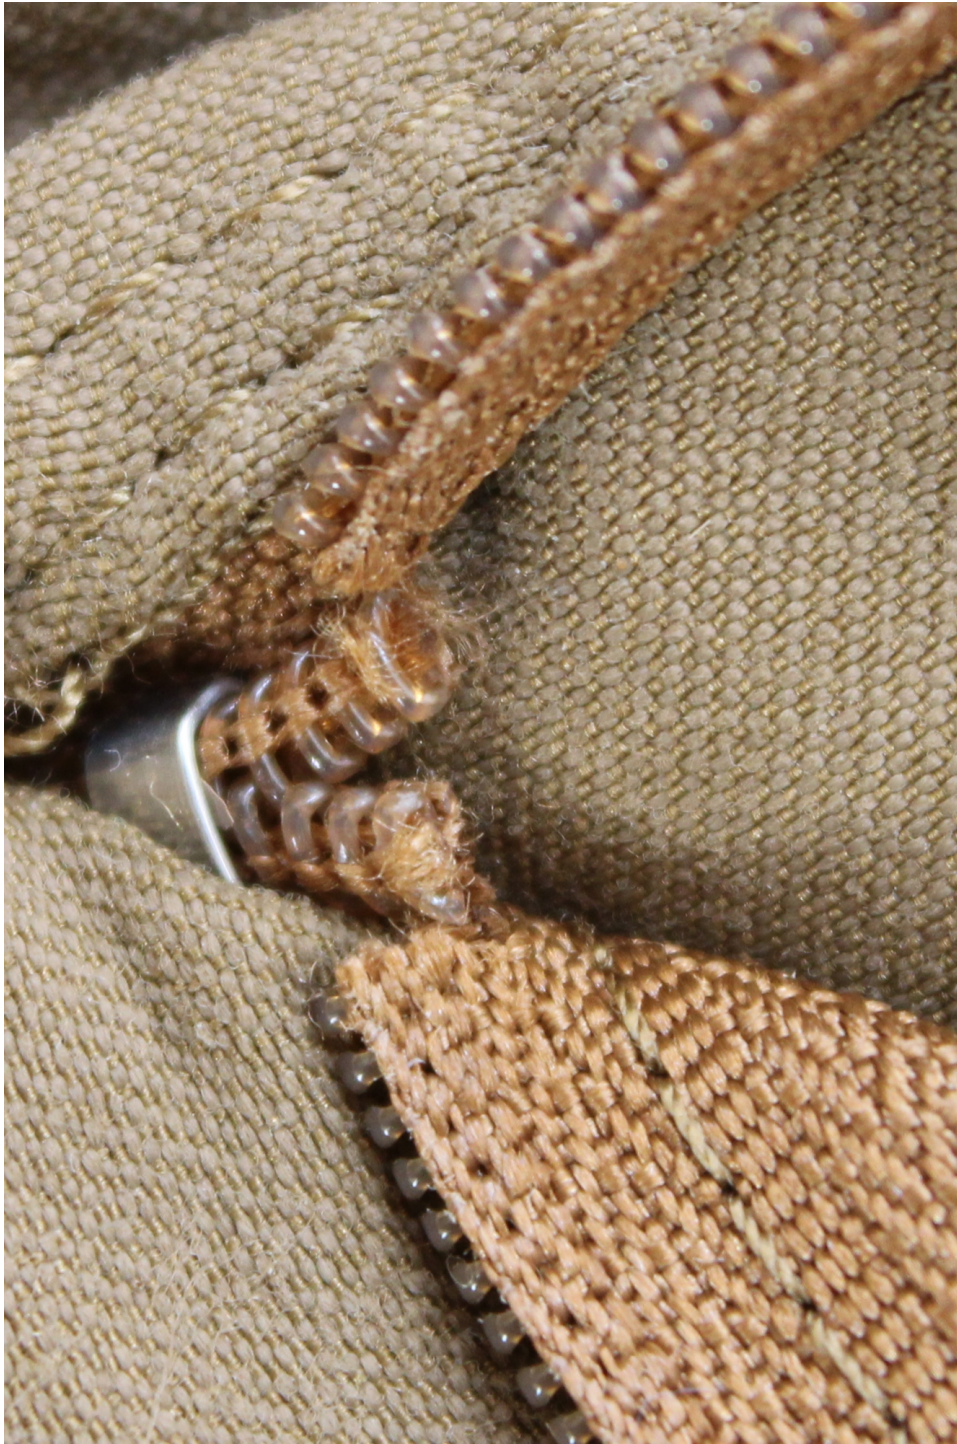
Cut zipper tape (between 4th and 5th tooth from bottom stop)

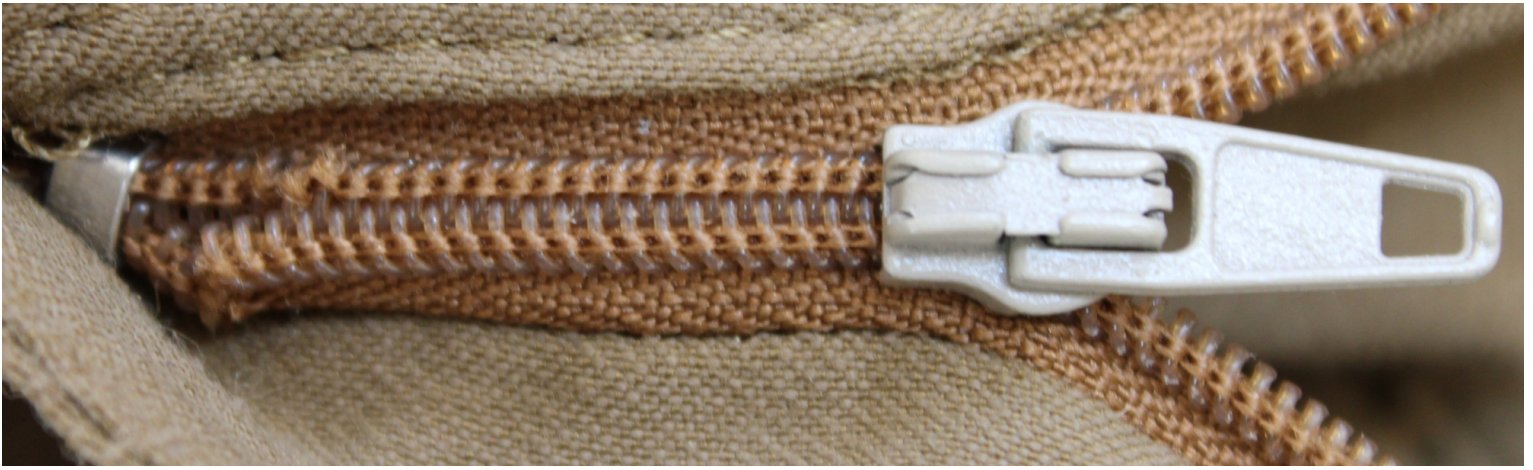
Slider in (lower 4 teeth not engaged yet)

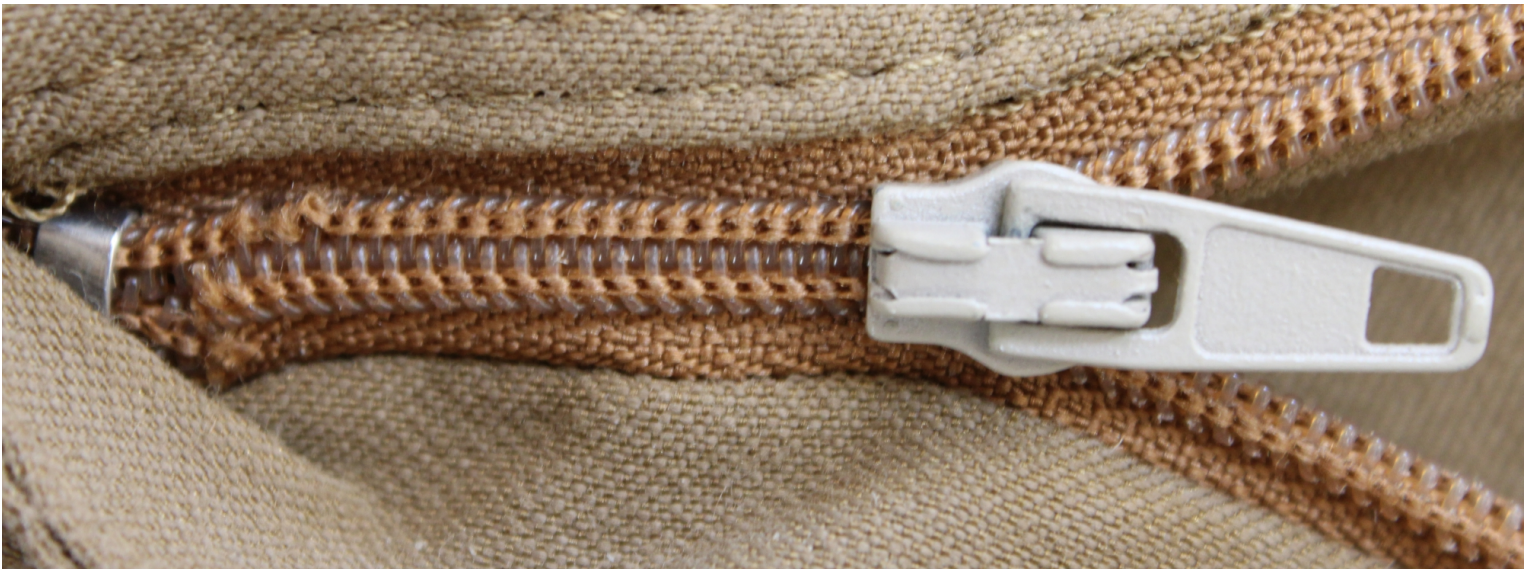
Success (Lower 4 teeth engaged manually by using finger nails and a small minus head driver)

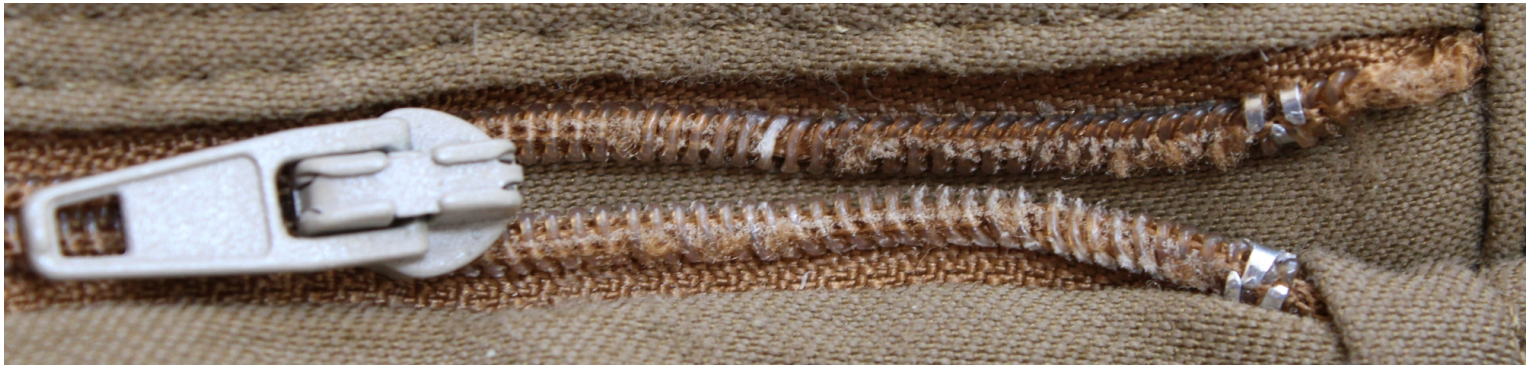
Lot of yarn waste near top stops (Probable cause of zipper slide derailment)
