1995 Toyota Camry Battery Terminal Replacement

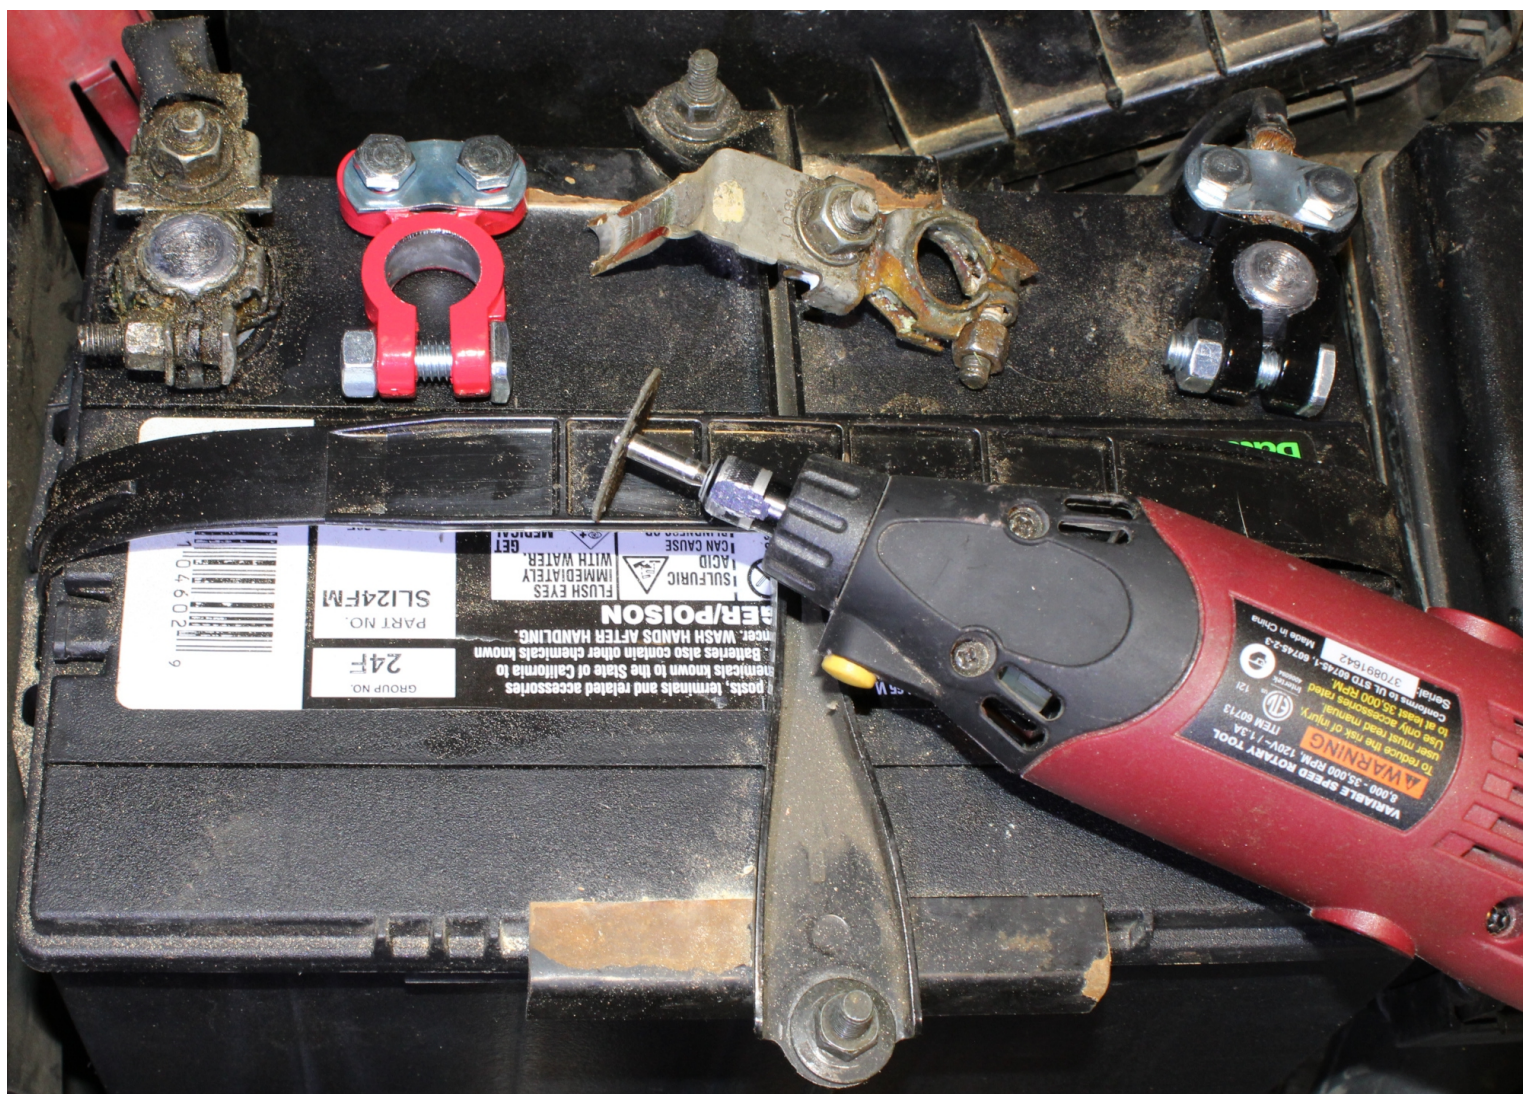
Negative battery terminal (right) replaced (Faulty insufficient contact without filing off black paint)

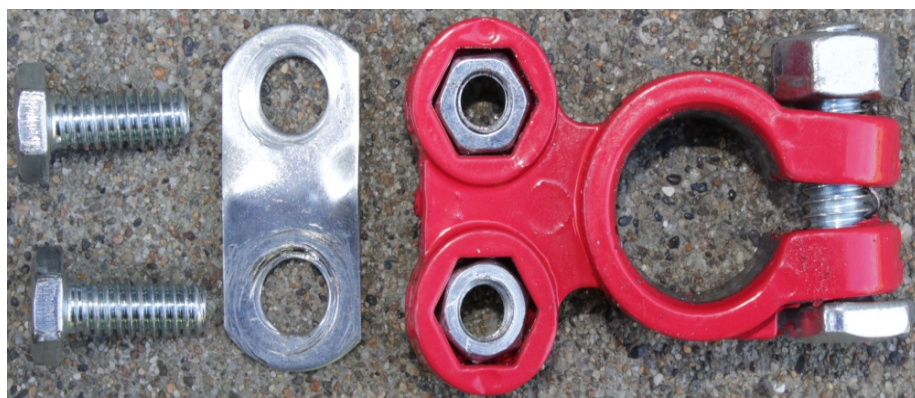
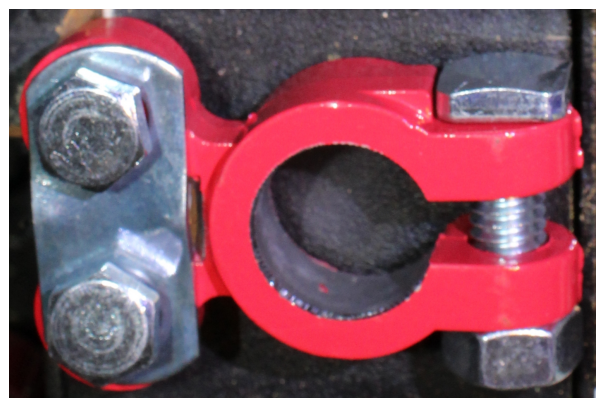
Good looking problematic battery terminal sold in market (Before filing off red paint on surface)
