1995 Toyota Camry Front Valve Cover Gasket Replacement

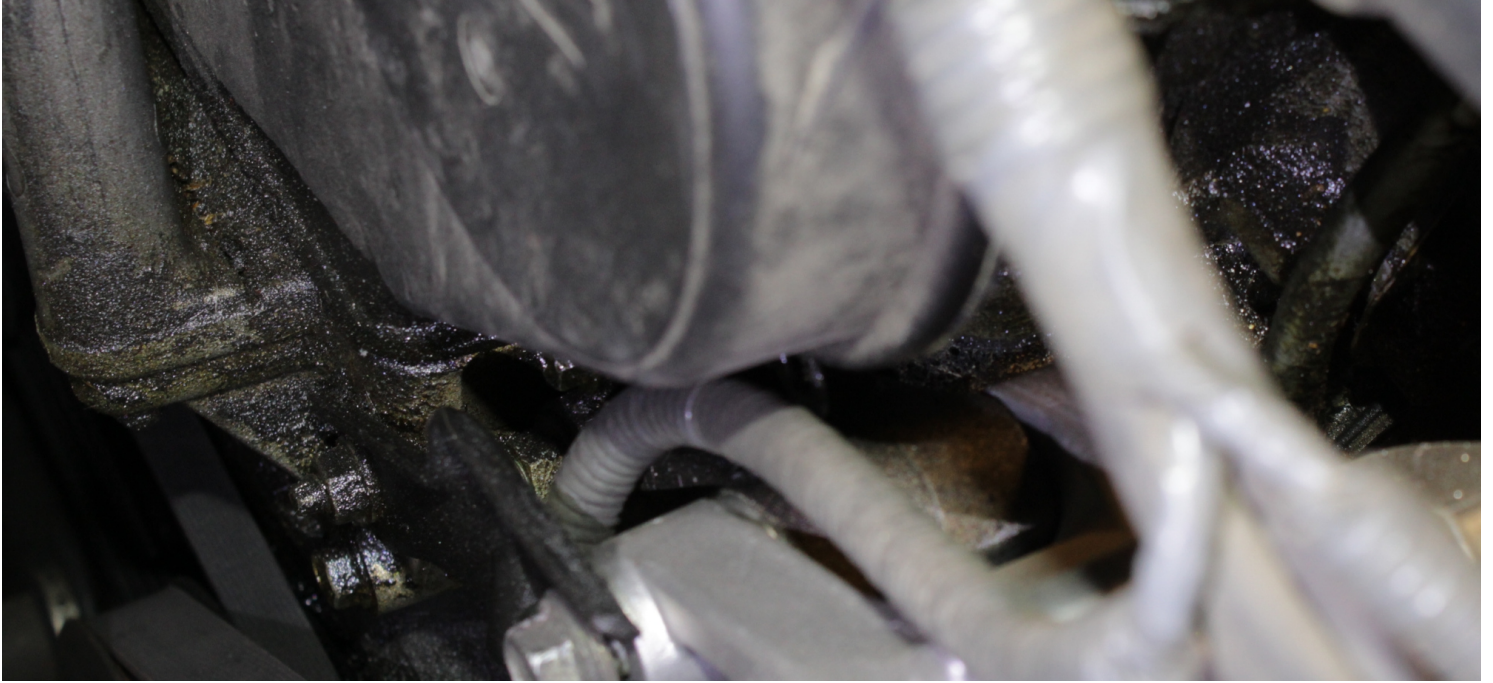
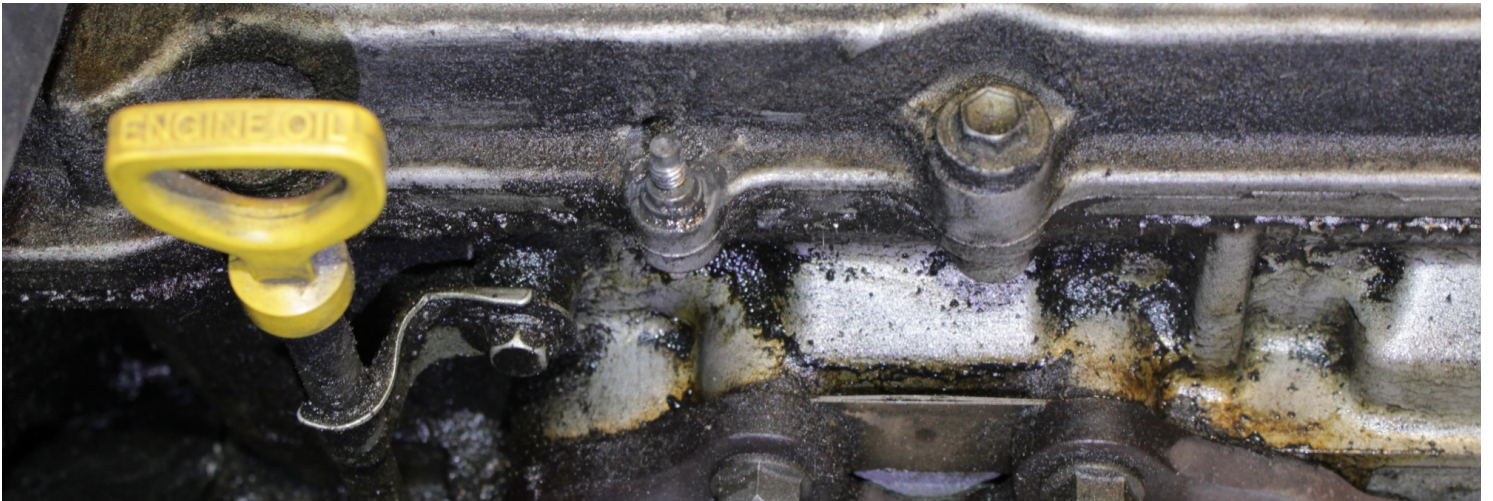
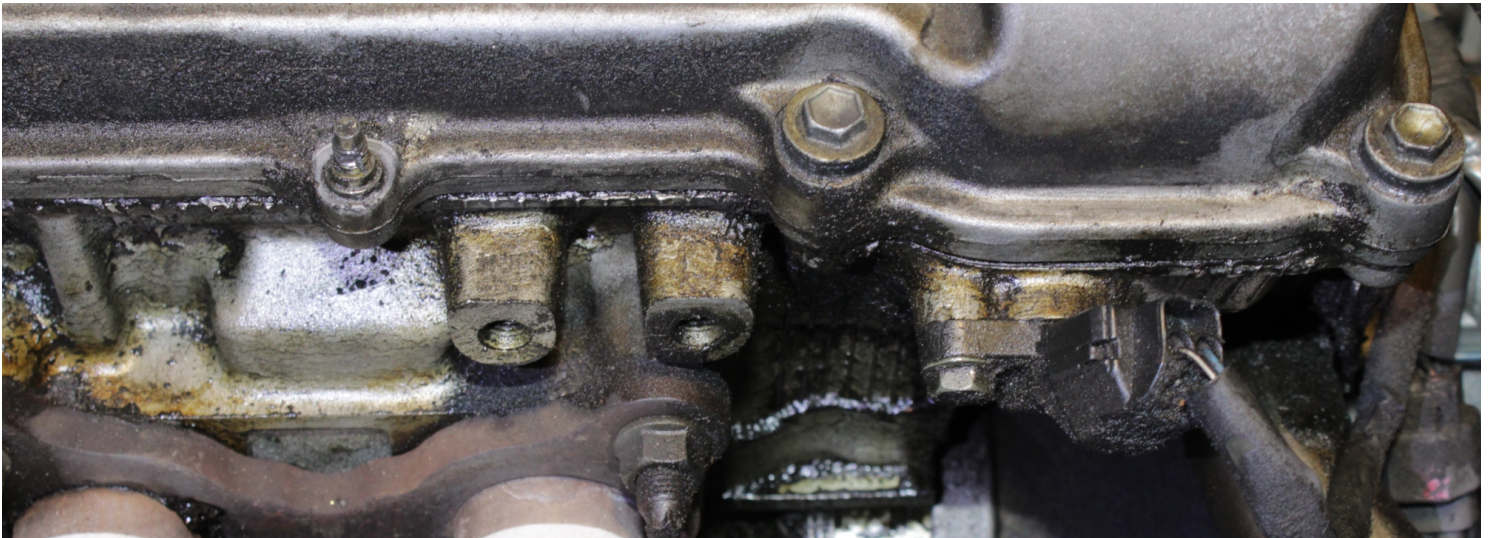
Left

Middle

Right

Consecutive but not intensive engine oil leak from front engine cover was observed.

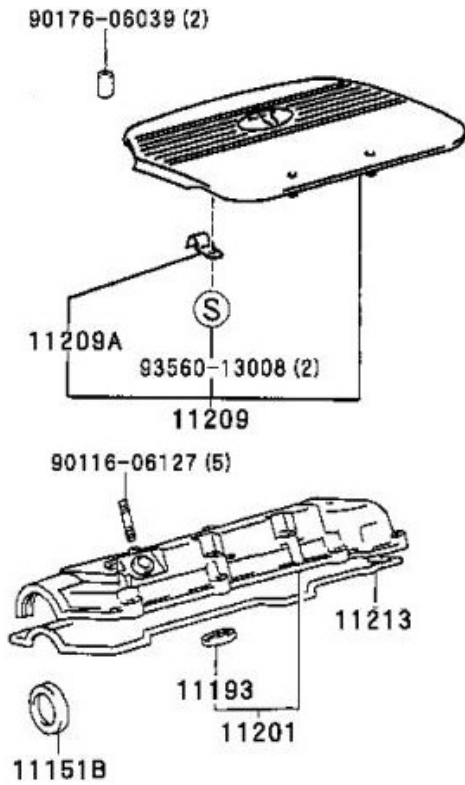
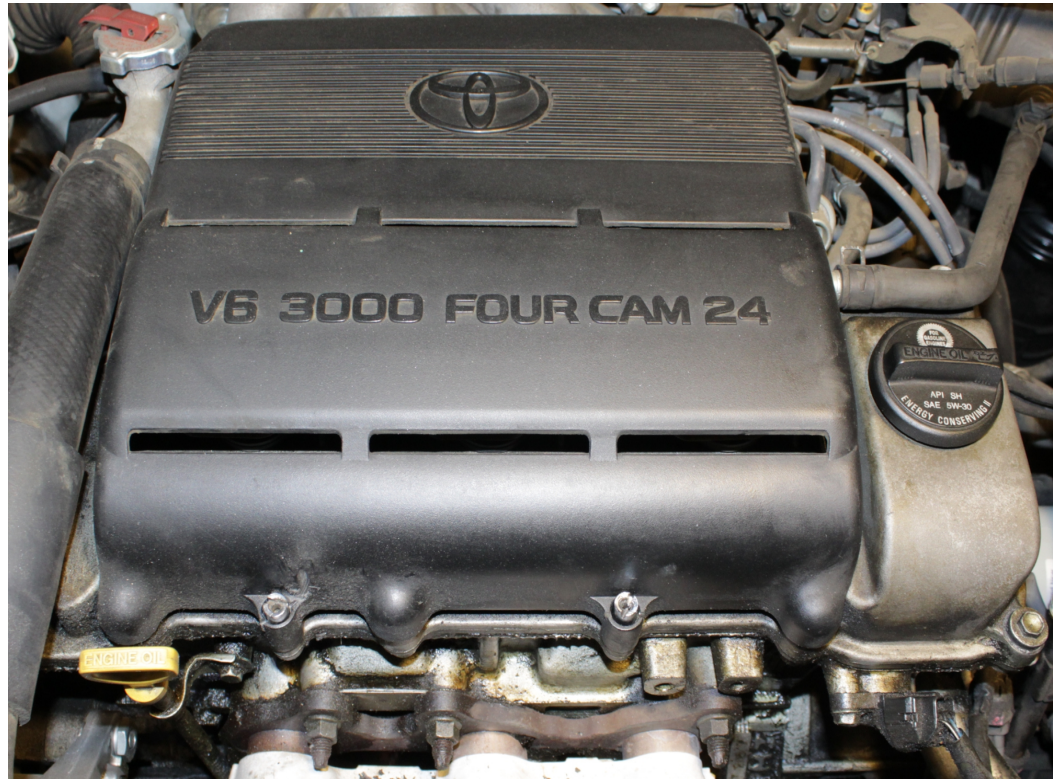
I faced with problem on removing a plastic engine cover caused by broken stud nuts although it had to be beginner level (Circle of like-minded people; 同好会 or 学会) work.

Plastic Engine Cover fastened by two stud nuts

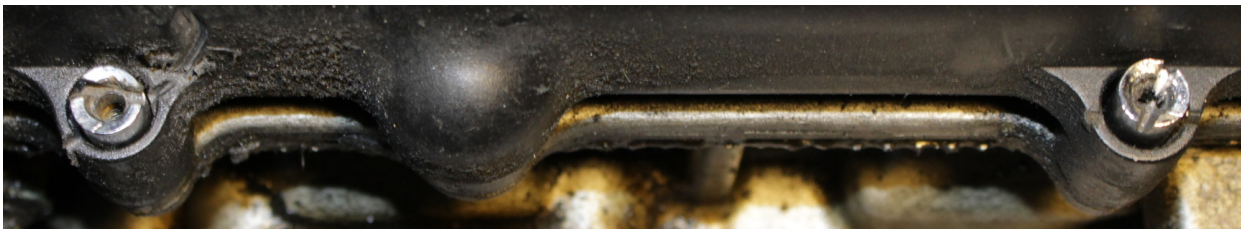
Old nuts made slit

Unable to unplug, Made slit by rotary tool with cutting disc, Unplugged by large flat driver

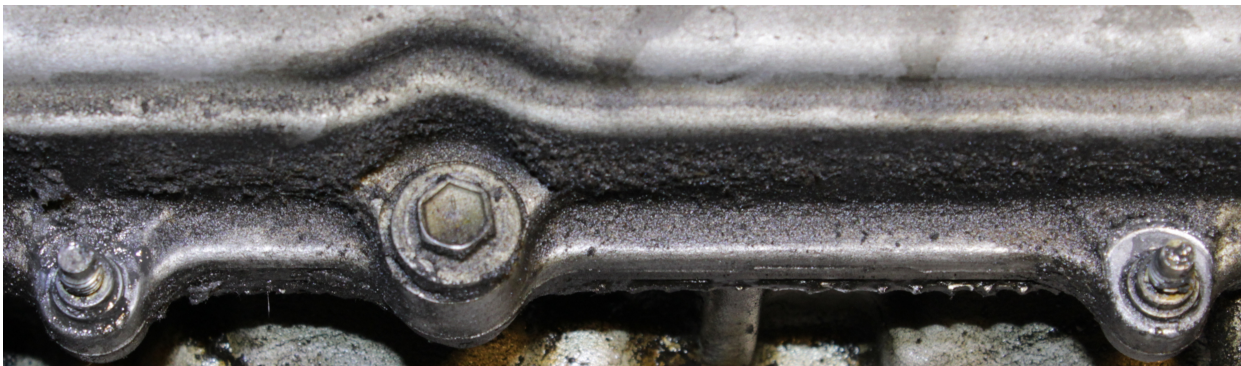
Old & New nuts

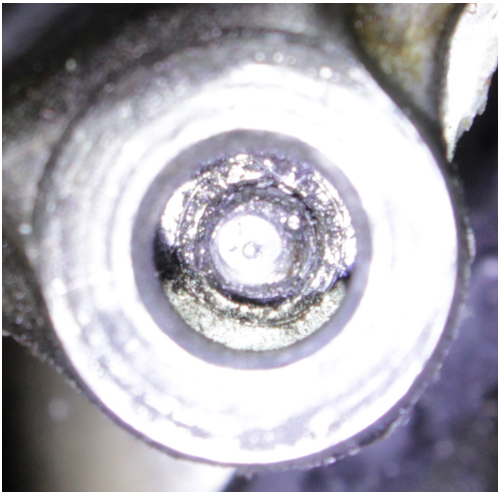
Center punch to get precise center

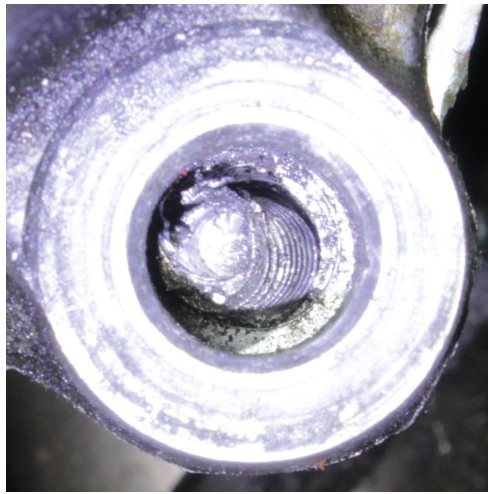
Successful removal

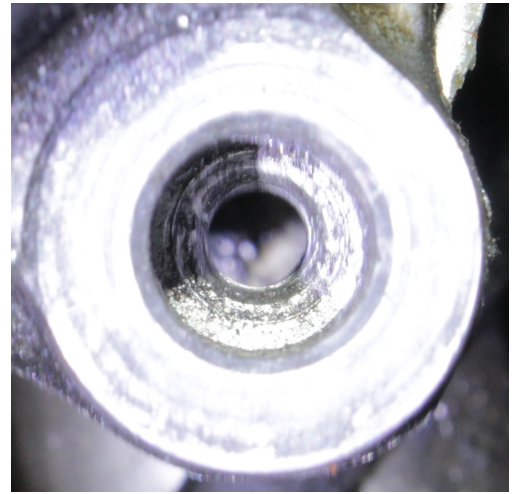
See through the intact thread

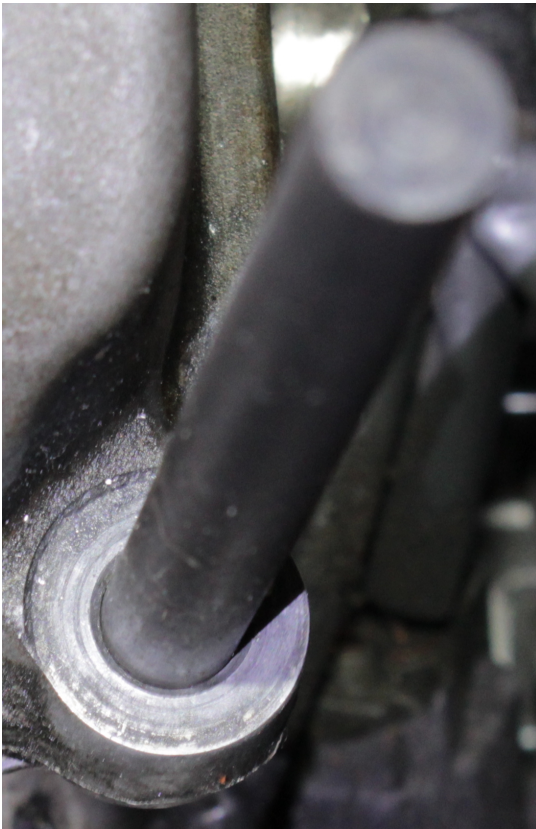
Center punch exactly fit the diameter

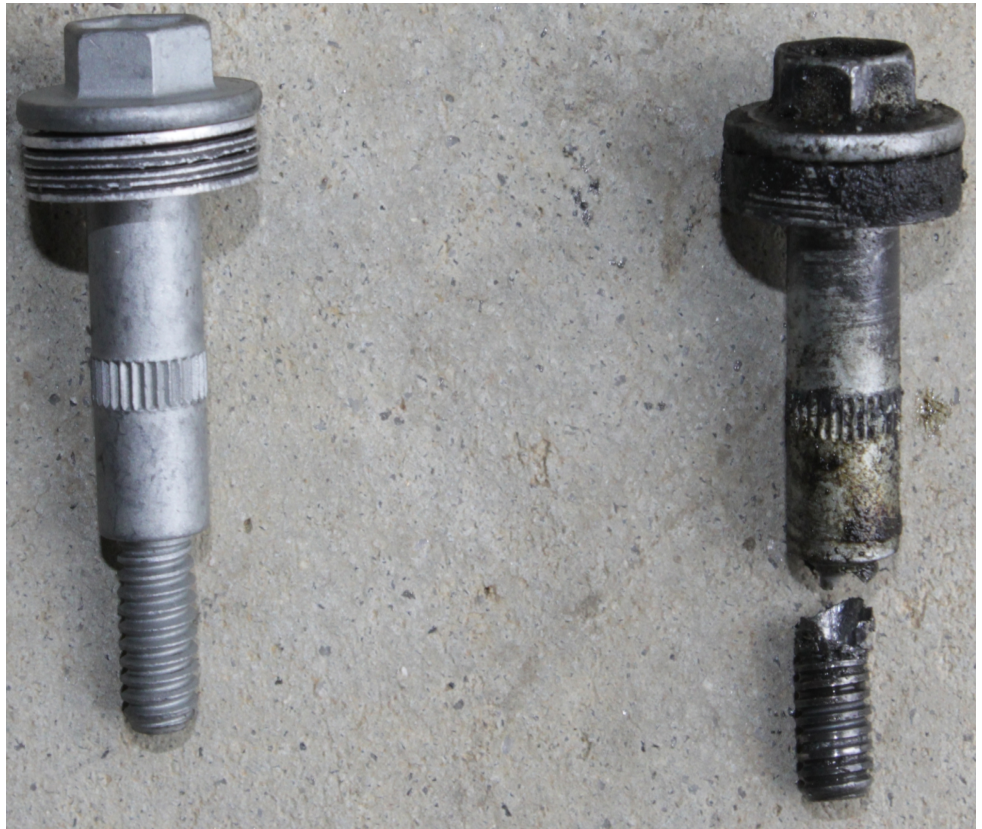
New stud bolt & Old stud bolt broke off

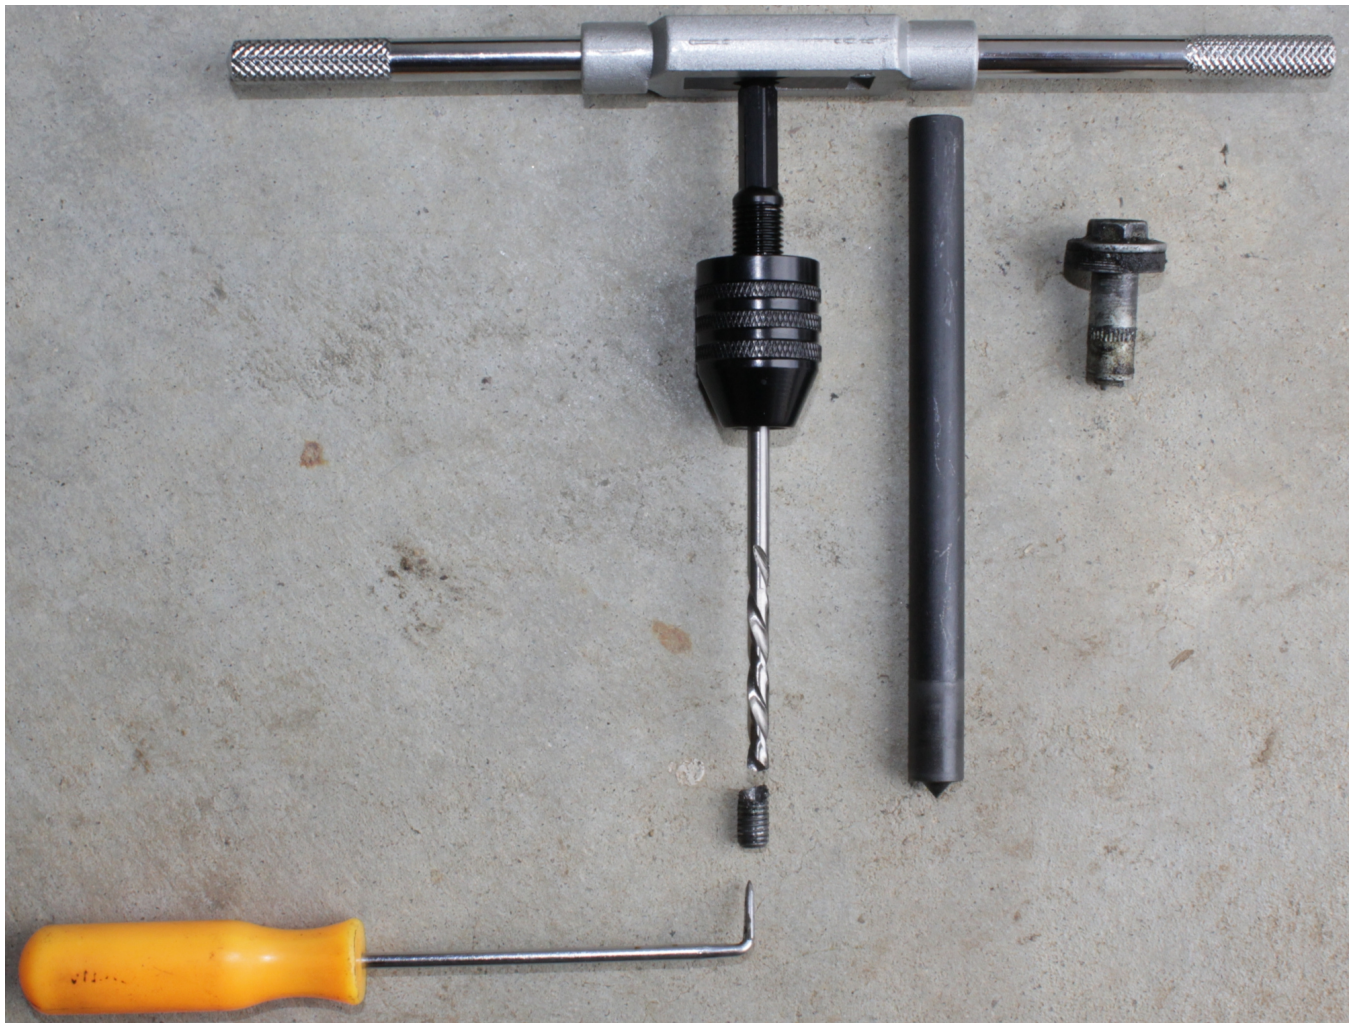
Anti-clockwise rotation pushing down lefthand drill bit by Tap & Die handle and Drill chuck
 Pushing up the bottom of threaded bolt head stuck,,, Reamer did not help in this case of restricted margin

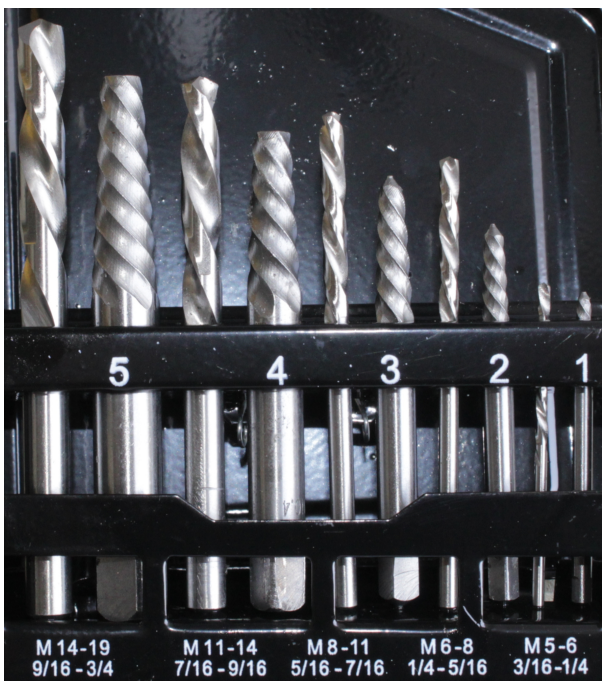
Lefthand drill bits & reamers

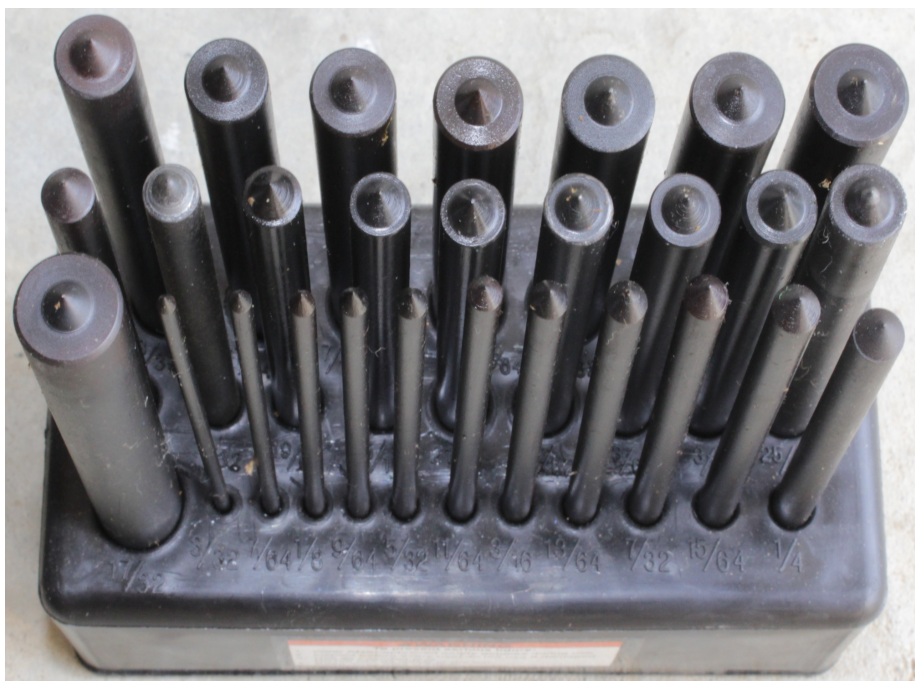
Center punches with various diameters

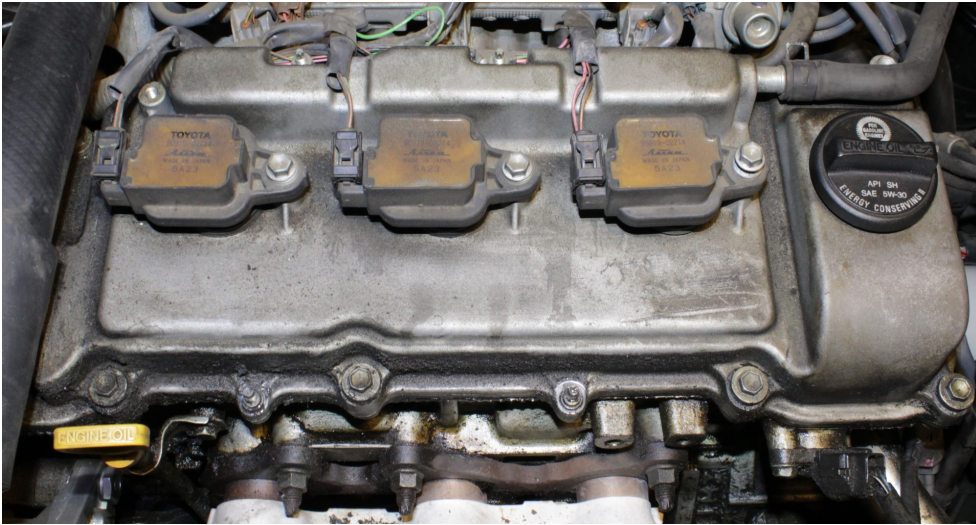
Plastic cover removed (Three ignition coil packs revealed)

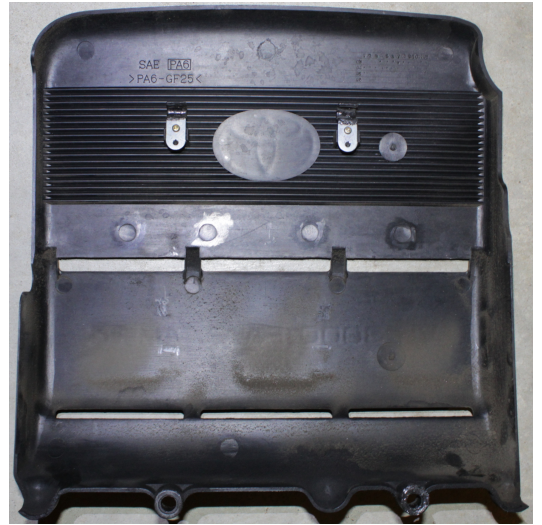
Plastic cover (Rear view)

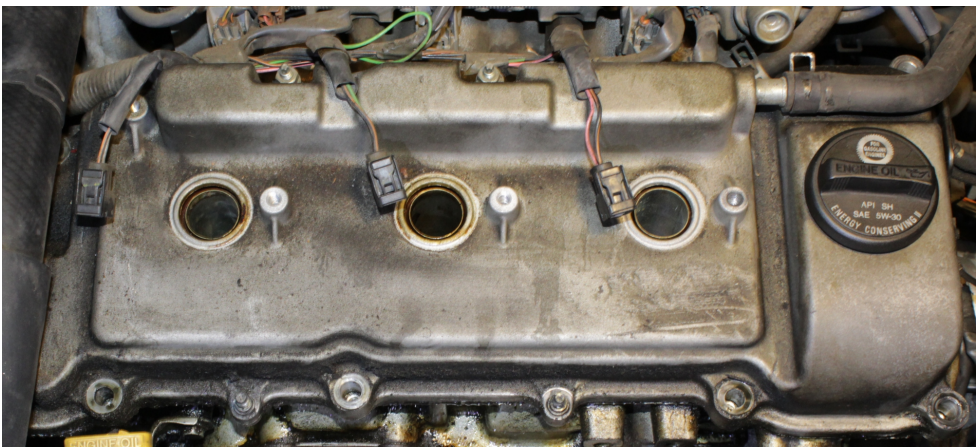
Ignition coil packs removed

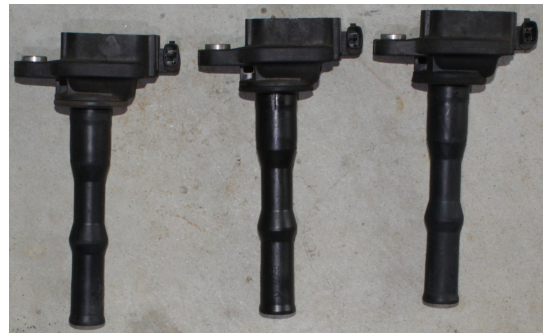
Three ignition coil packs

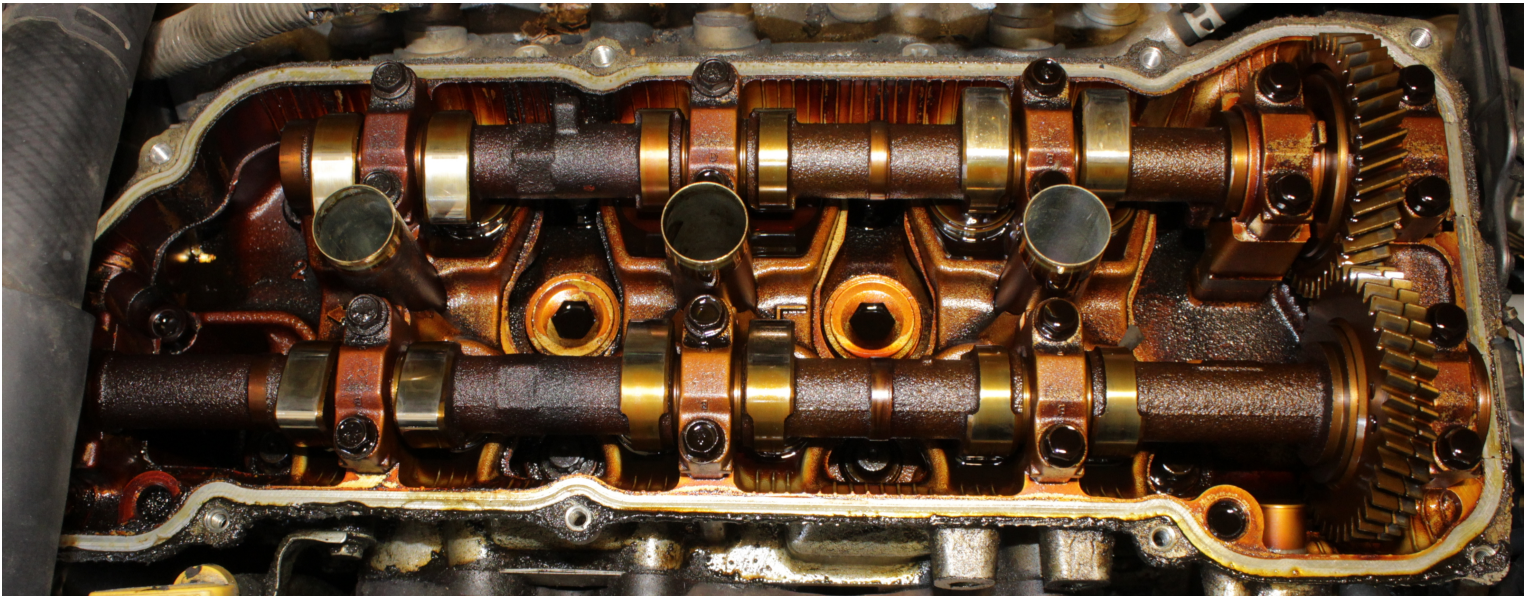
Inside engine room (Dirty engine oil remained should be cleaned out later)

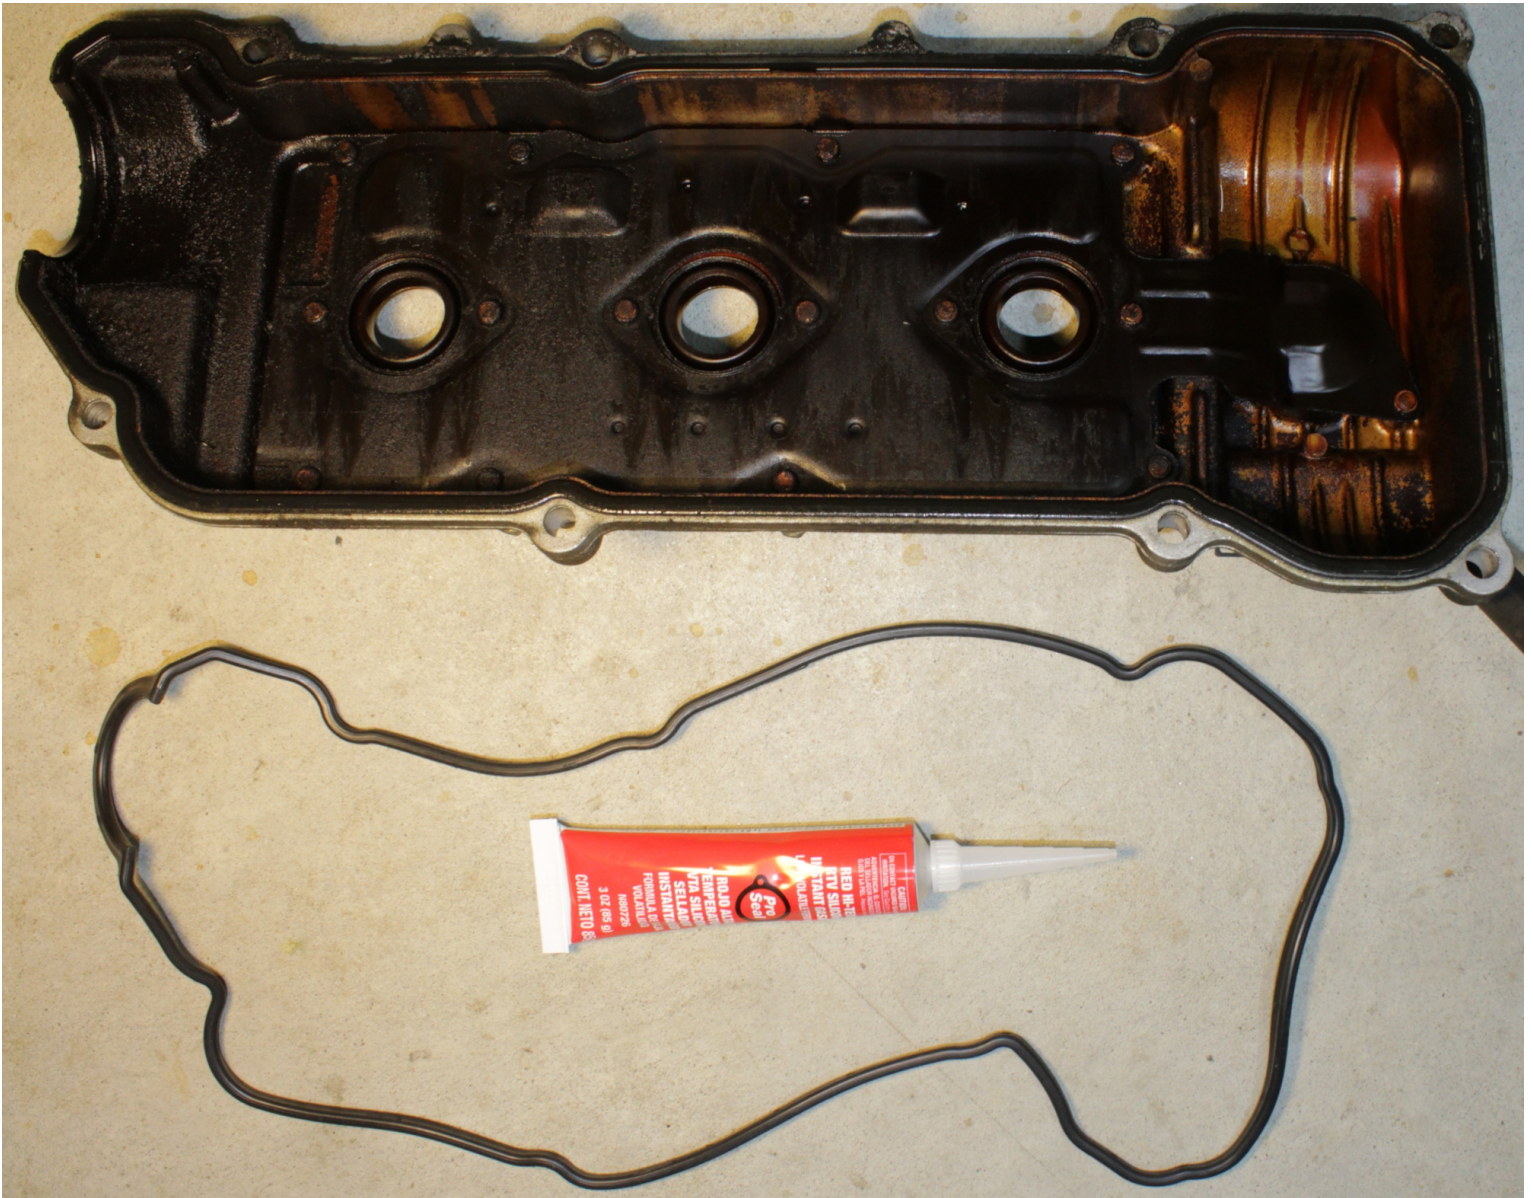
Front valve cover detached (Deteriorated black gasket must be replaced to new one (below) with sealant (red))

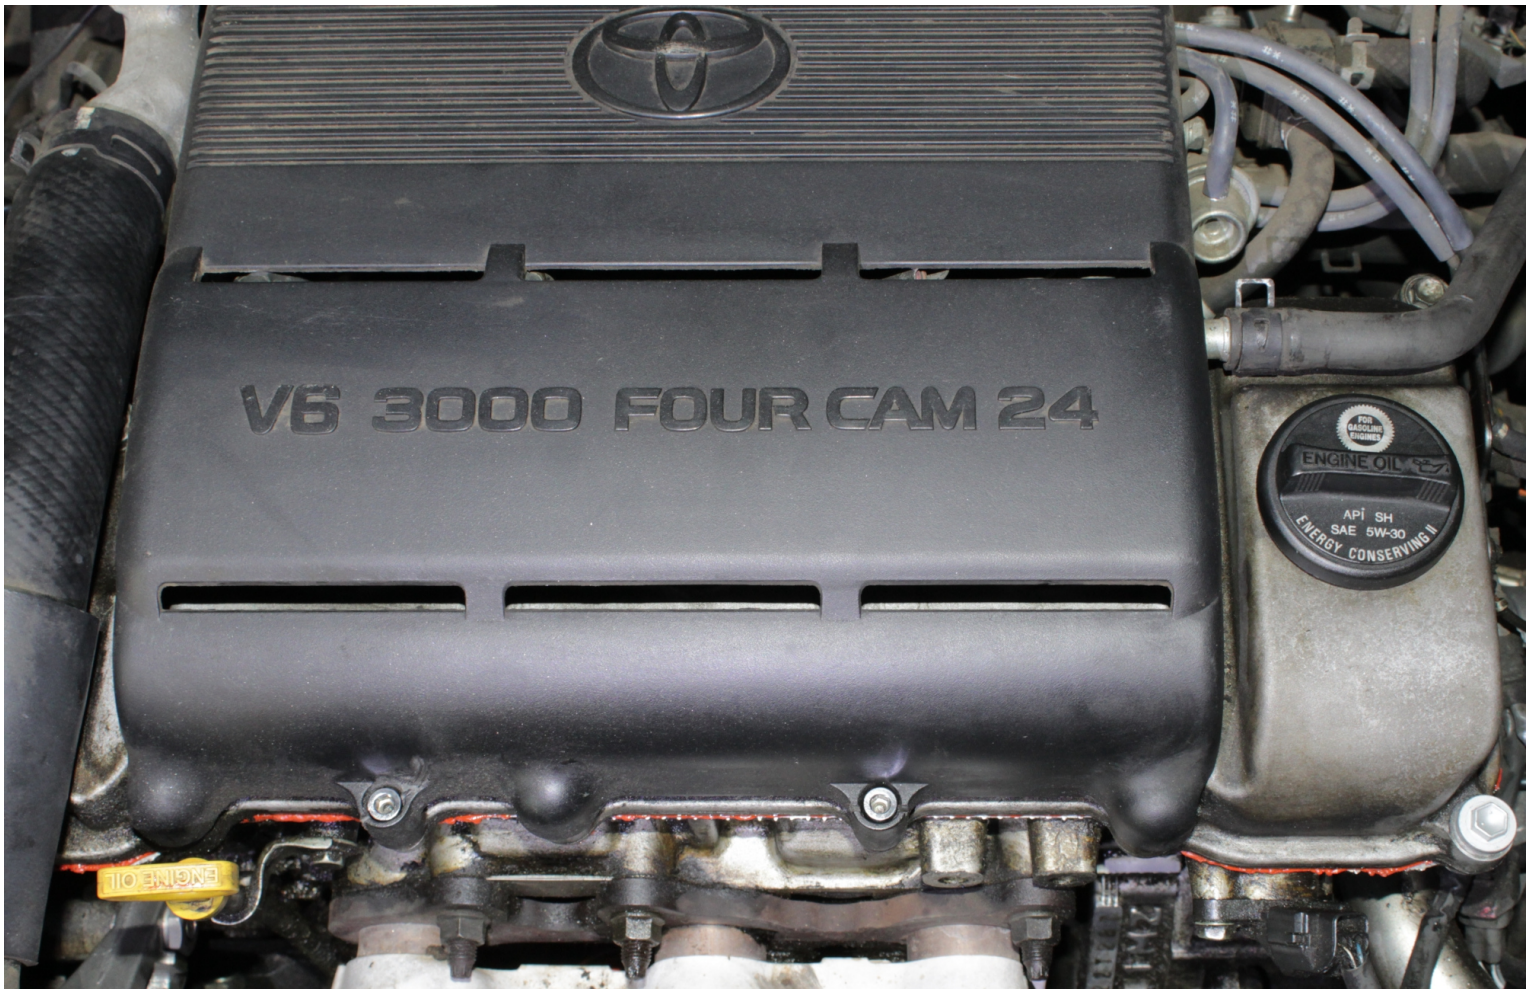
Done (Red sealant exuded, Stud bolt (lower right) and two stud nuts (center) replaced)
