1999 Toyota Avalon Coolant Thermostat Replacement

Check engine light lit and OBD II scanner indicated P0125.

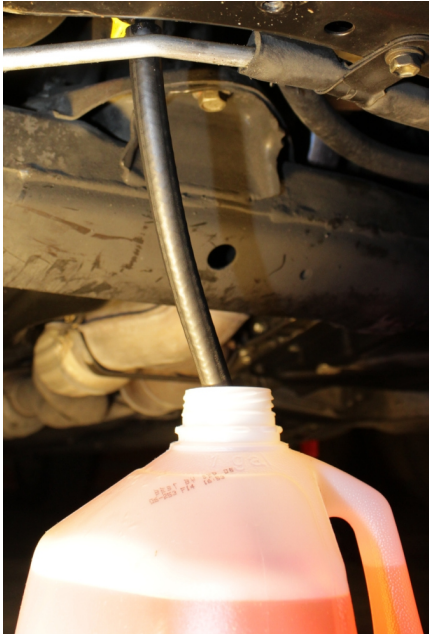
Draining coolant from radiator

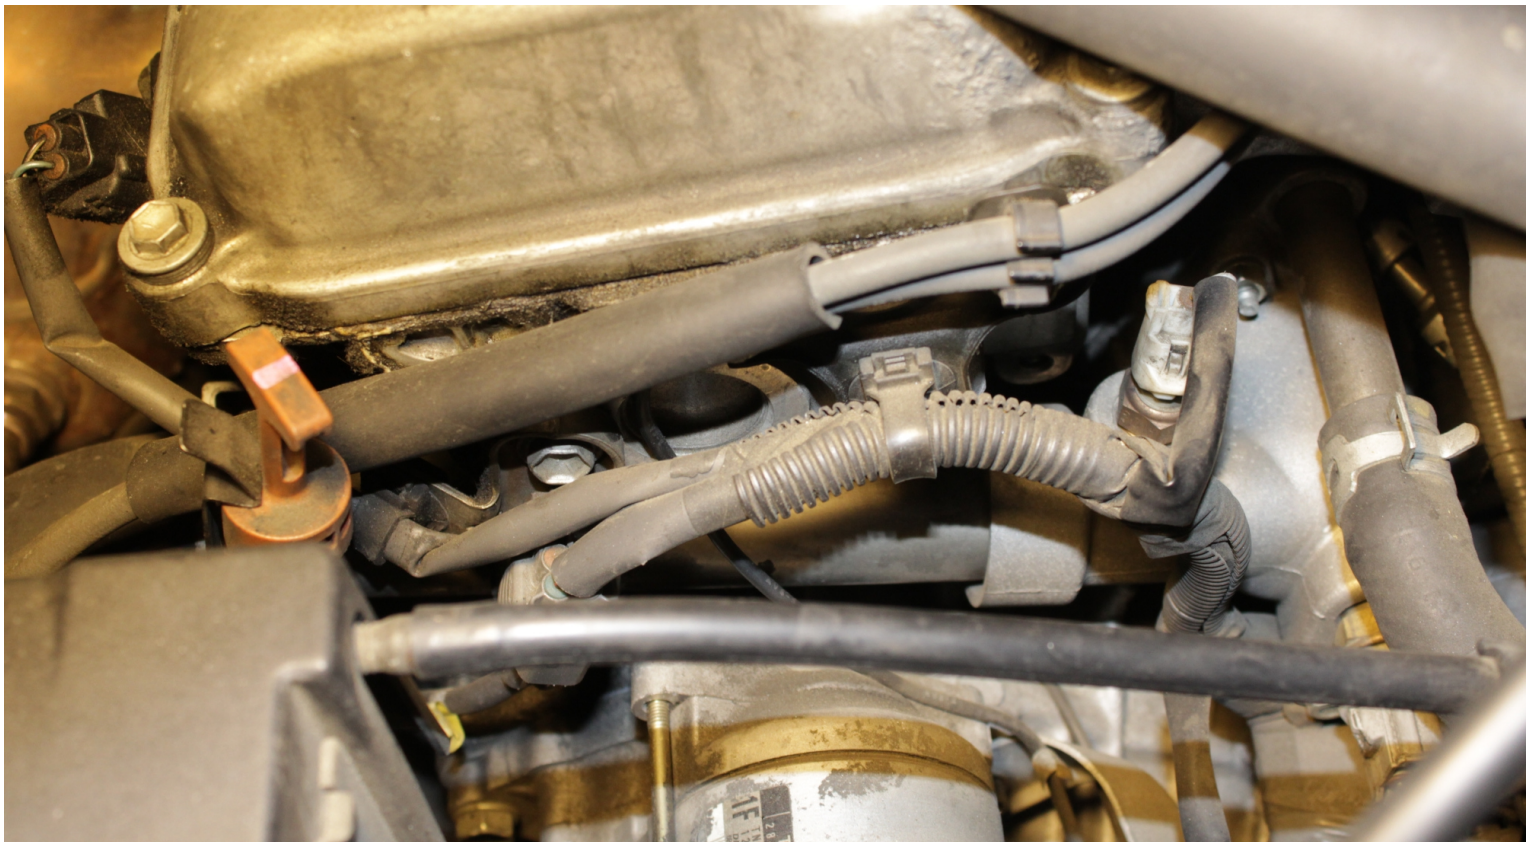
Before

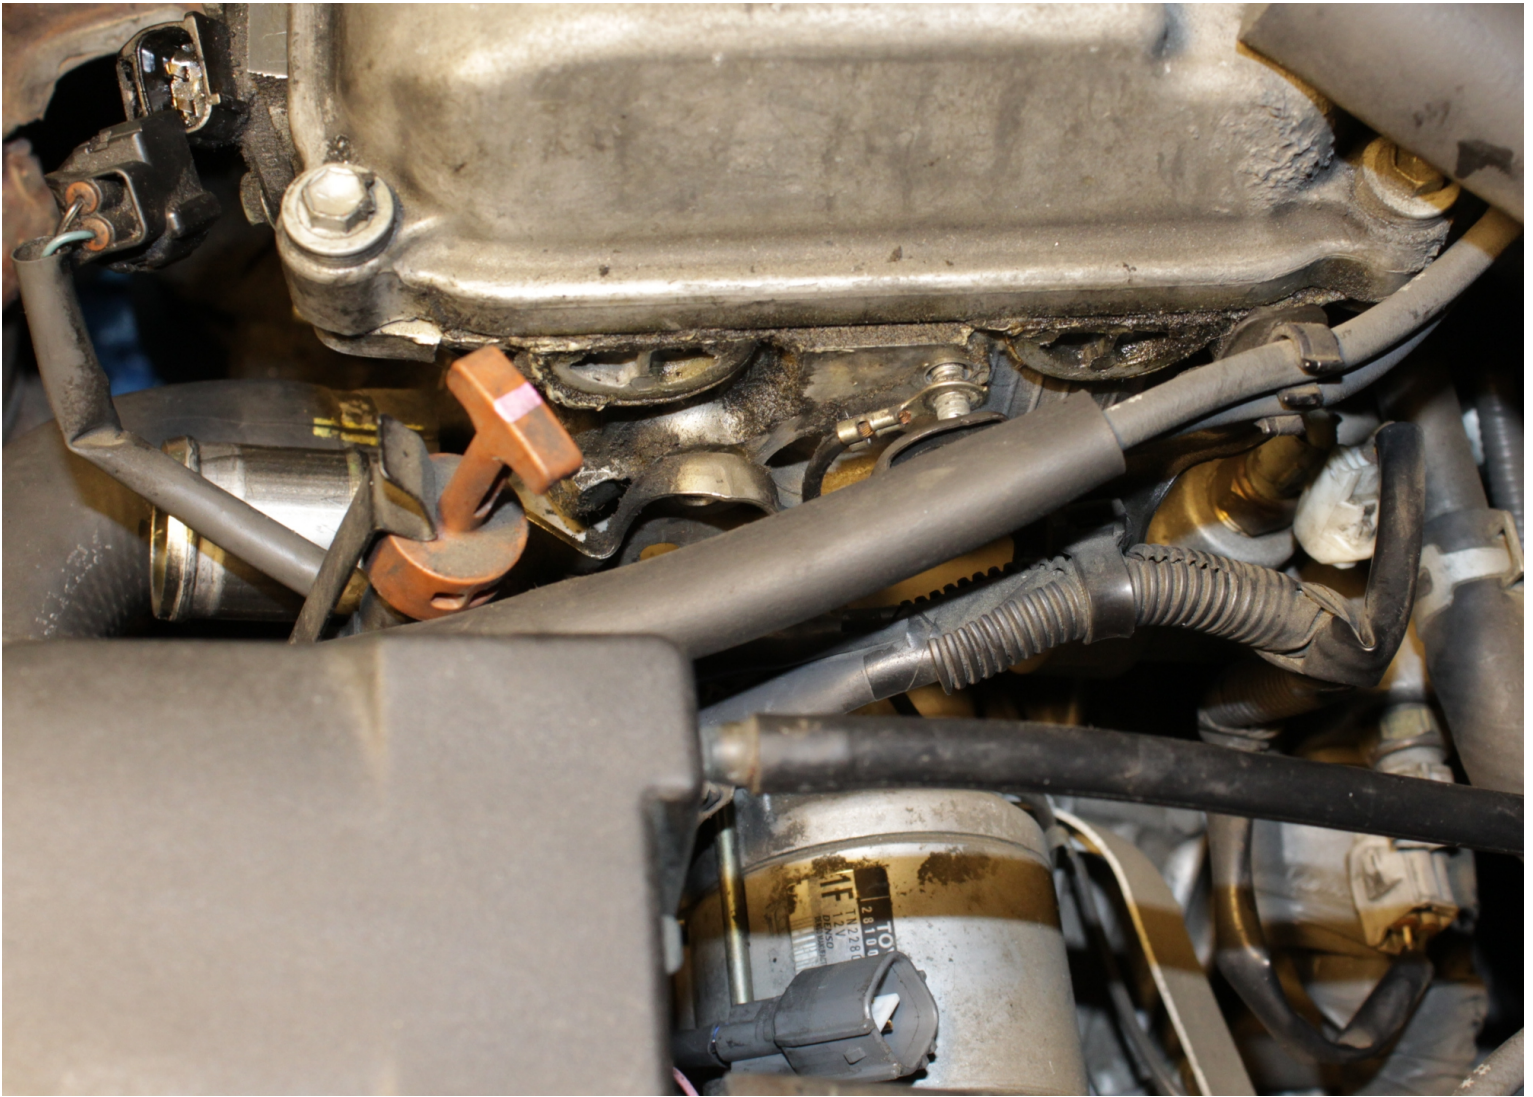
Detached four electrical connectors, radiator upstream rubber hose, and clamps

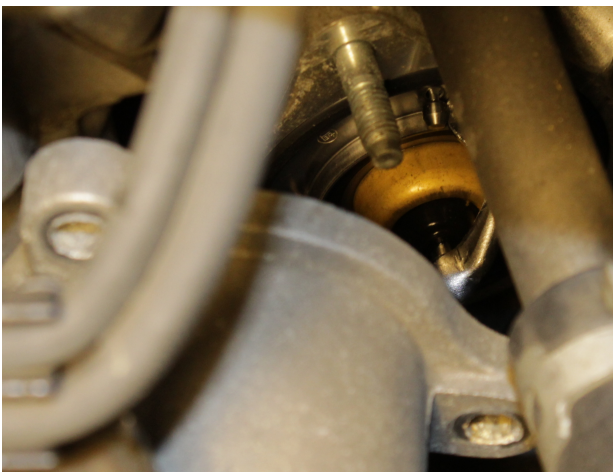
Old coolant thermostat appeared

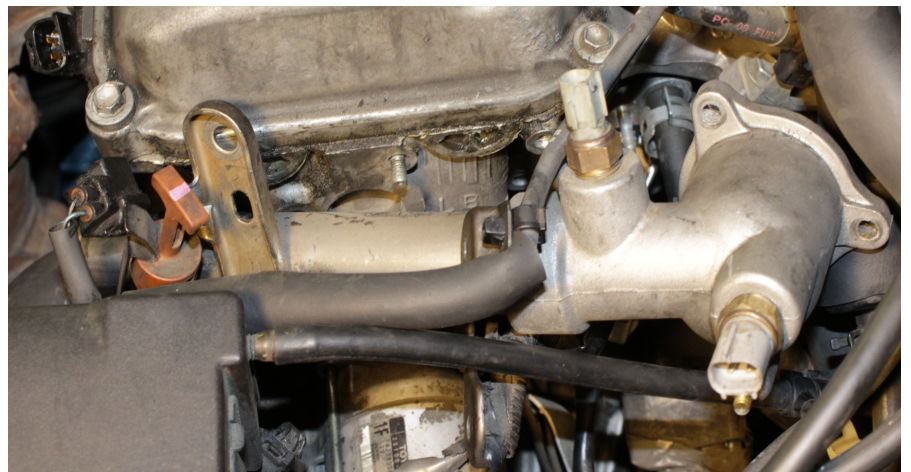
Removing coolant path housing

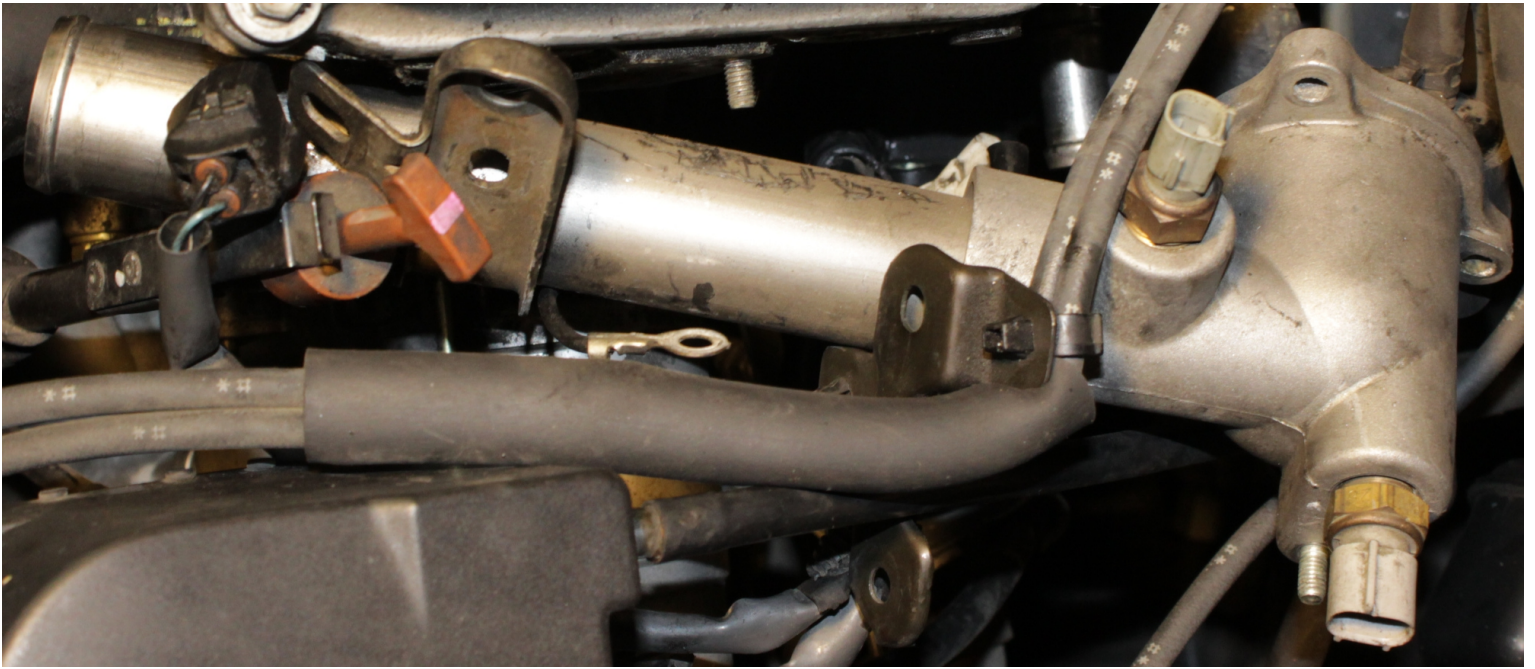
About to be removed...

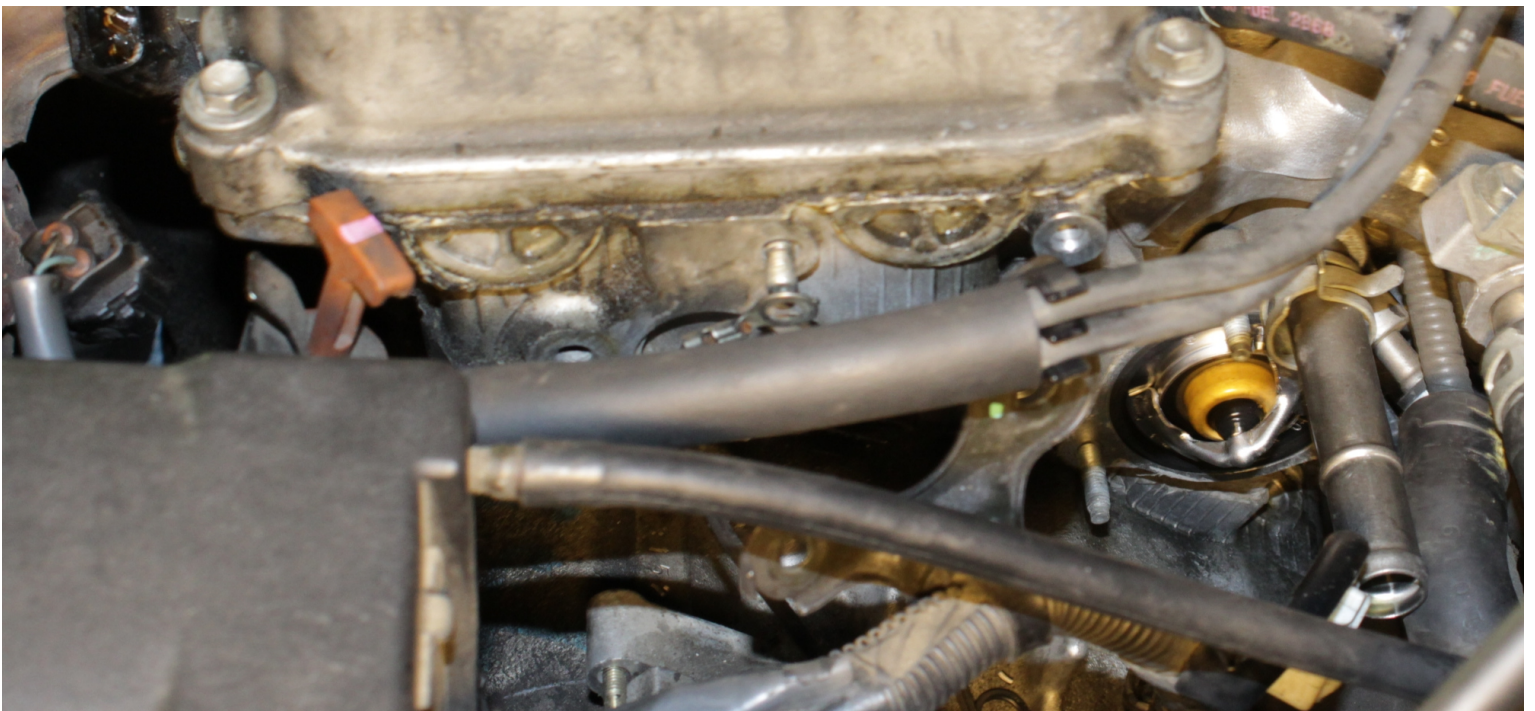
Removed

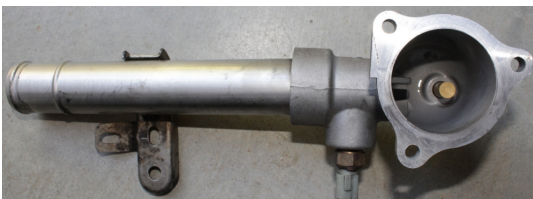
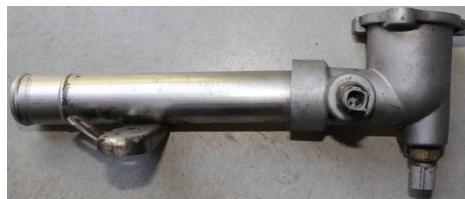
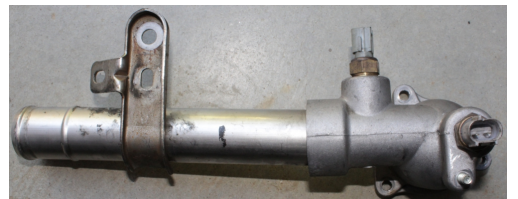
Coolant path housing

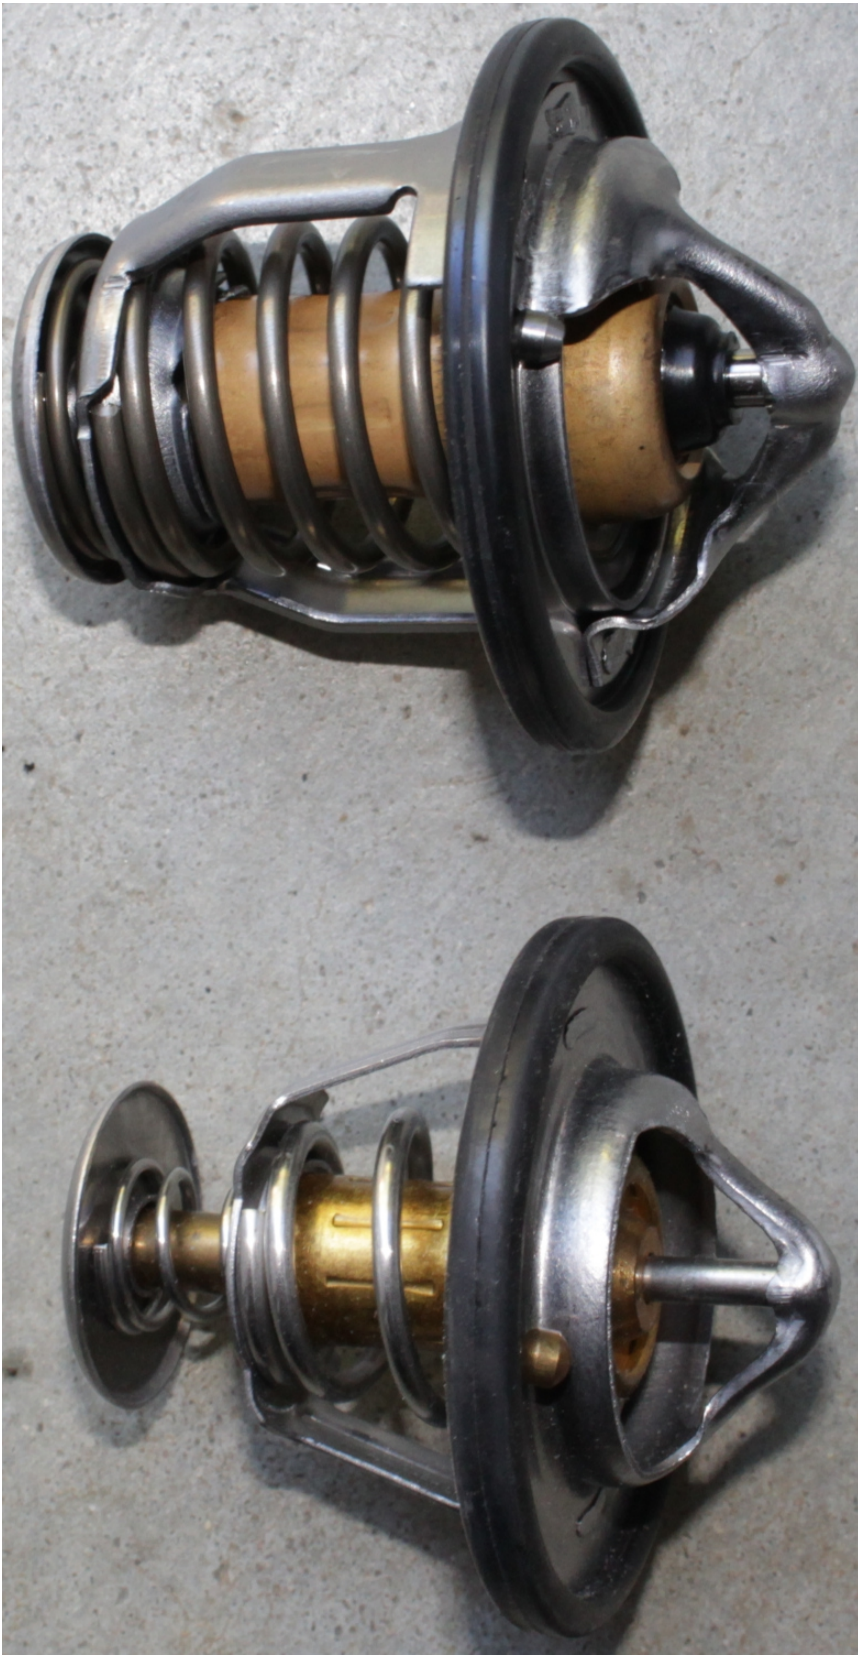
Coolant thermostat (Up; Old, Down; New)

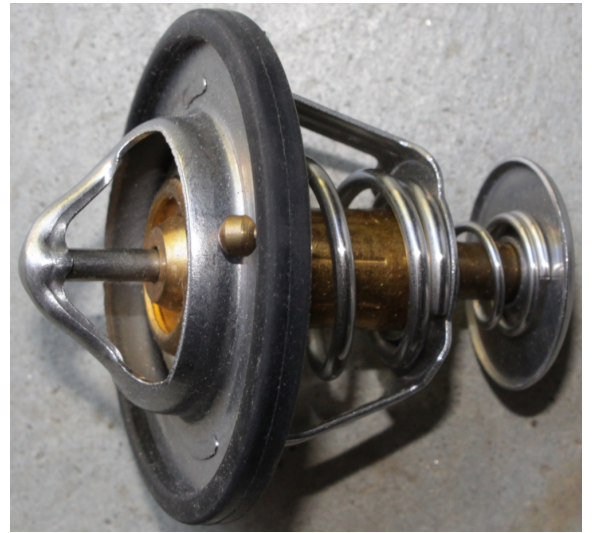
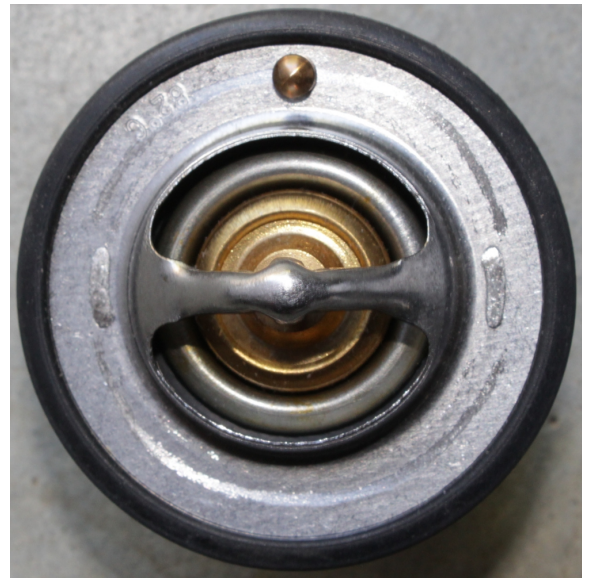
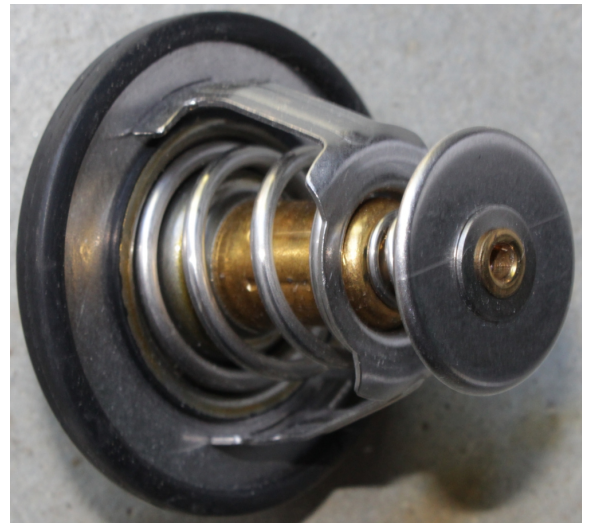
New coolant thermostat

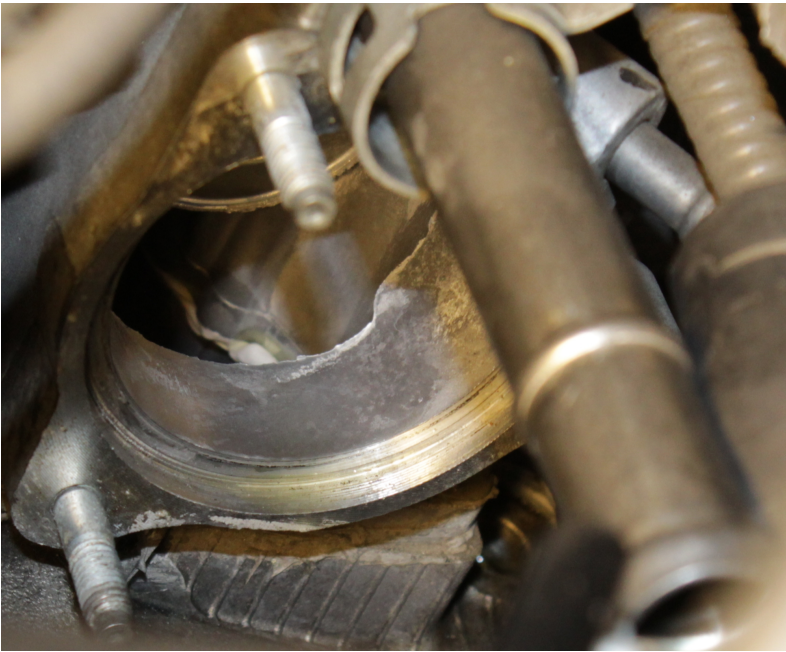
Before attaching new coolant thermostat
(Inside engine compartment)

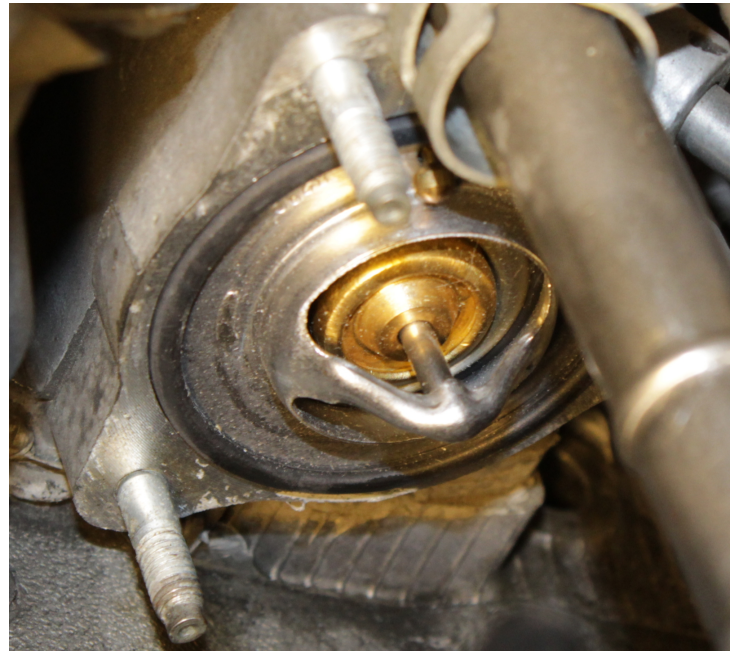
New coolant thermostat attached

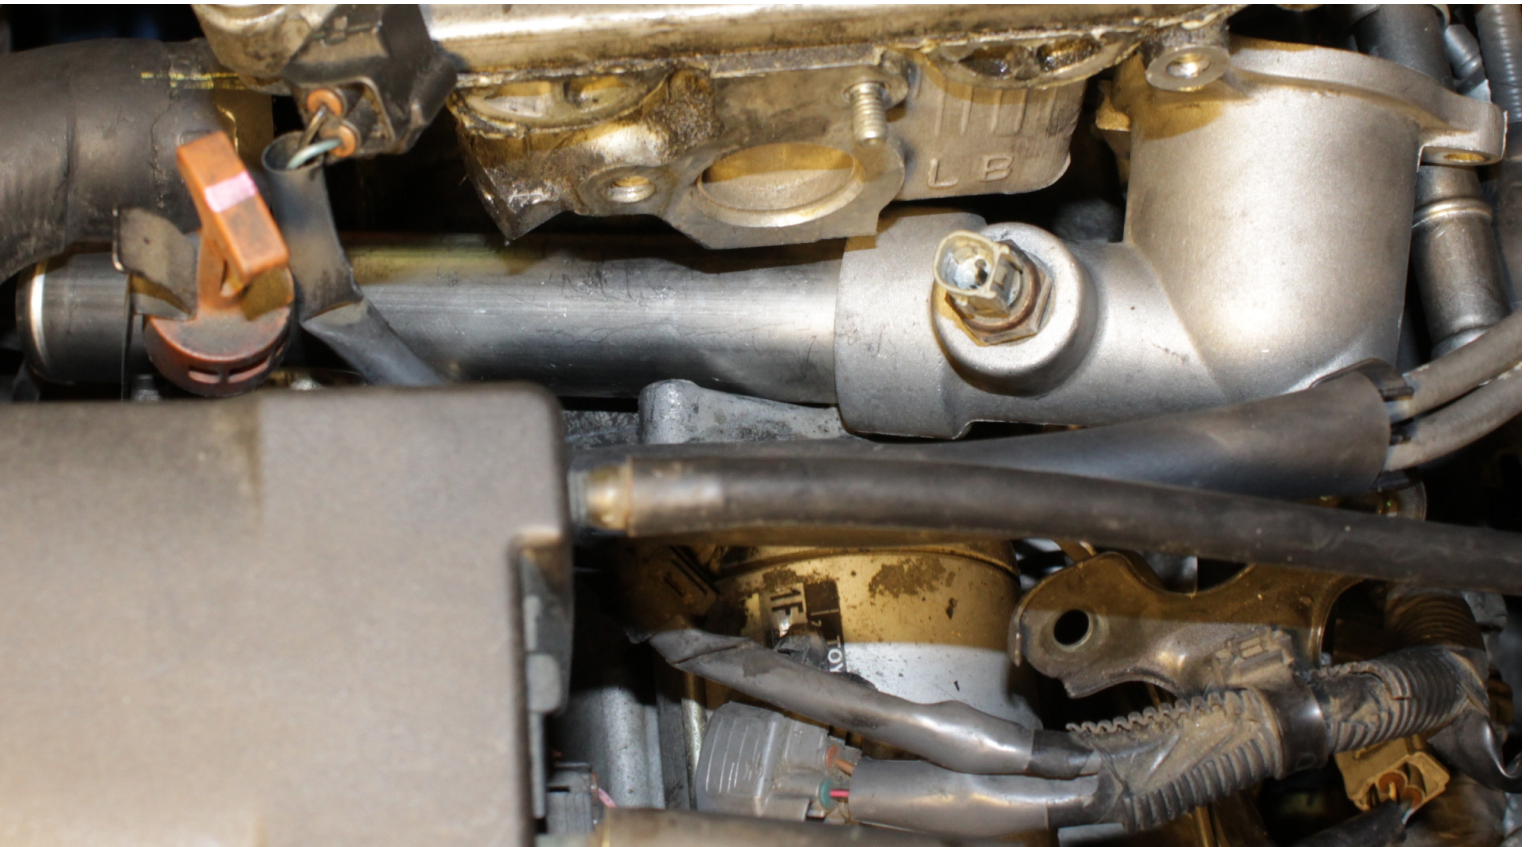
Burying coolant path housing making room into extremely narrow space
