## Repair Chain Saw

Chain saw stopped working all of sudden. It is common knowledge that the cause is carbon brush contact failure. Carbon brushes must be replaced. Tools with AC (Alternate Current) motor such as chain saw is sold with spare carbon brushes but this chain saw was exclusive.

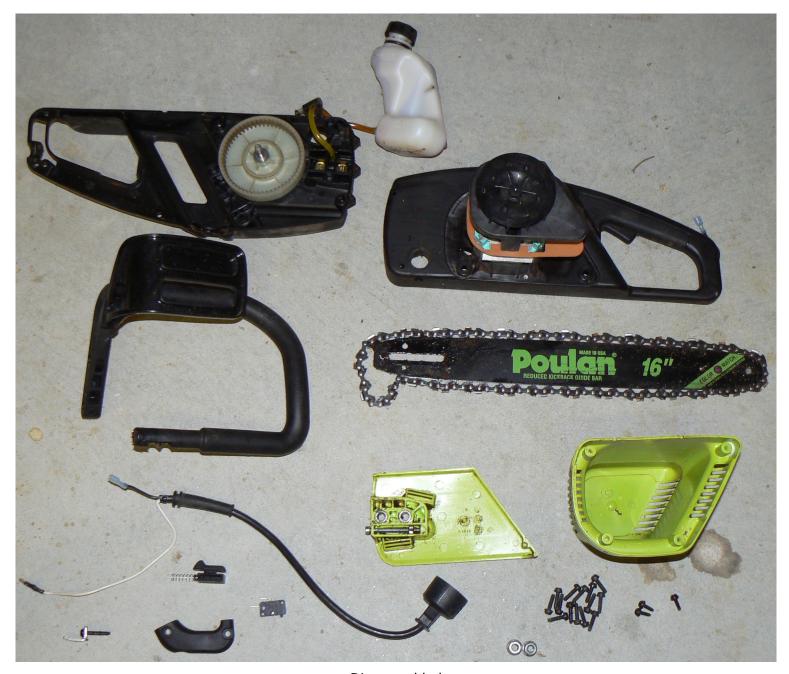
Disassembled

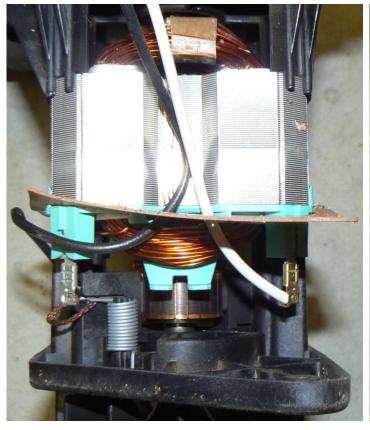
Side View (AC 120V Supply; Black & White Wire)

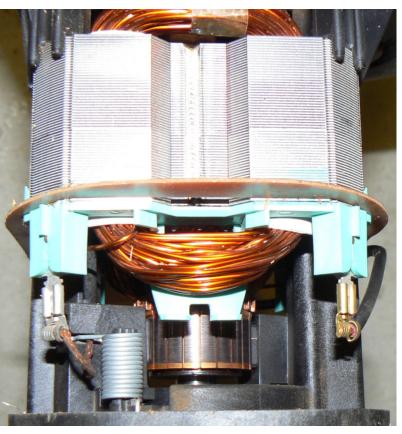
Side View (180 Degrees Reversed Direction)

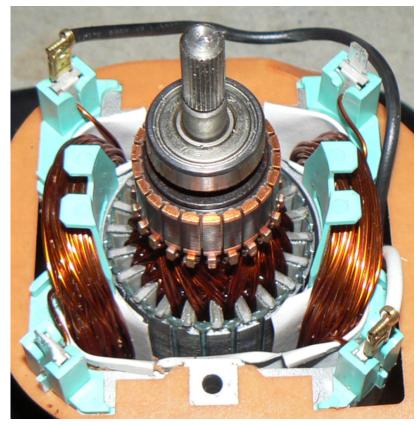
Rotor with Windings & Commutator, Stator Windings, Ports

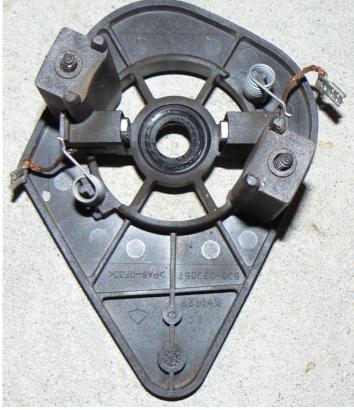
Two Carbon Brushes & Guides & Push Springs

Two bolts (Right) go through the holes (Left). Brush female terminals (Right) are connected to each stator windings through male terminal pins (Left).

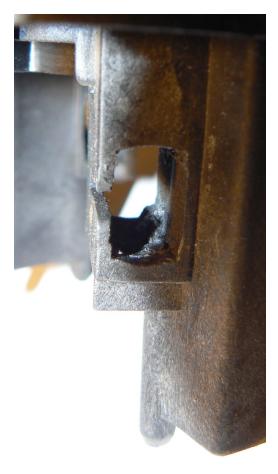
Inside Brush Guide (Burnt Carbon Clagged)

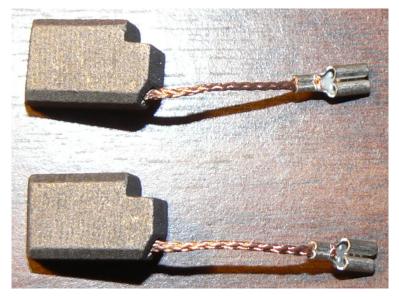
New Carbon Brush with Female Terminal & Wire

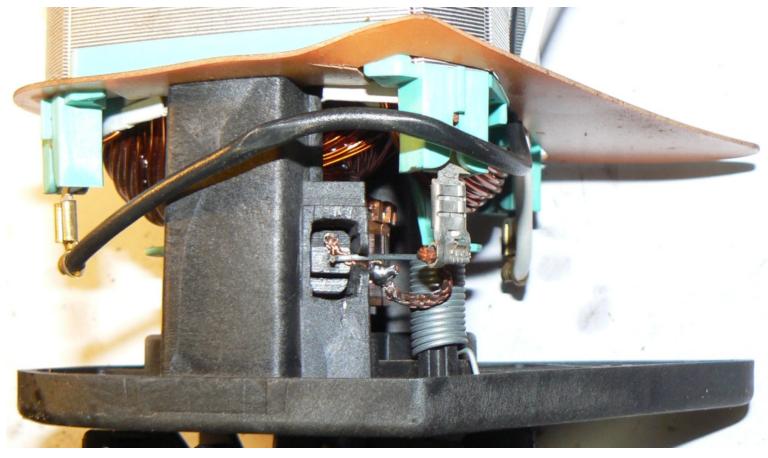
Replaced Carbon Brushes & Connected to the Terminal
