Repair Tiller

Leaking gasoline started because fuel hose deteriorated.

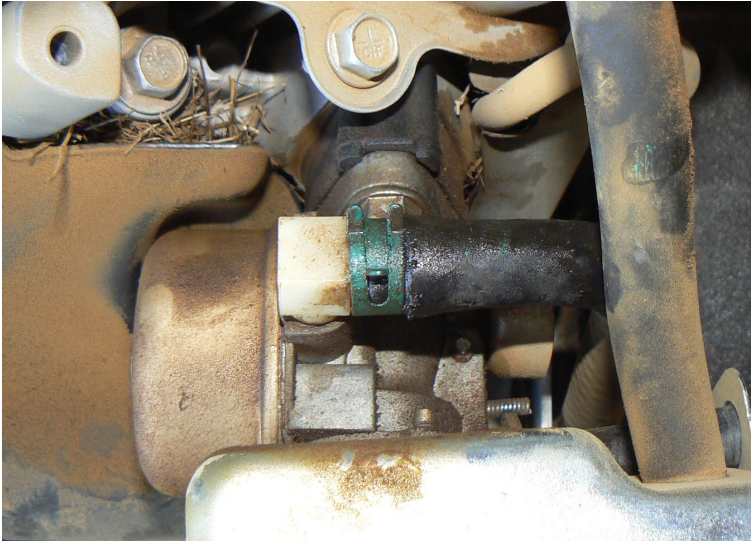
Leaking Gasoline through Black Deteriorated Fuel Hose
