## Wall Clock Core Replacement

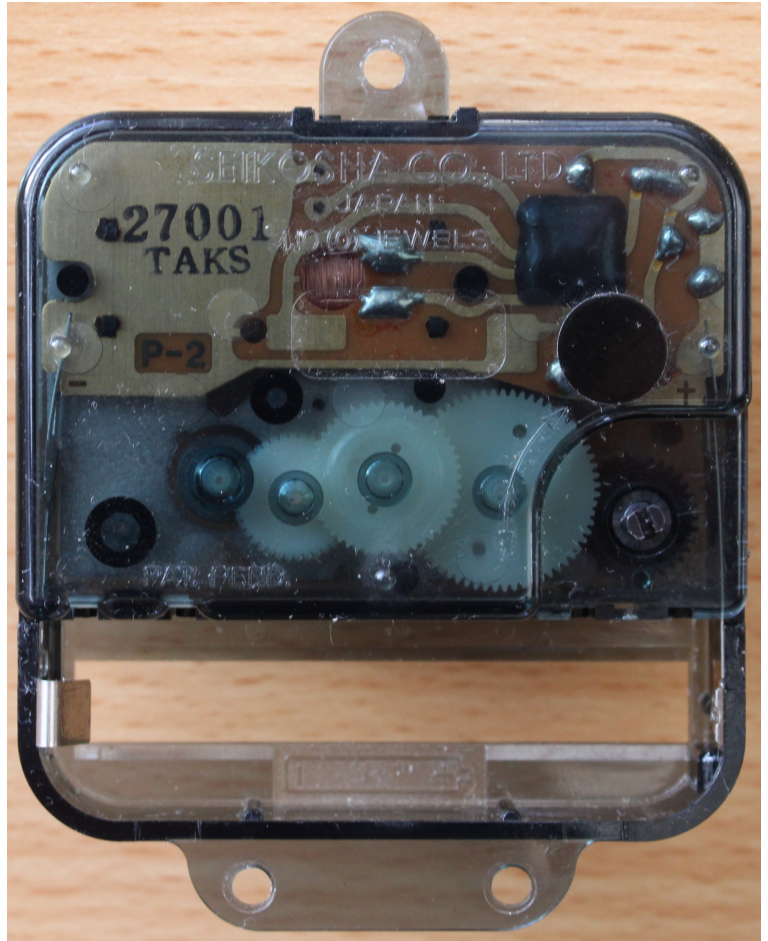
Original clock core (Rear) to be replaced

Original clock core was ticking but often stopped ([watch MP4 video](#)).

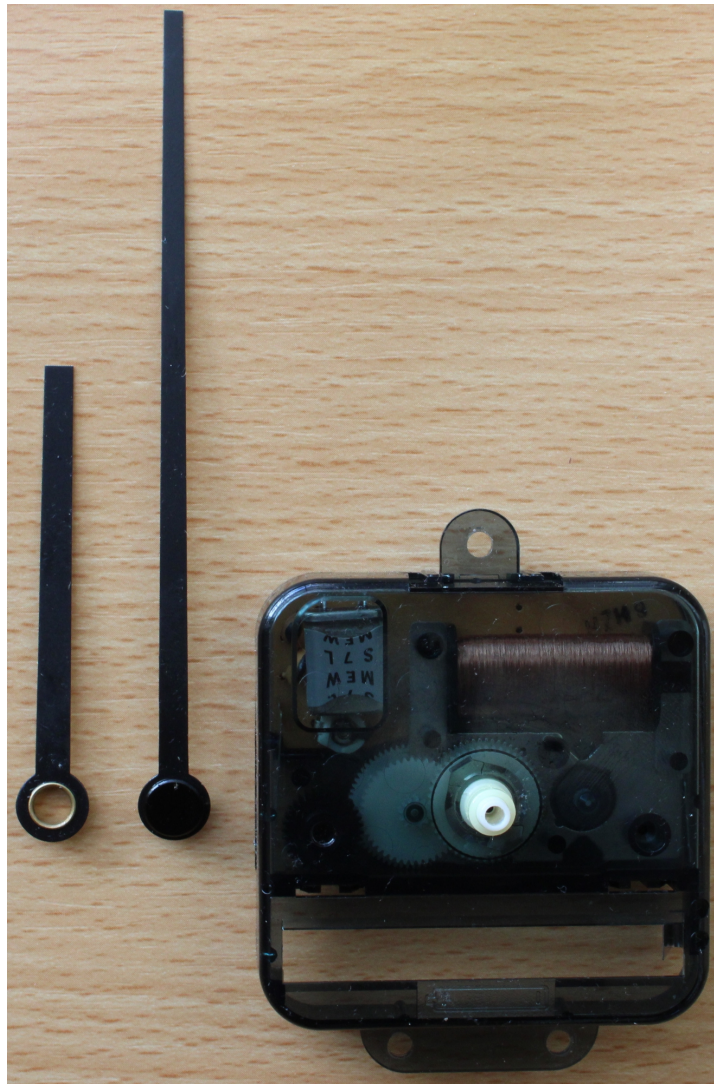
Original needles & clock core (Front) to be replaced

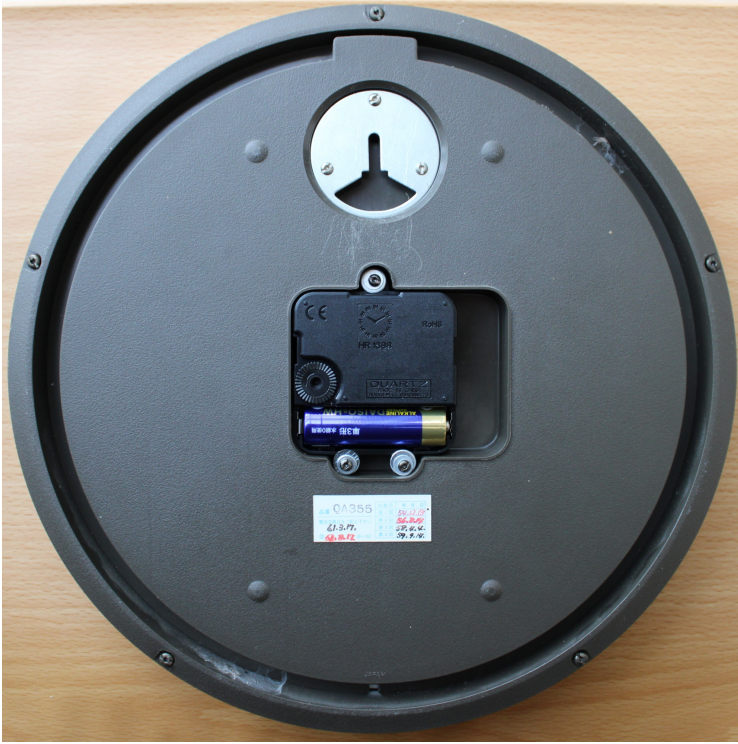
New clock core assembled

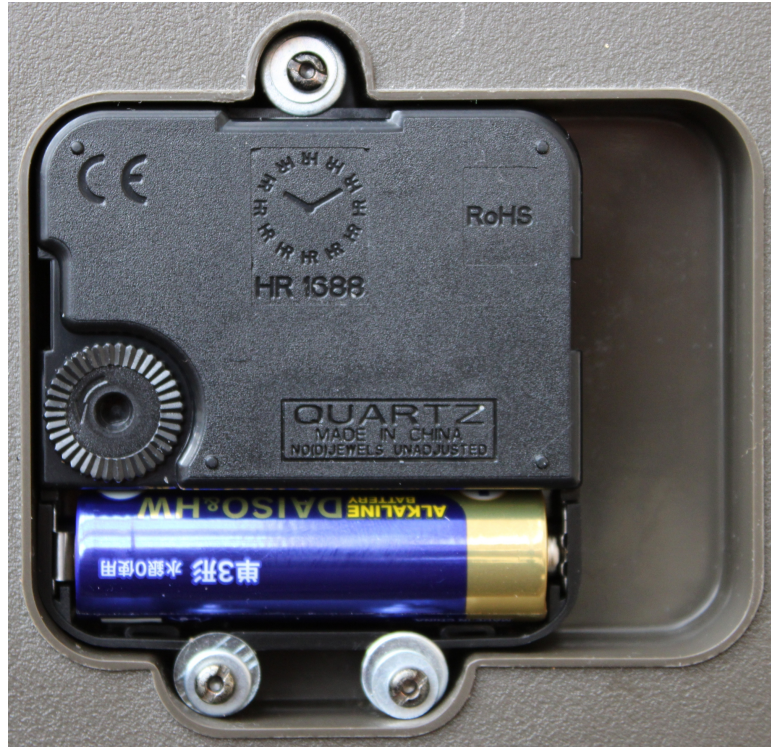
New clock core anchored by washers & original screws

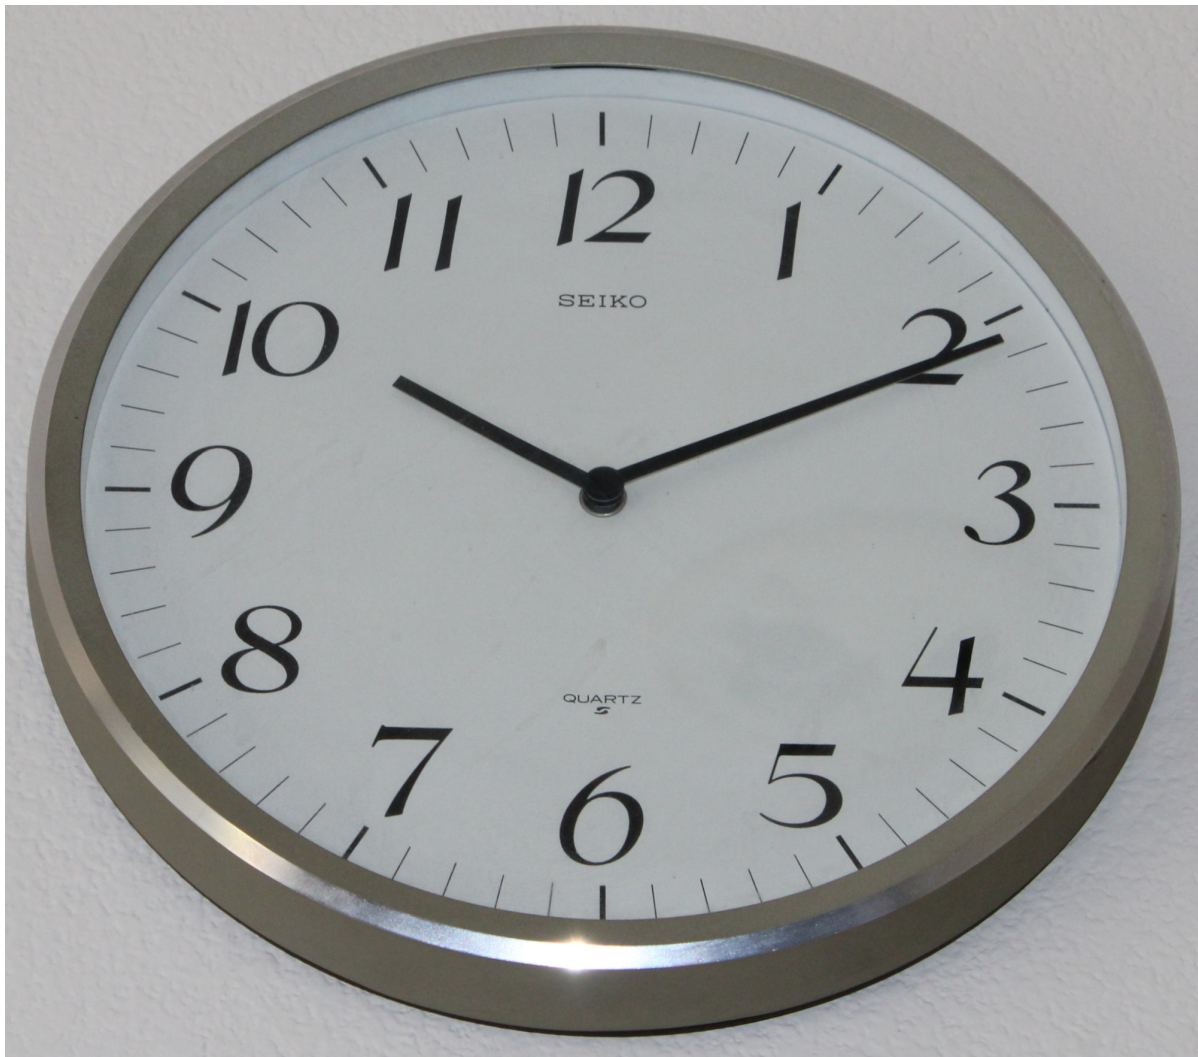
Working, ticking,,
