## Yardwork Splinkler System

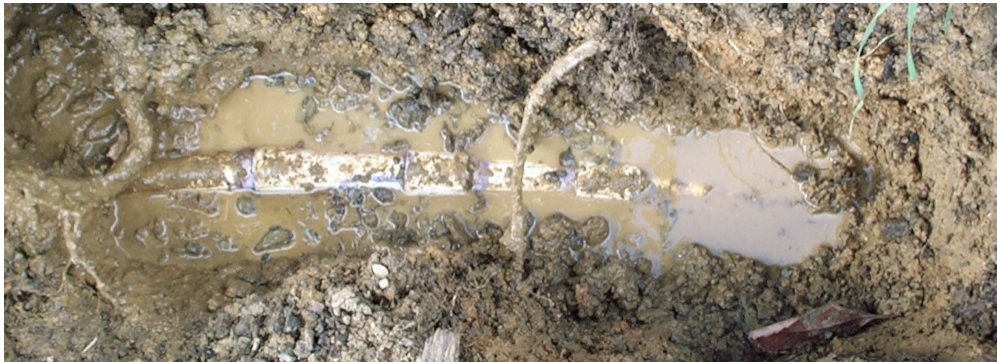
Leaking (Due to Undesired Connection at Curving (not Straight) Overstretched Pipes)

Gardener's PVC routing skill level looks so low because water leak at many places were observed. The reasons obtained as a result of my repair works are;

- (1) Pipe connection where pipe is forced to curve (not straight) as shown above.
- (2) Less cautious treatment for pipe connection (1" PVC pipe gets more water pressure than 3/4" PVC pipe)
- (3) Piping near trees which root breaks pipe
- (4) Sloppy pipe routing (Ex. overlaid pipes) without making schematic, etc.

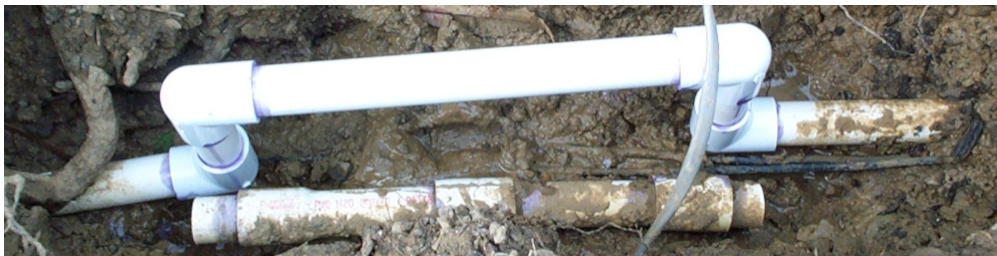
Repaired (Applied by All-around PVC Pipe Repair Method; Two Pipes are not Straight (Curved))

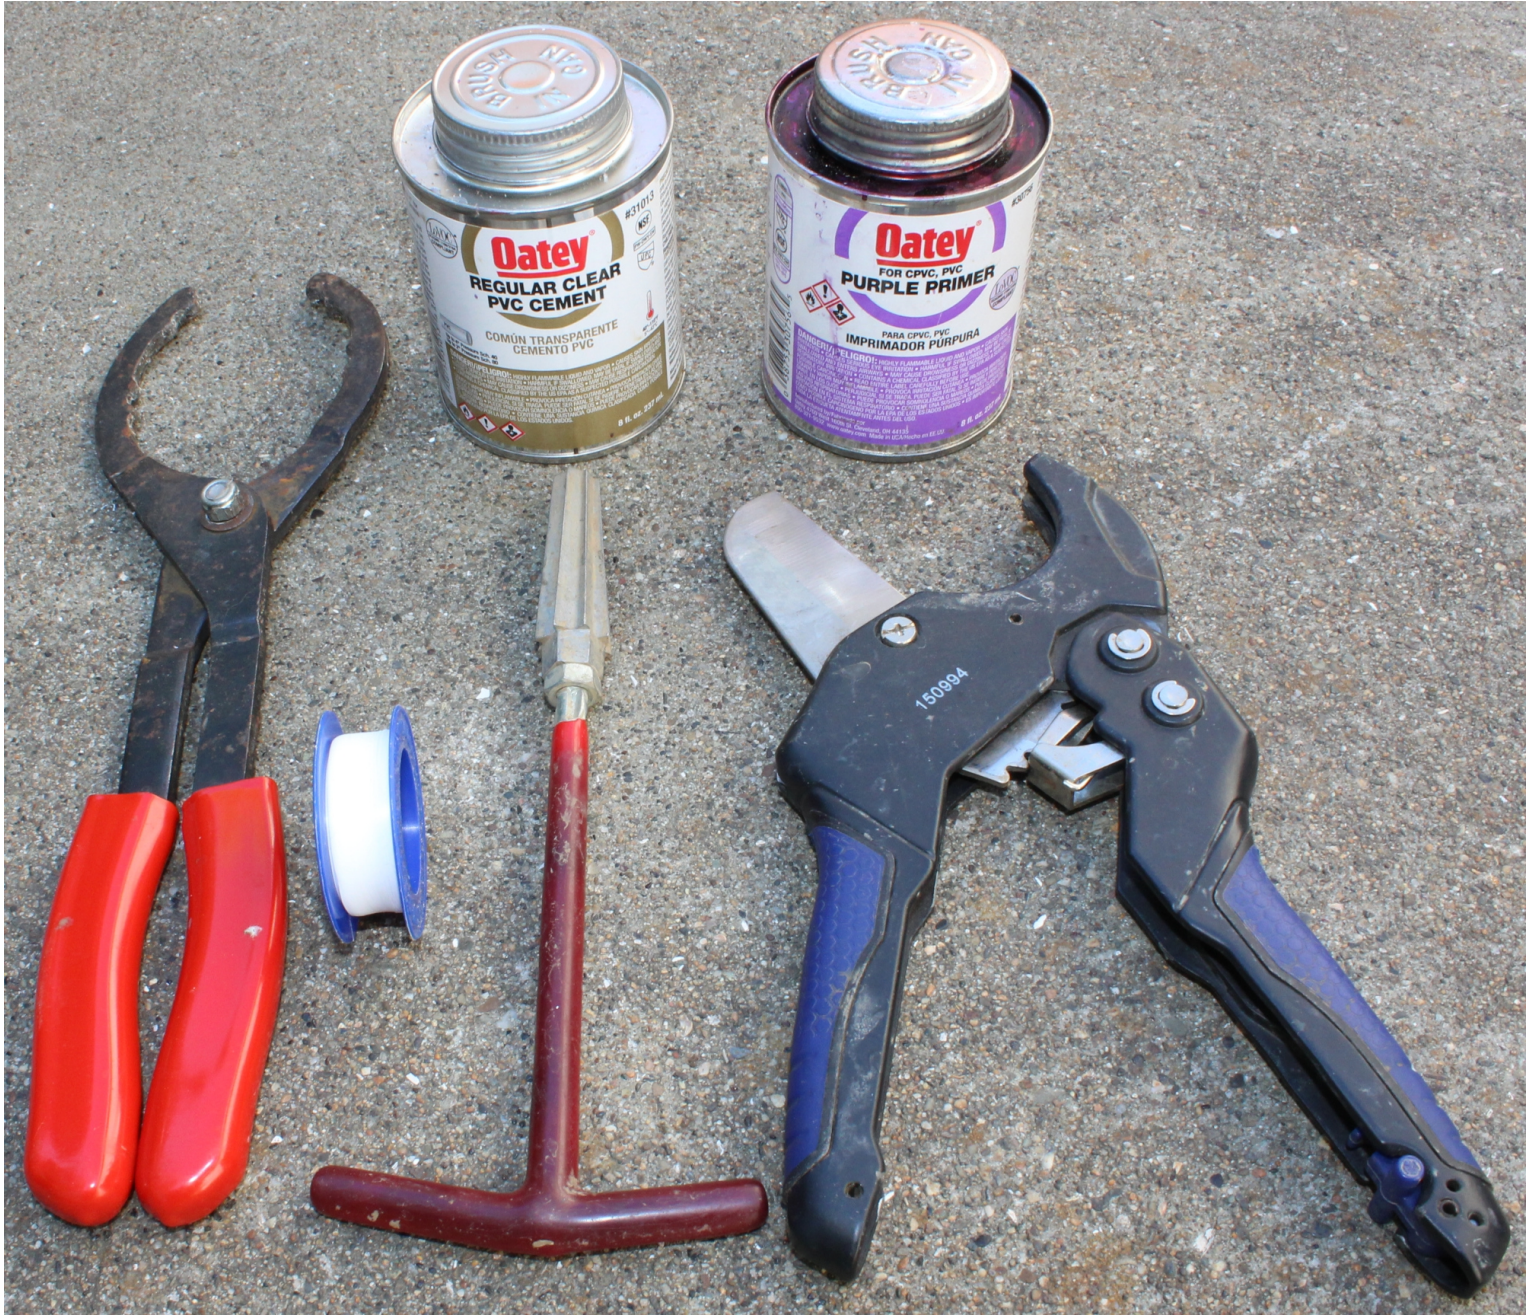
- PVC Pipe Solvent Cement & Primer,
- Big Jaw Slip-joint Pliers,
- Thread Seal Tape (Teflon Tape, PTFE (Poly Tetra Fluoro Ethylen) Tape),
- Nipple Extractor,
- Ratcheting PVC Pipe Cutter

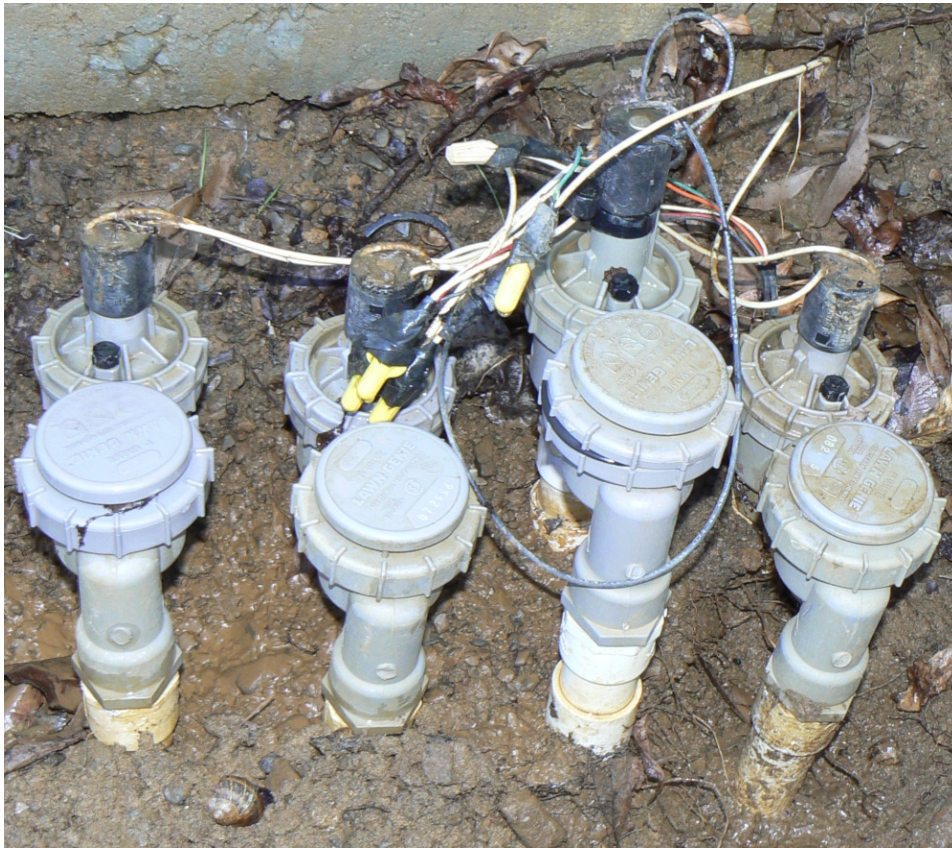
Shield Cap Assembly Cracked (Elastic Seal Exposed)

Shield cap assembly is for back flow protection. The quality was insufficient and cracked at the weakest portion. In my long term piping experience, 1" "Orbit" Anti-siphon Valve is better than "Lawn Genie (Example above)".

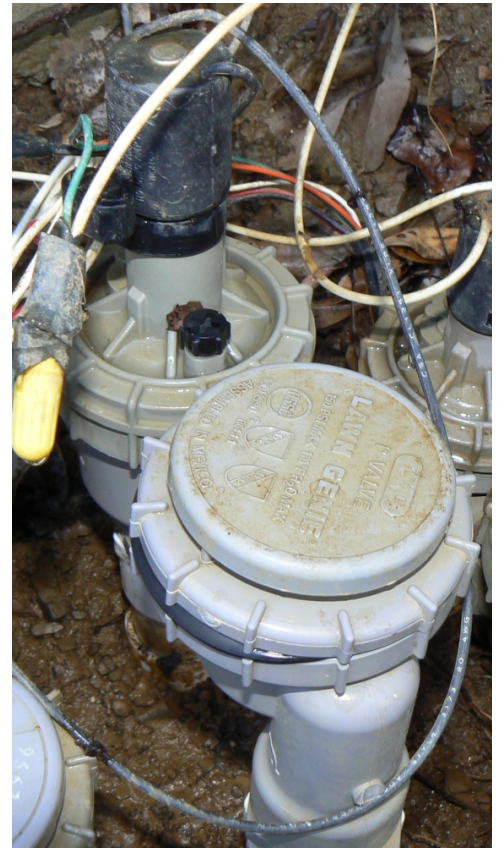
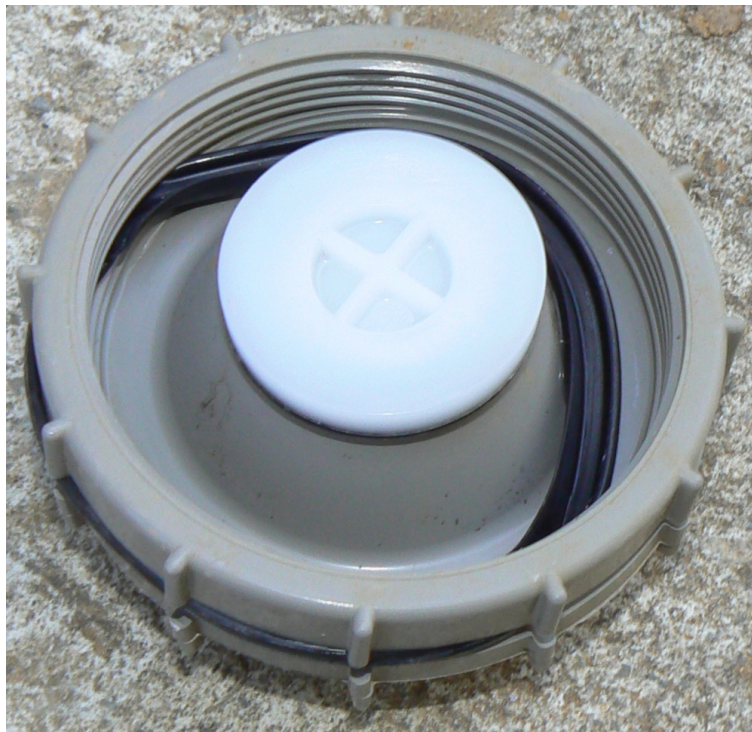
Cracked Shield Cap Assembly

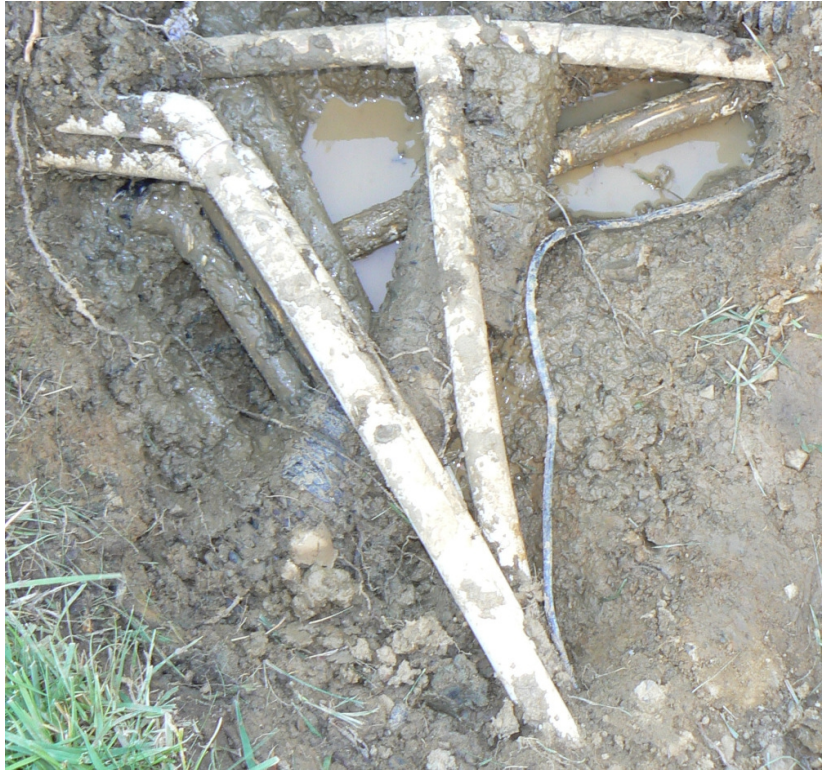
Leaking Sprinkler Main Pipe (Lowest Layer)

PVC pipes are stacked together with rain water drain pipe as well as connected under curving together. This is a gardener's symbolized sloppy work that incurred water leak everywhere.

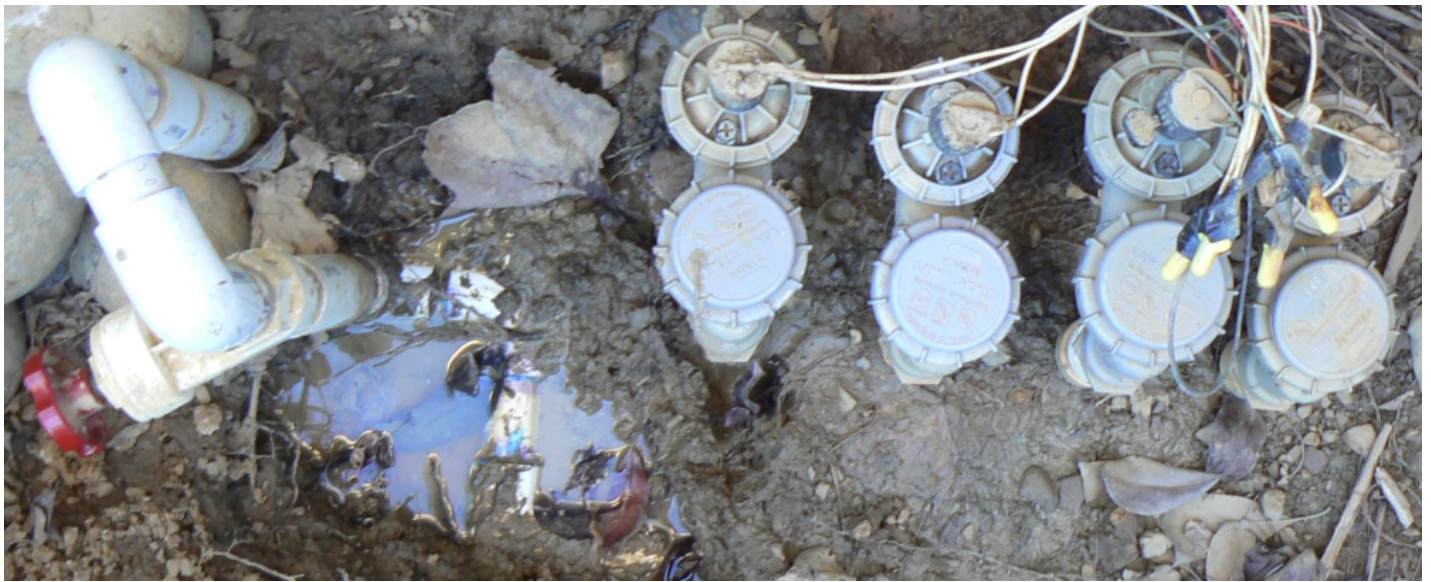
Leaking Sprinkler Main Pipe (Newly Attached Sprinkler Main Valve (Red; Left))

So many water leaks happened on sprinkler main pipe found. It is so bad because water leaks all the time unlike water leak on PVC pipes connected after sprinkler valve.

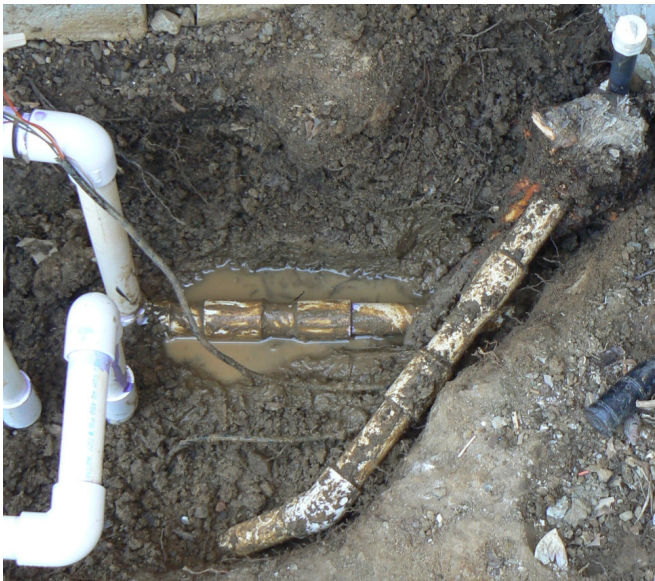
Leaking Sprinkler Main Pipe

It is hard to find water leak happened on pipes after sprinkler valve and it reduces water pressure drastically and incurs fatal result.

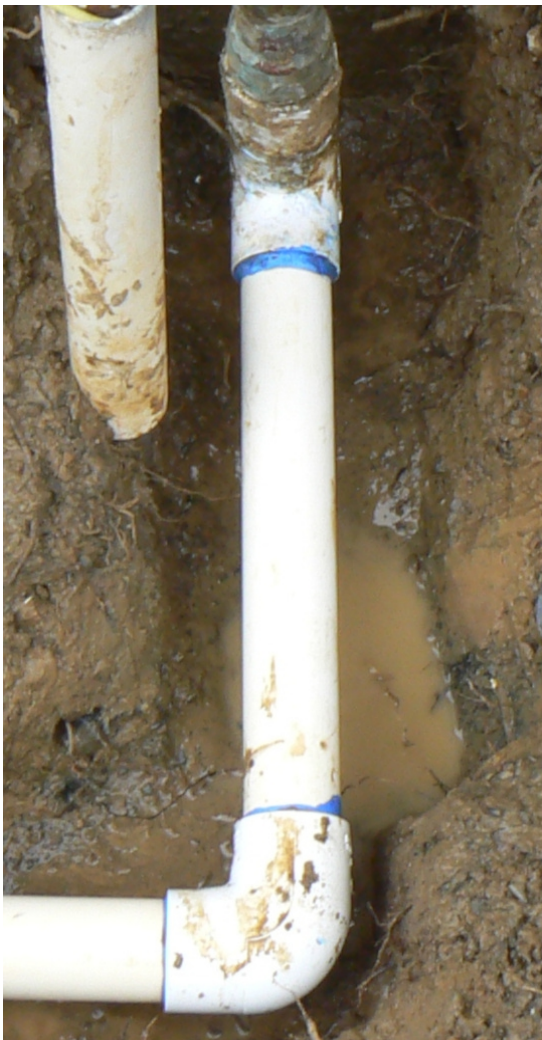
Utility Water Main Pipe Leaking

This 1 1/4" PVC piping for utility water main pipe was done by gardener who did not have sufficient skill of PVC piping. This is ultimate evidence of my judgement for the gardener's work. Give me a break!

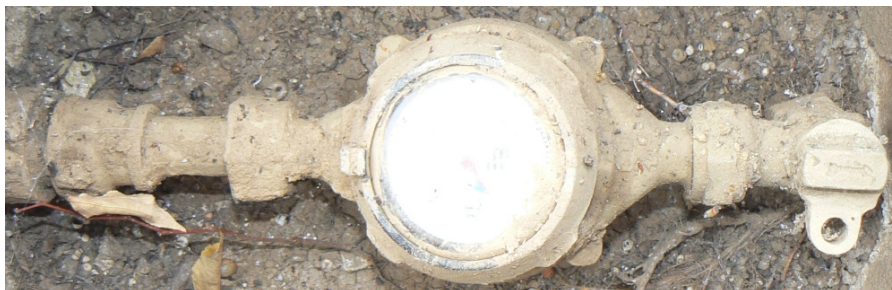
Utility Water Main Valve (Stop Water Flowing (Close) Position)

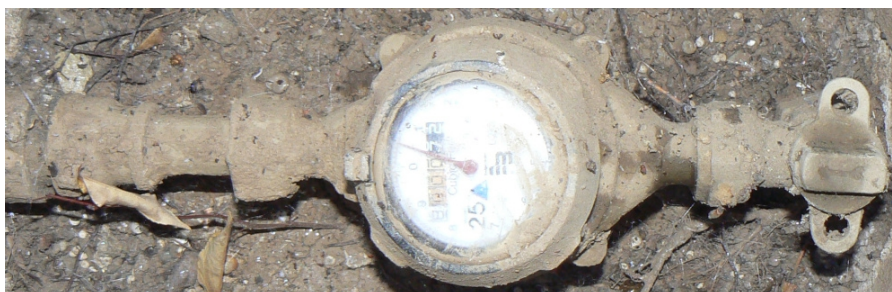
Utility Water Main Valve (Water Flowing (Open) Position)
