2007 Pontiac Vibe Oxygen Sensor Replacement

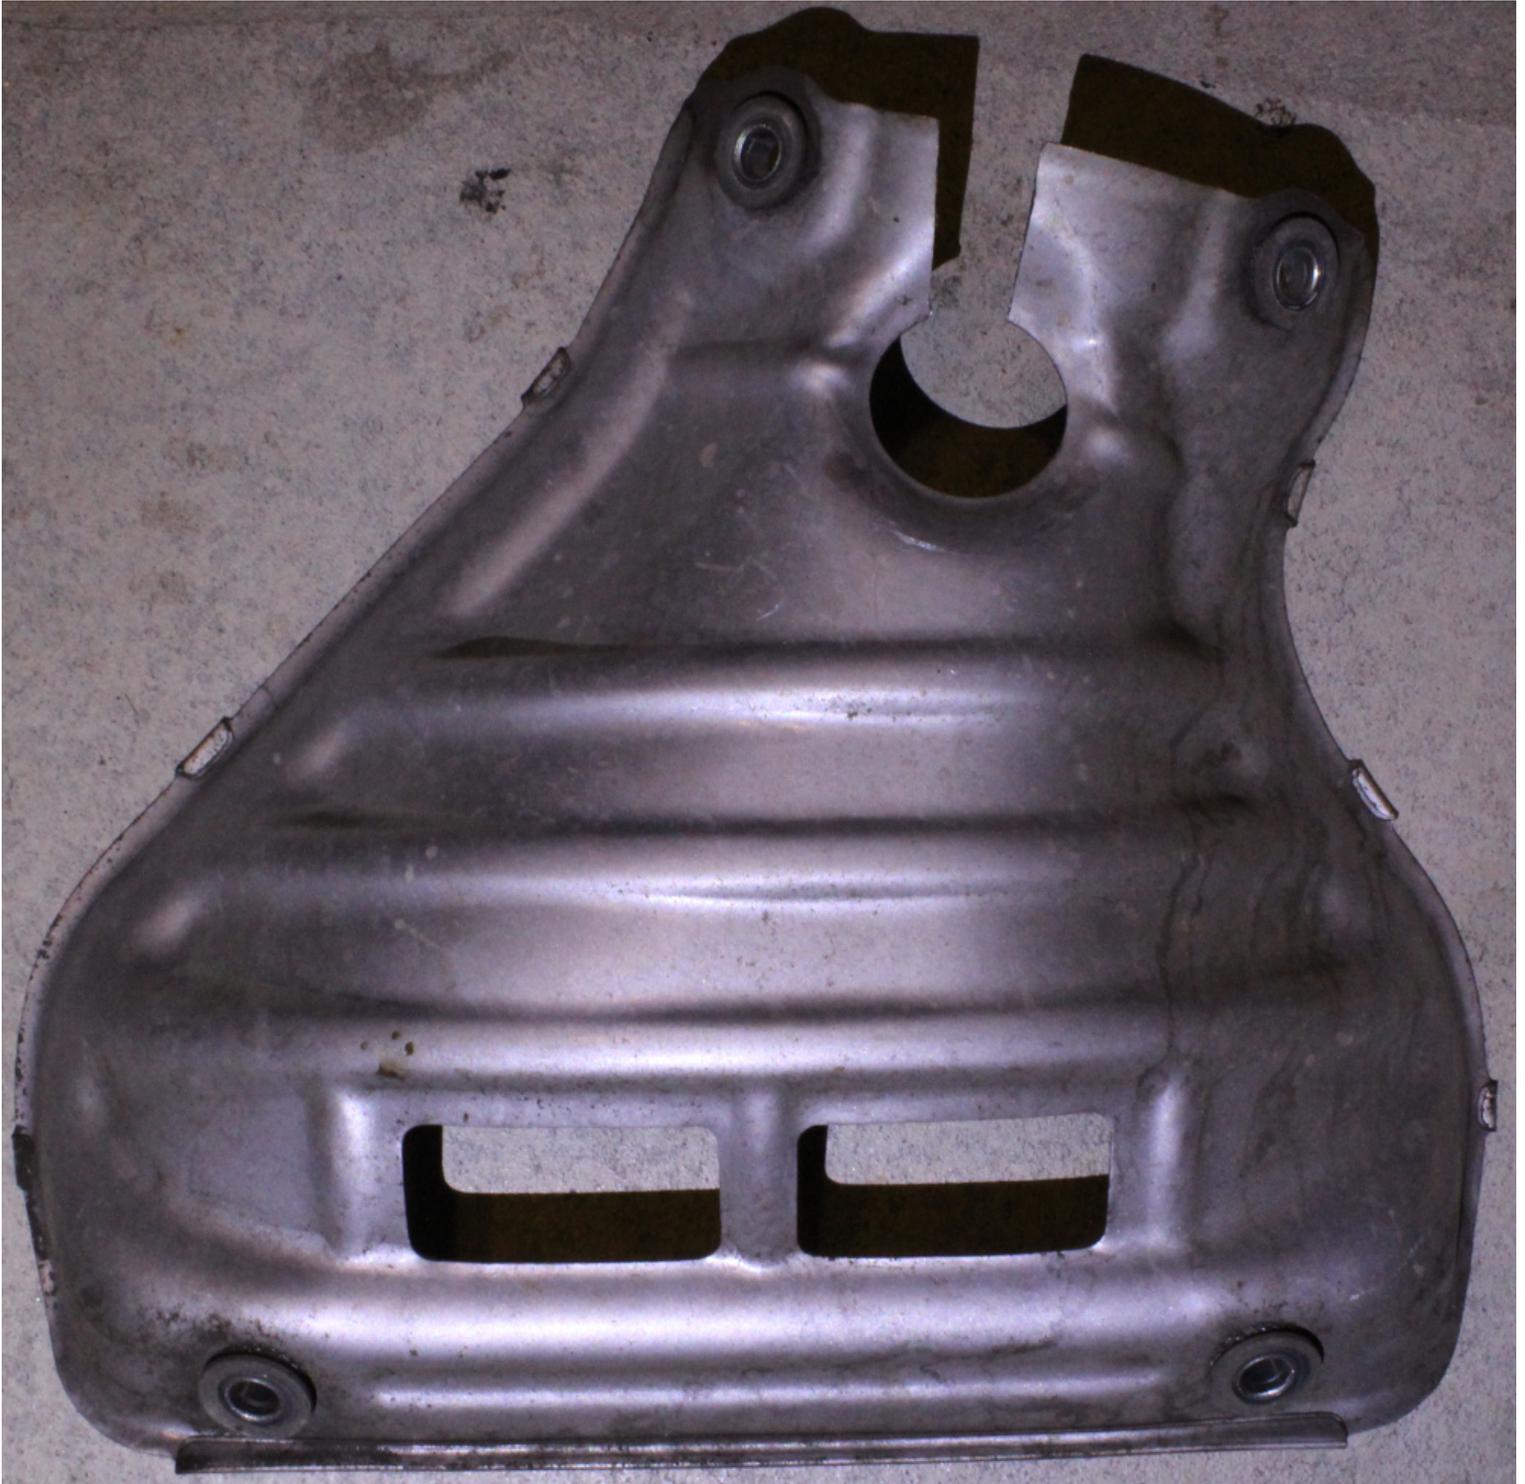
Heat Shield Cut Out

There was difficulty of disengaging and pulling oxygen sensor through a small hole, a portion of the heat shield (top; looks like a key hole) was cut out by angle grinder to ease handling of tool and oxygen sensor.

OBDII scanner exhibited diagnostic error on oxygen sensor.

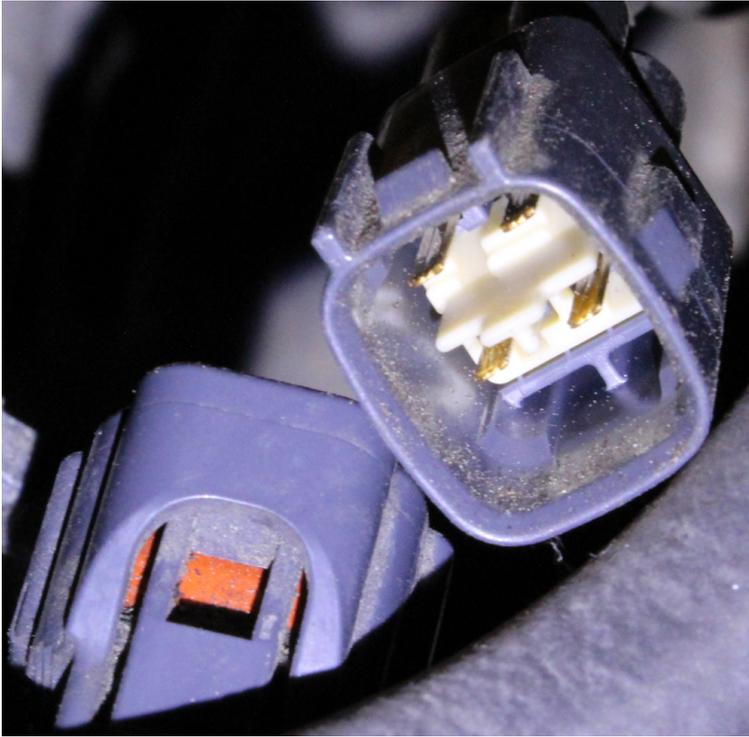
Oxygen Sensor Connector Disconnected (System Side)

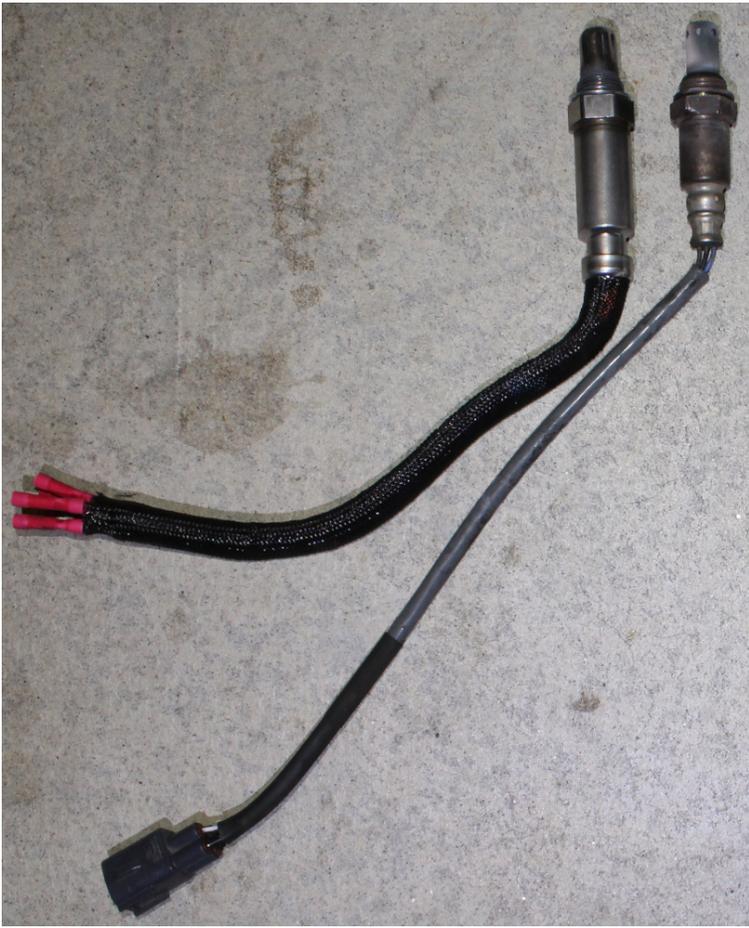
New & Old Oxygen Sensor

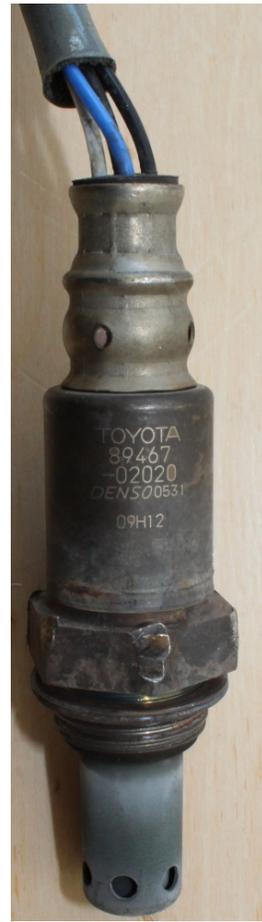
Old Oxygen Sensor from Denso
