1995 Toyota Camry Power Steering Pump & Hose Replacement

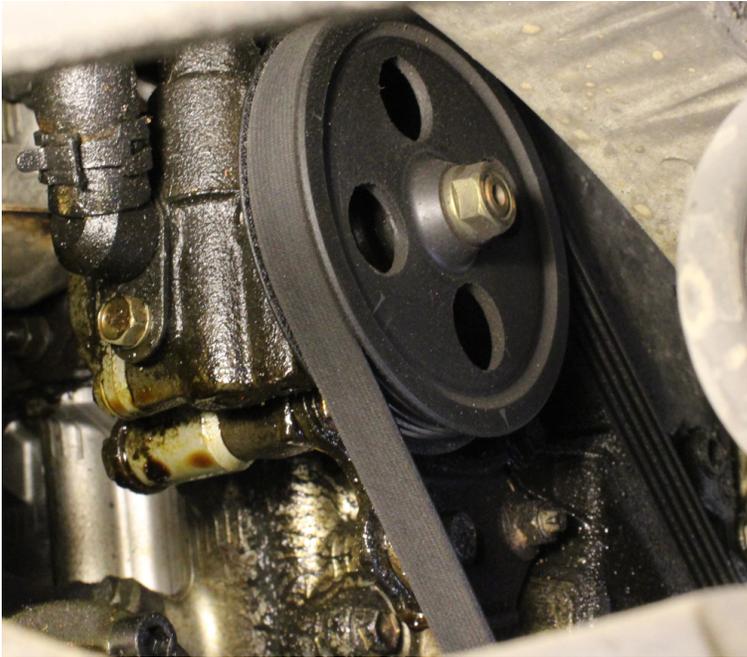
Before

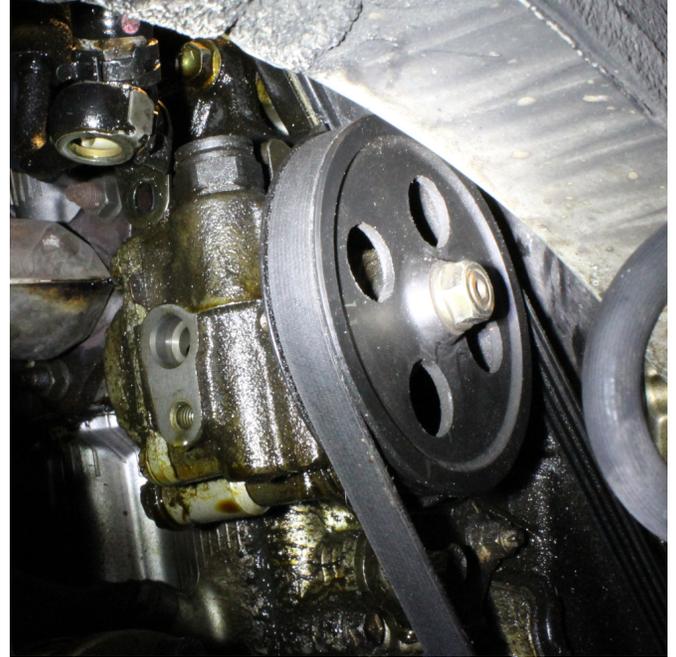
Return Hose & Pressure Feed Union Bolt Removed

Power steering oil leaked from the pump.

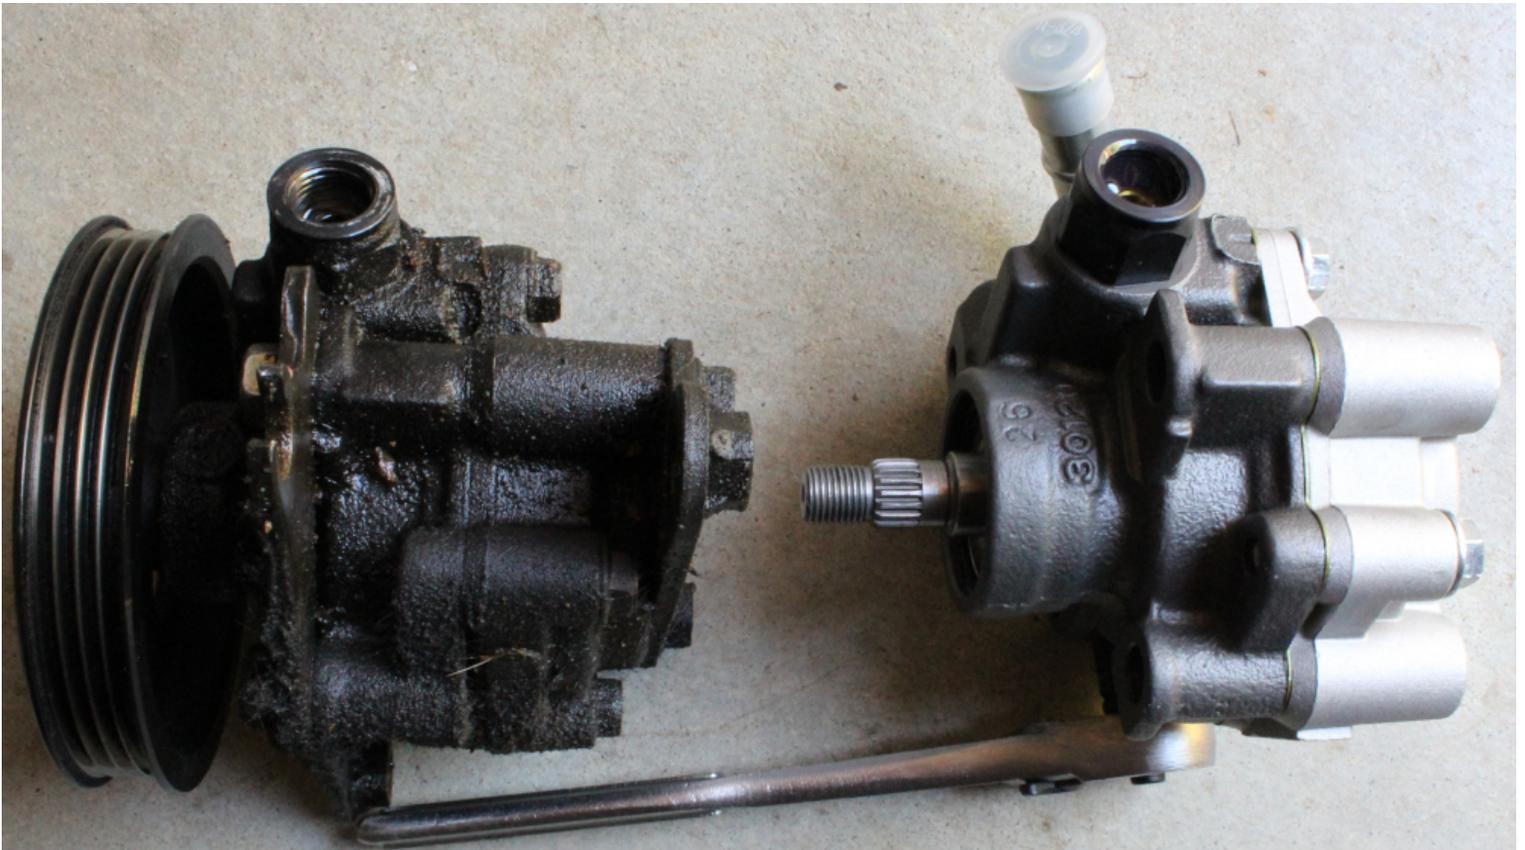
Old & New Power Steering Pump

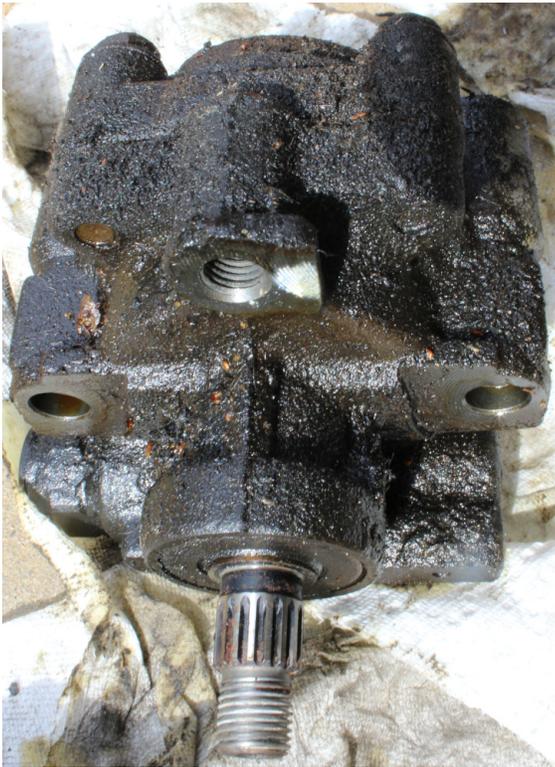
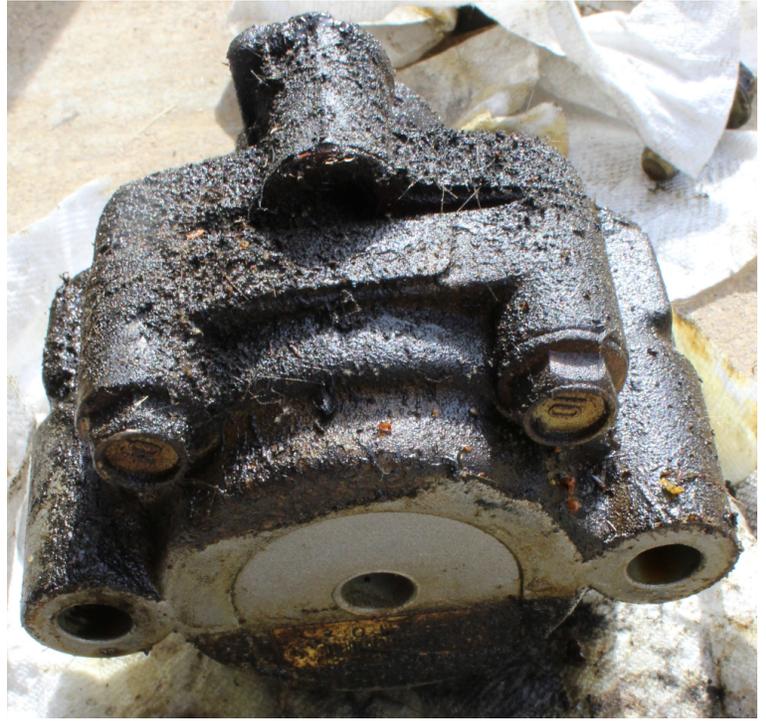
Old Power Steering Pump Fully Being Drenched by Power Steering Oil

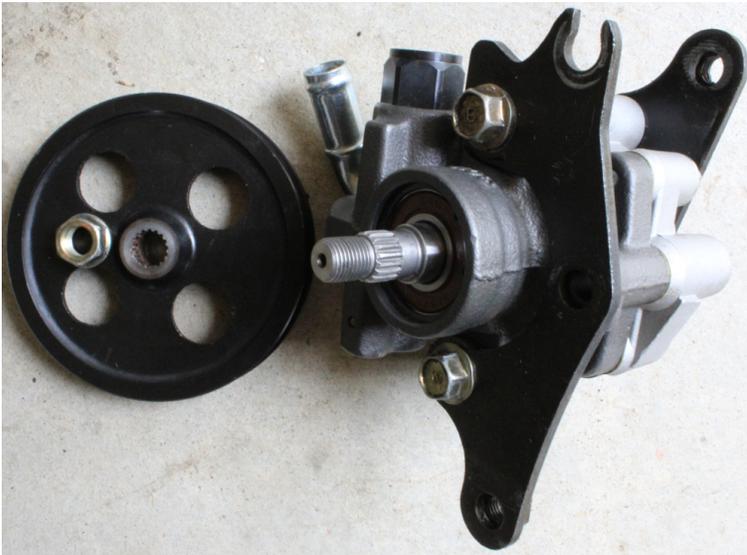
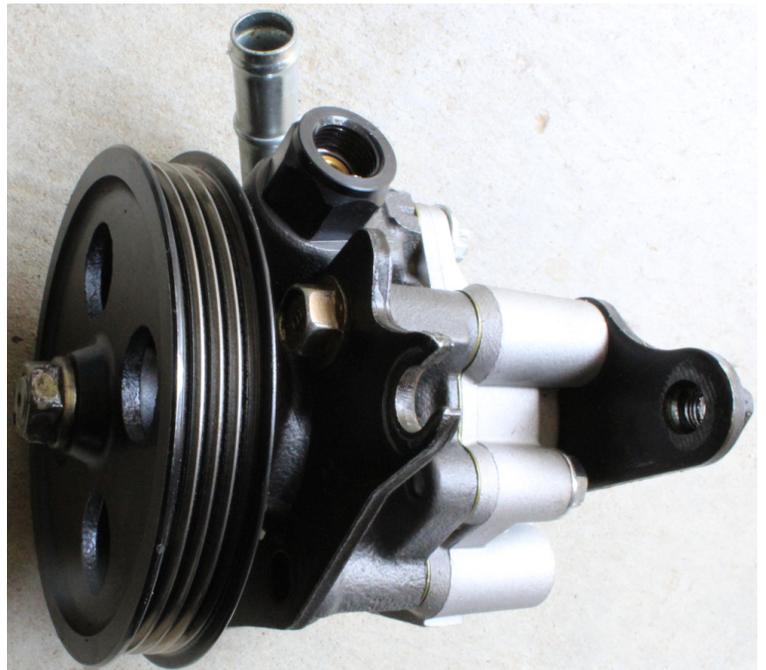
New Power Steering Pump

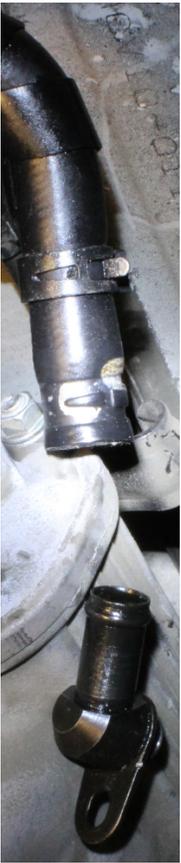
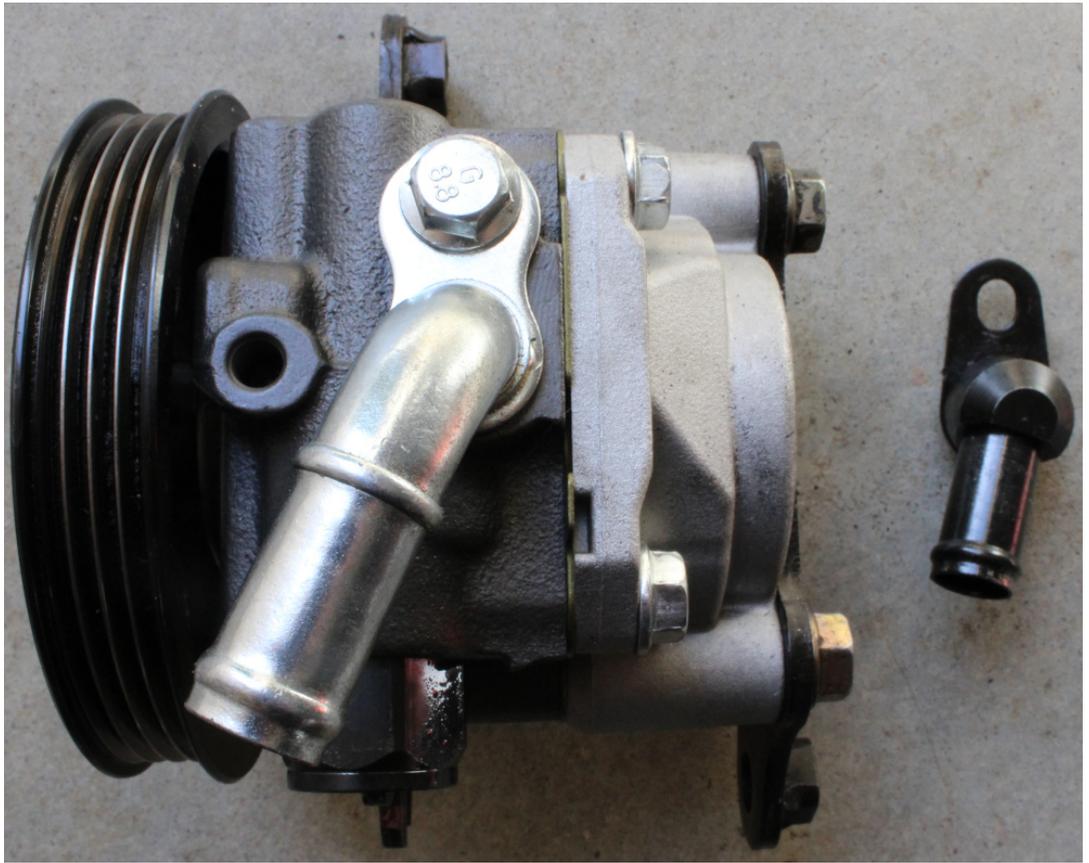
Return Hose, Bracket, New Power Steering Pump Assembled with Parts

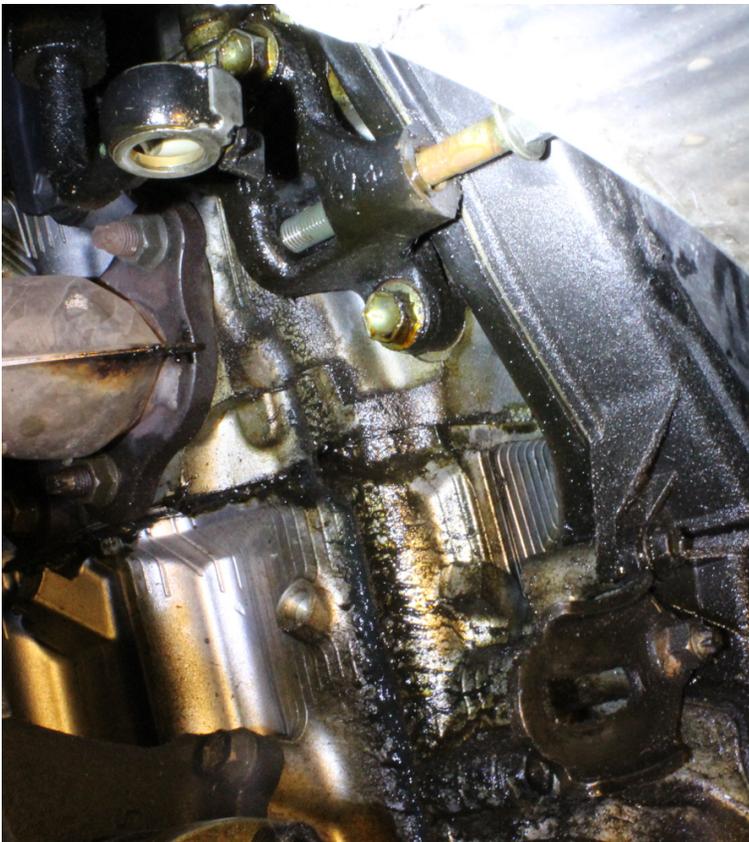
Old Power Steering Pump Removed

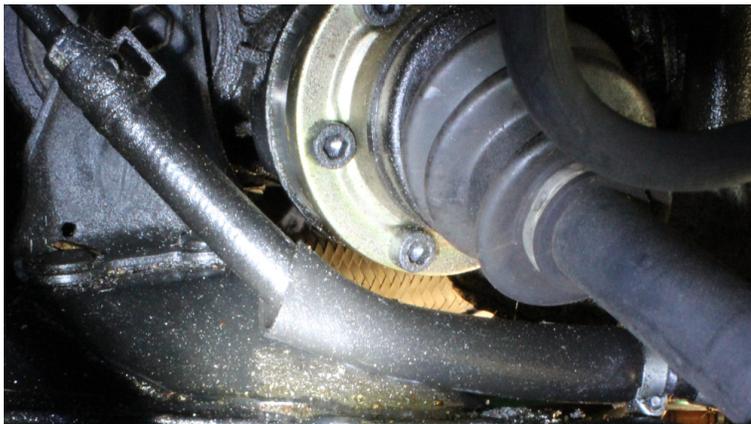
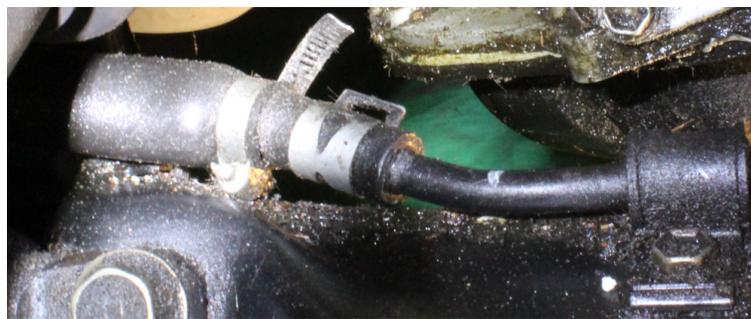
Before (Leaking oil)

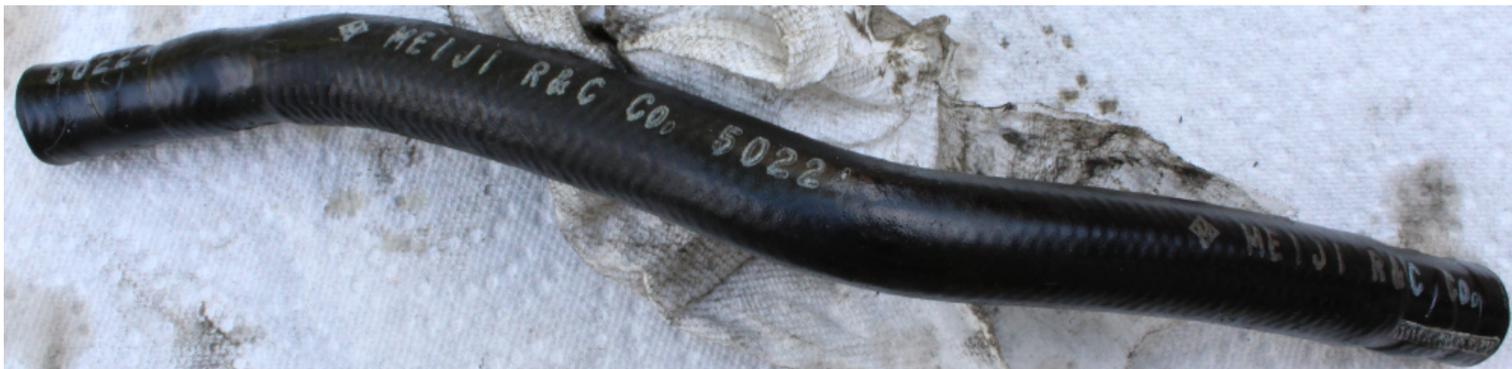
Old Power Steering Pump Pressure Feed Tube with Crack

The crack caused power steering oil leak.

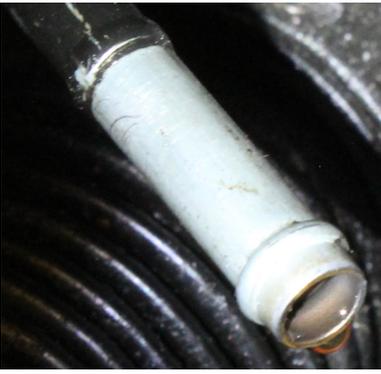
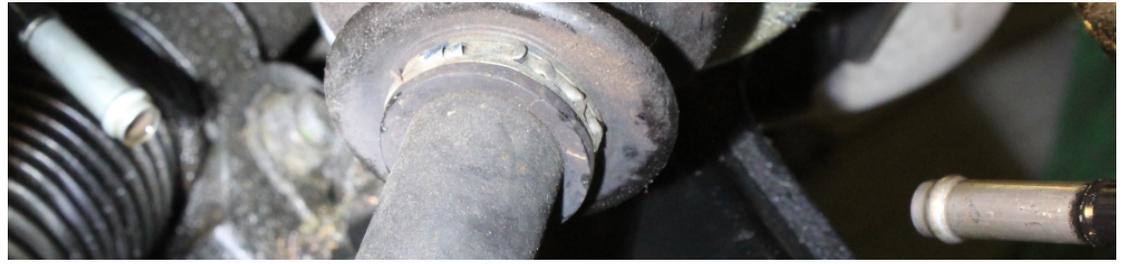
Old Power Steering Pump Pressure Feed Tube Removed
