1999 Toyota Avalon Hood Support Replacement

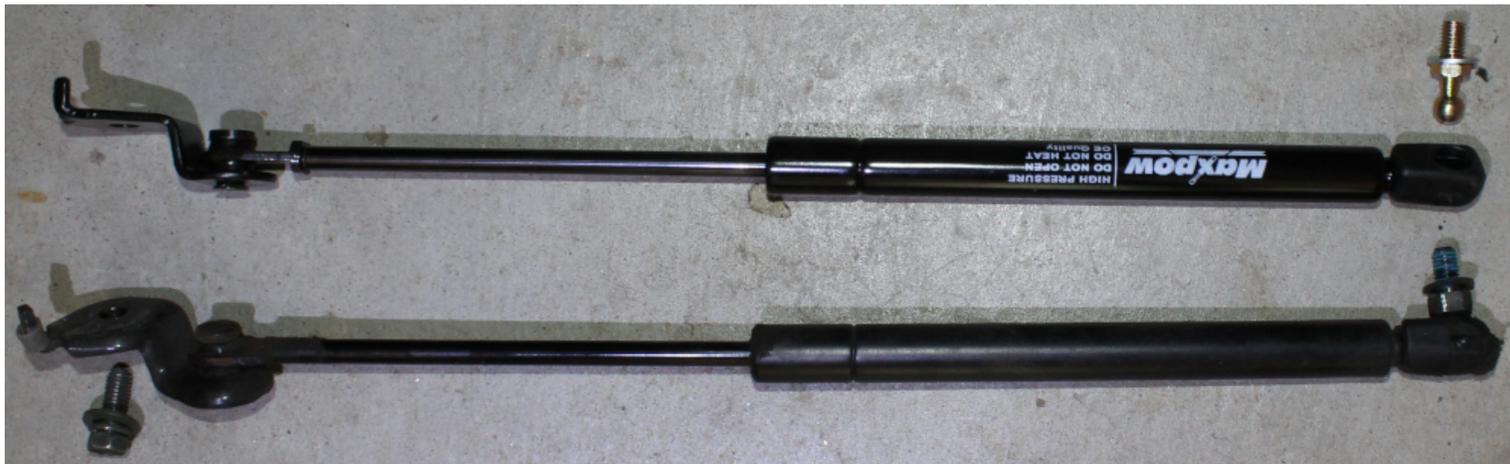
New (Top) & Old (Bottom) Hood Support

Old hood support became not stuck out the heavy engine room hood due to leaking gas stored inside. Even though one side of hood supports gets problem, it is better to replace both side of hood supports. Old and new hood supports have different type of lower metal fittings.

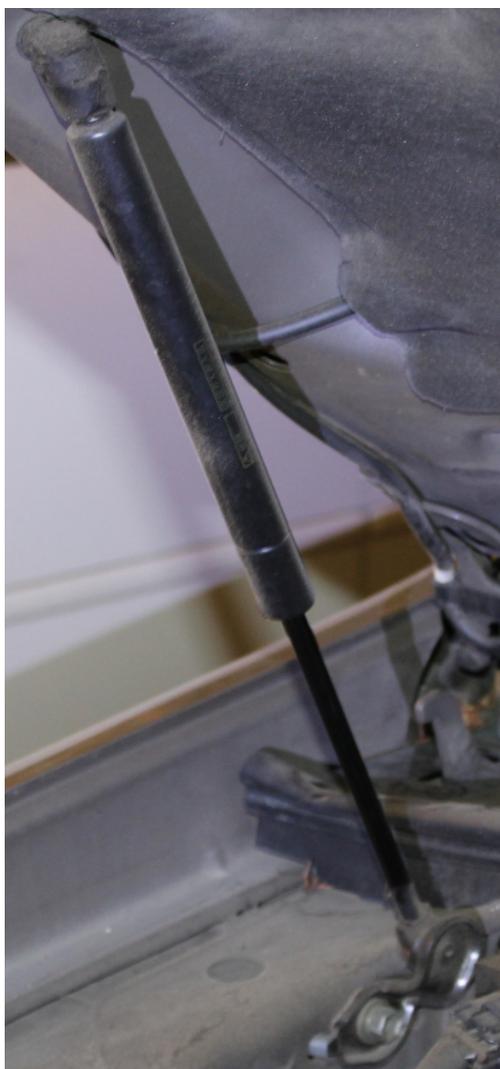
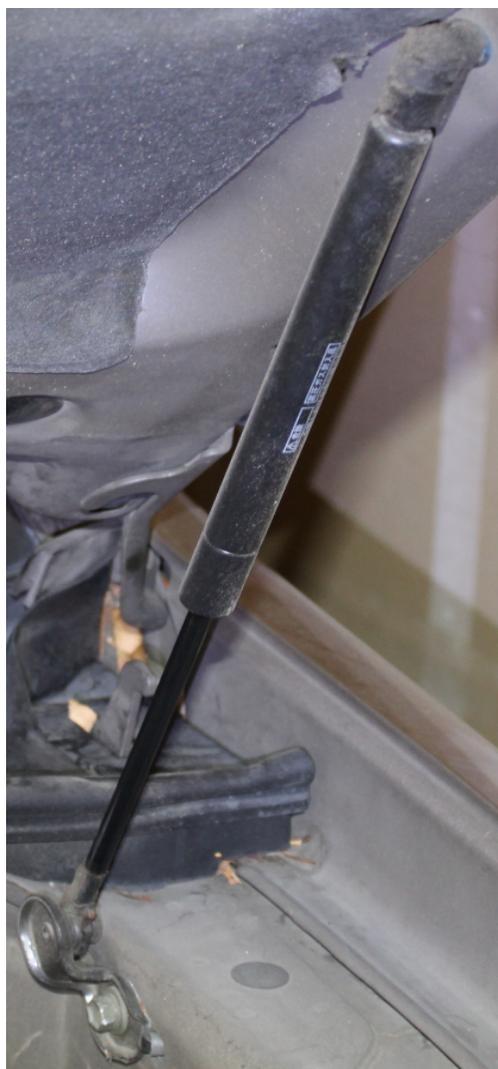
Old (Right; Passenger Side) & (Left; Driver's Side)

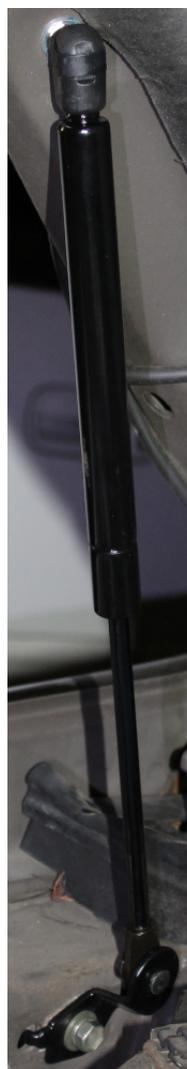
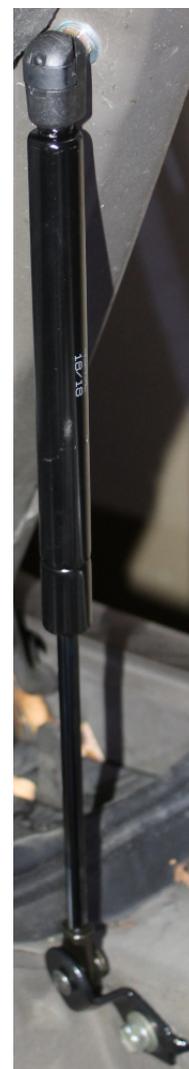
New (Right) & (Left)
