Repair Bidet Water Leak

Old Version (Astor)

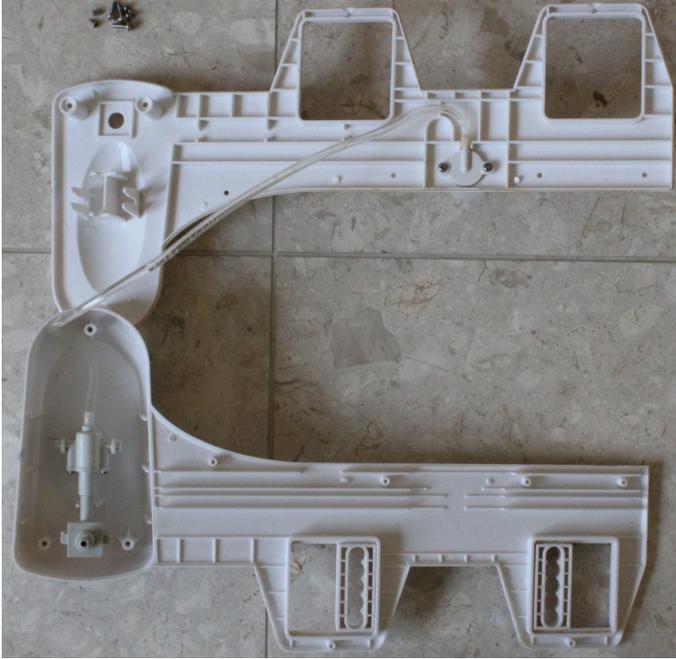
Before (Hose Cracked)

Water Leaked Due to Seriously Cracked Hose (Low Quality Hose Used)

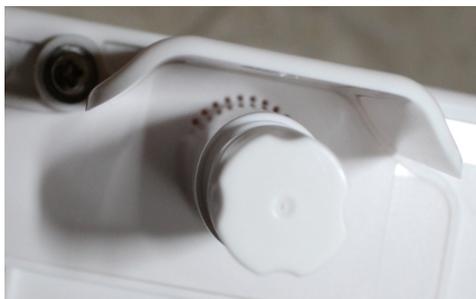
Splash Nozzle

Splash Nozzle Cleaner & Guard

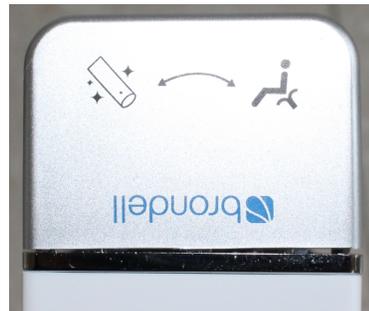
Water off

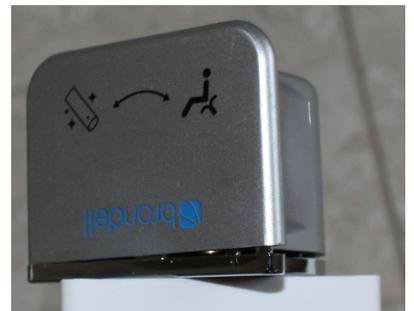
Water on to Nozzle Cleaner

Splash water direction and strength are simply controlled by rotating the knob.

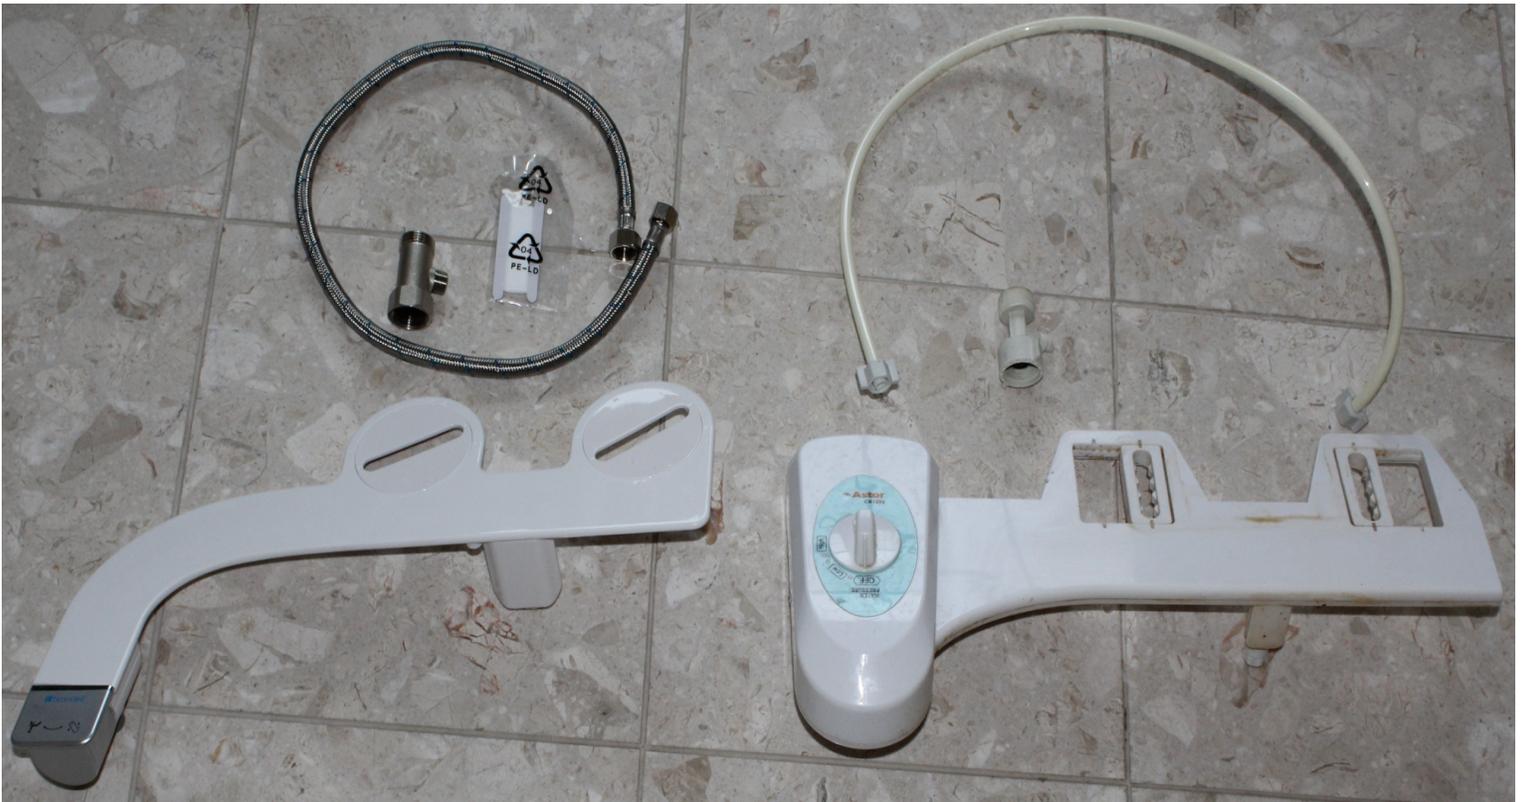
New ("Brondell": Metal Tube & Connectors) & Old Version ("Astor": Plastic Tube & Connectors)

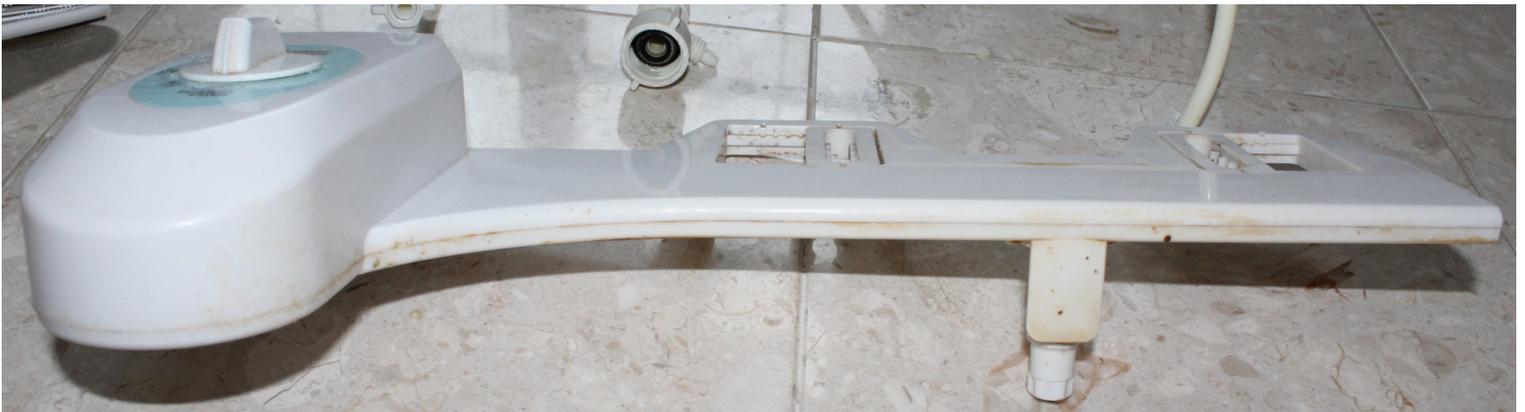
Ugly Old-fashioned Control Box & Thick Body Due to Wiring Hose Inside

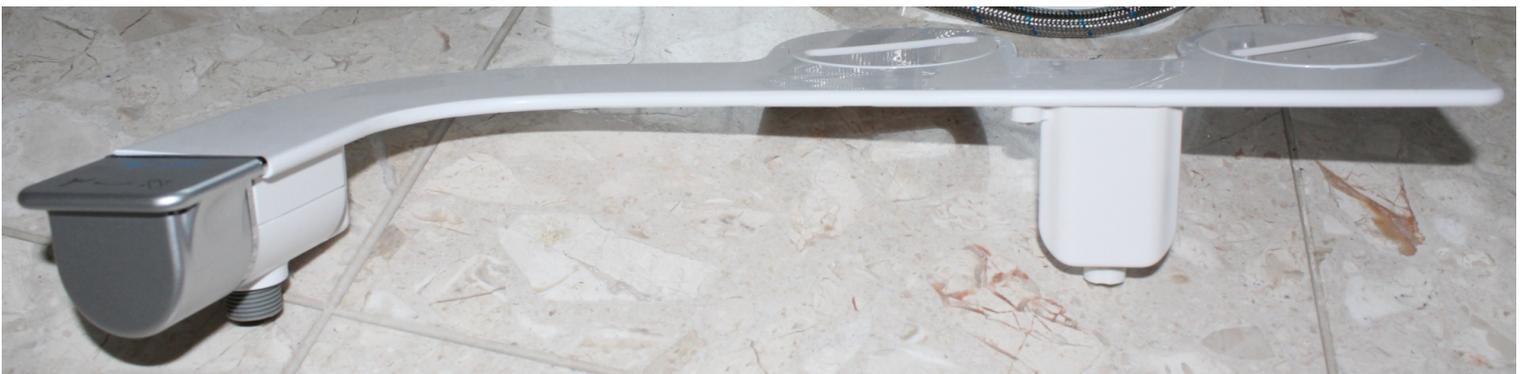
Smart Looking Control Box & Thin Body (Water Pass through Inside Plastic Mold)

"Brondell" is much better than "Astor" and the sales price is competitive.
