Wall Clock Core Replacement

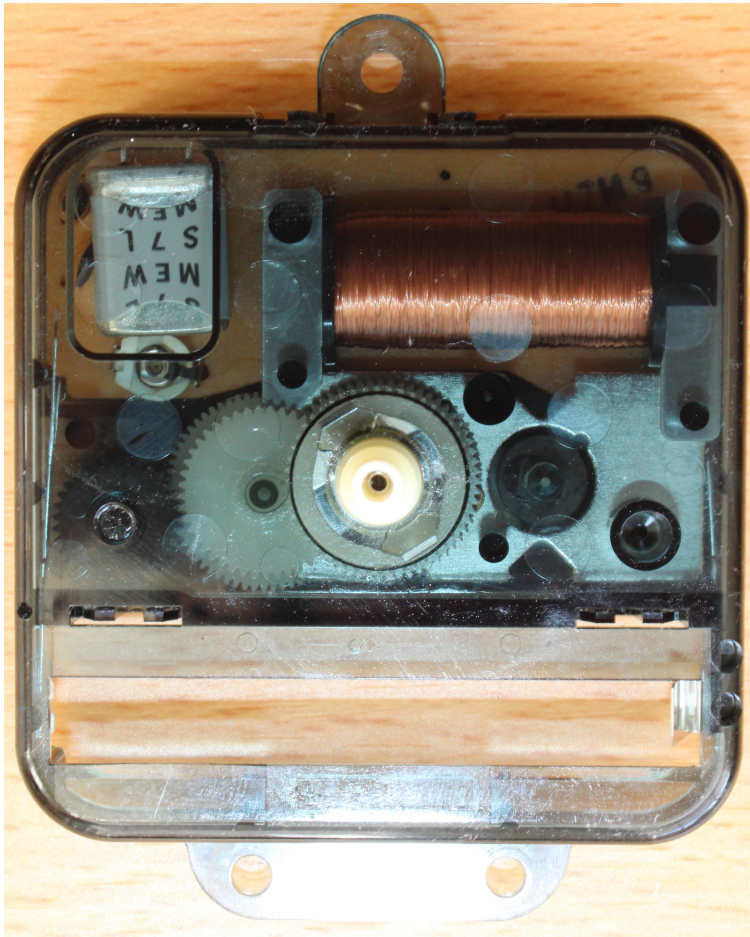
A Seiko wall clock I bought in 1978 started stopping once a month. I doubted the battery at the beginning but recognized that the too much gear friction was the cause. All gears are supported by plastic dimples (Plastic to plastic contacts) without using artificial jewels unlike expensive old-fashioned wrist watches.

Original clock core (Front) to be replaced

I decided to replace only a clock core preserving other costly parts (Dial plate, Needles, Frame) manufactured by prestigious Seiko.

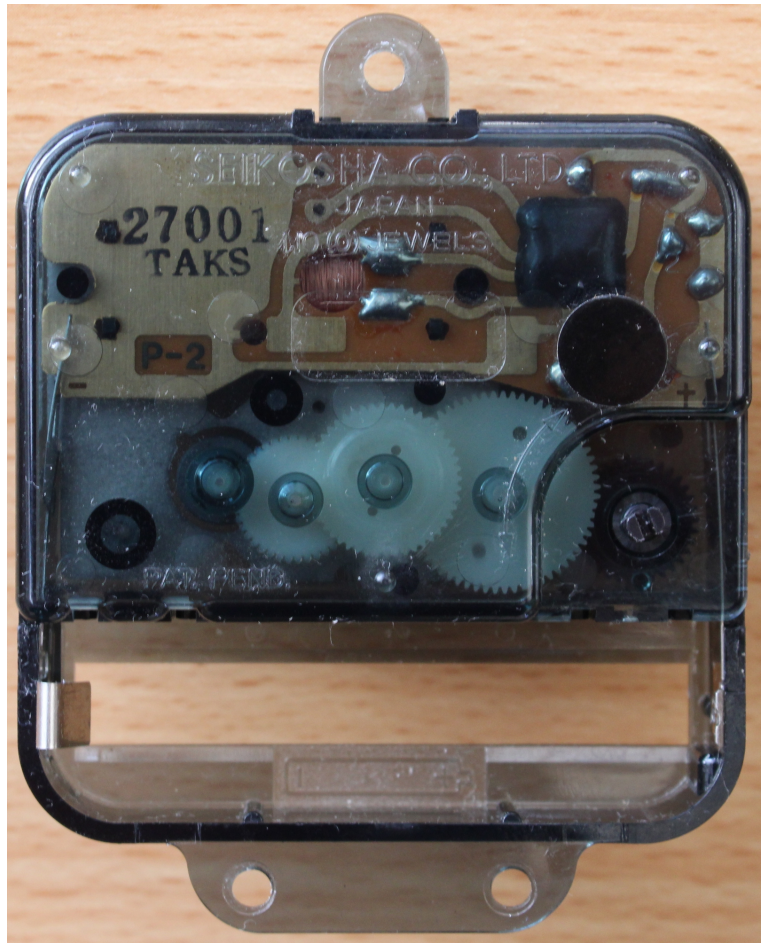
Original clock core (Rear) to be replaced

Original clock core was ticking but often stopped ([watch MP4 video](#)).

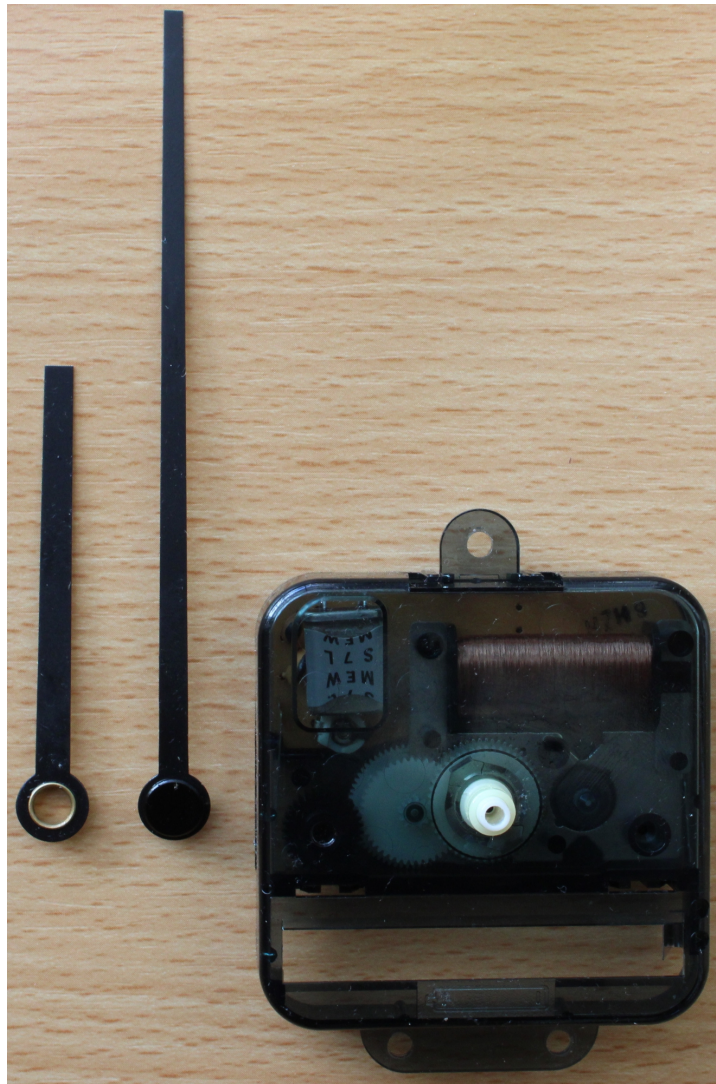
Original needles & clock core (Front) to be replaced

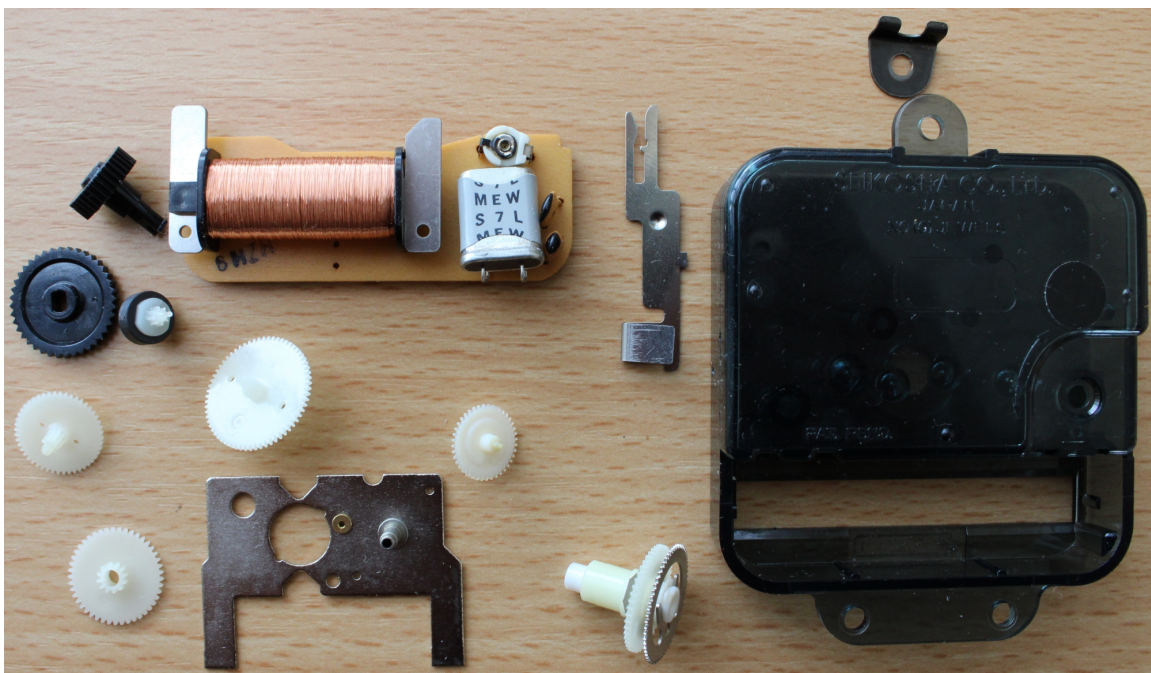
Problematic clock core disassembled (was unable to rebuild)

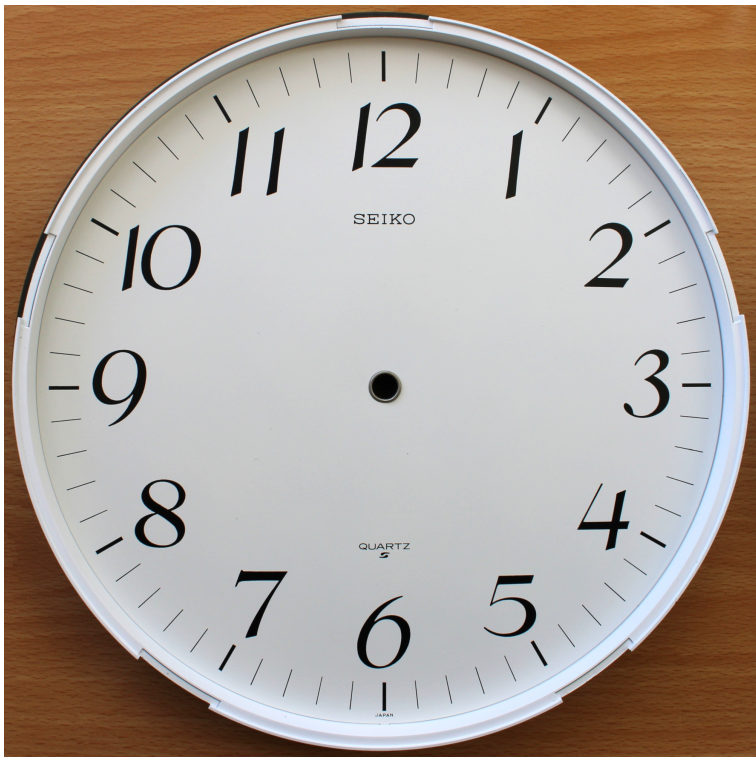
Original dial plate (Front)

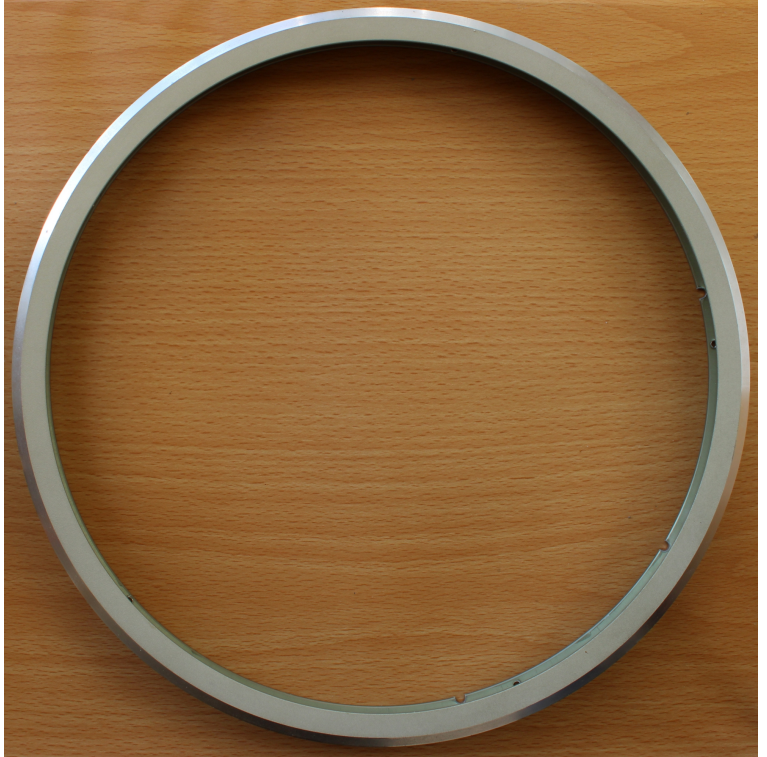
Original frame (Front)

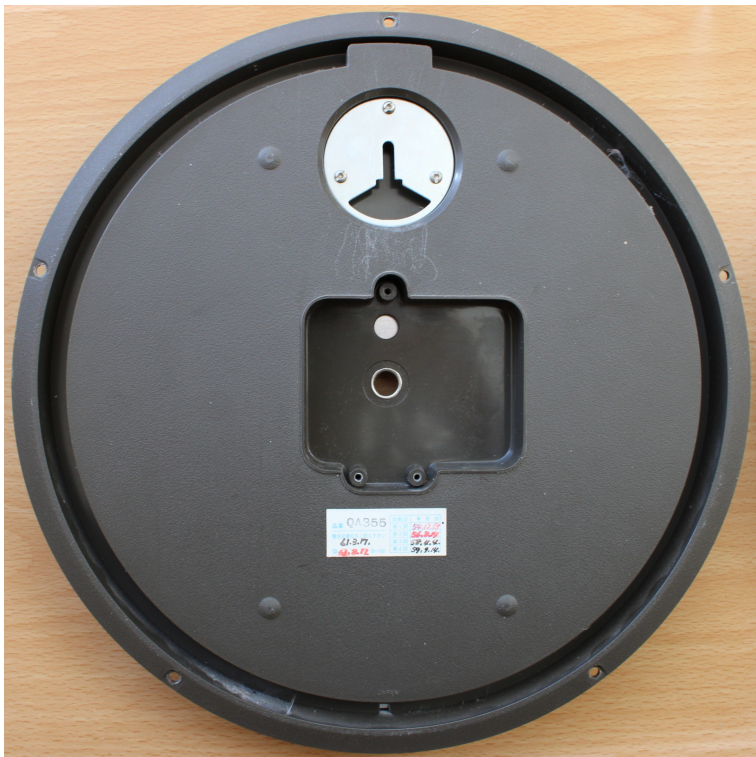
Original dial plate (Rear)

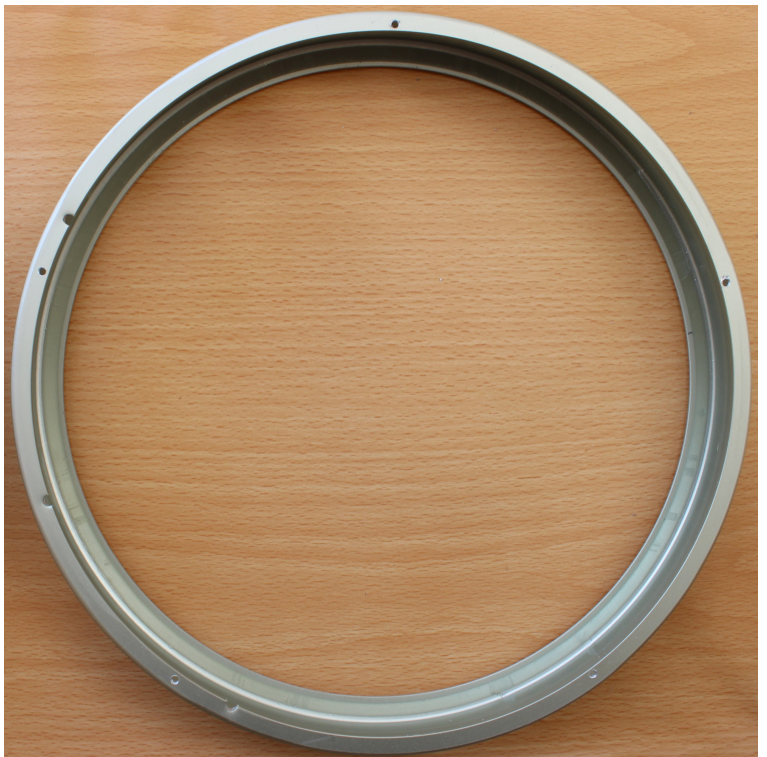
Original frame (Rear)

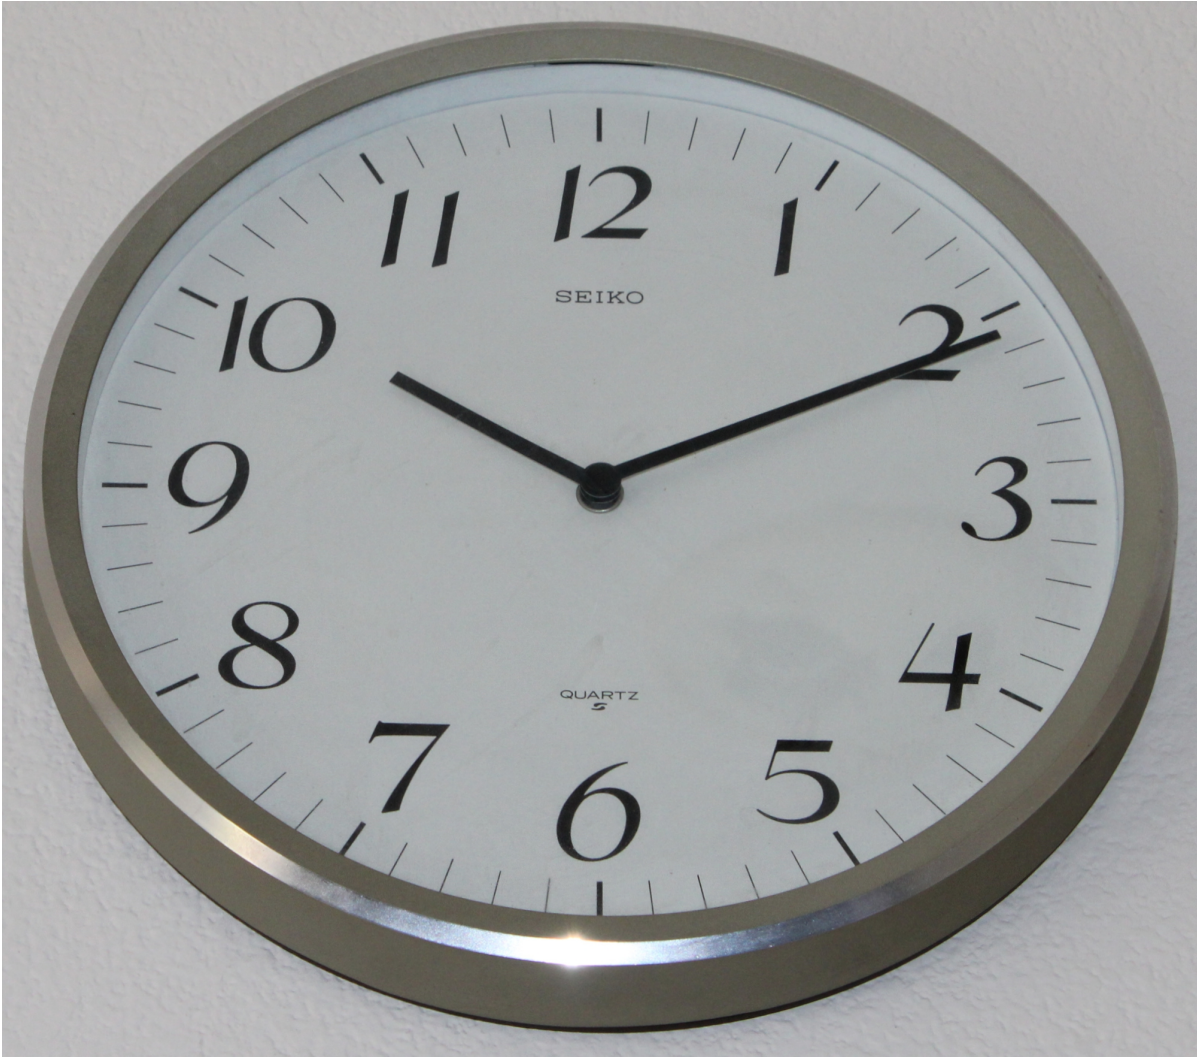
Working, ticking,,
