Big Dent on Left Rear Bumber

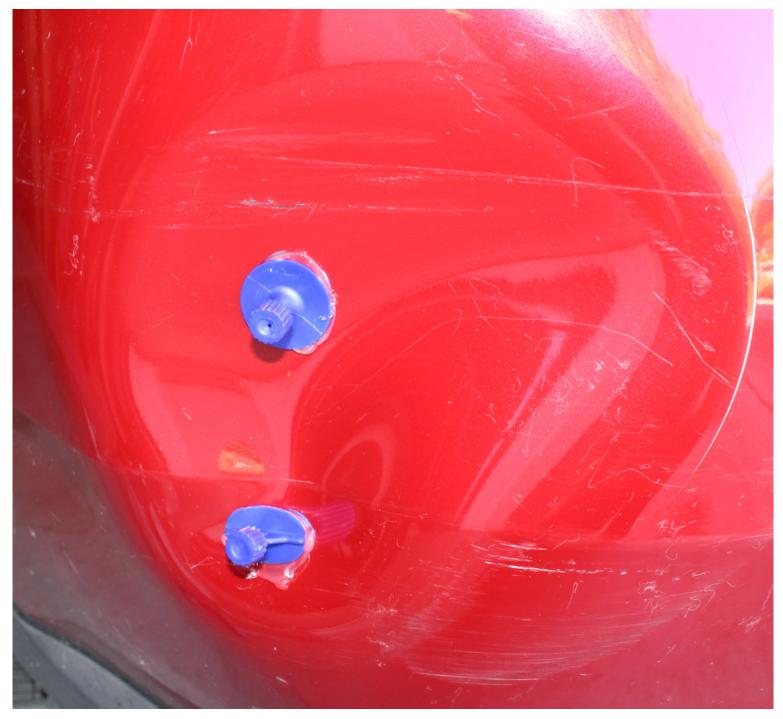
Dent Repair Trial by Pulling the Dent (Failed)

Pasting plastic clips by glue on the dent, pull the clips to outside strongly. The trial did not work.

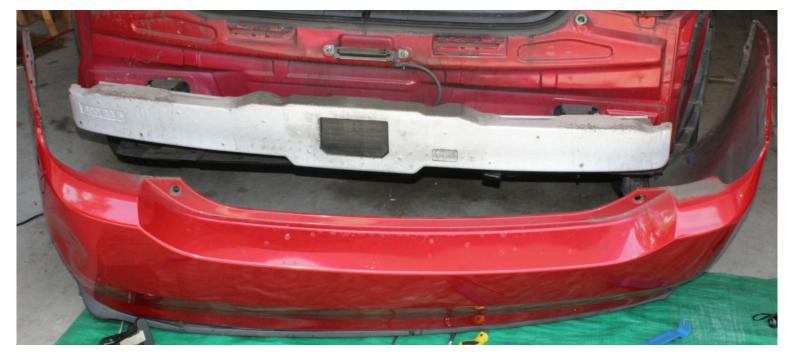
Rear Bumper Removed

Recent vehicle equips bumper made by reinforced plastic which softens when heat is applied.

After removing rear bumper, pouring hot water to the dent from rear side of rear bumper, push the dent by foot and hand strongly as soon as possible. The portion of the dent looks recovered as before.

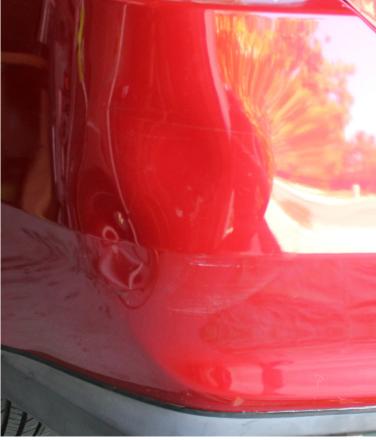
After Dent Repair
