Even though the screen frame is not a moving equipment unlike door, holes were made probably by birds or sun shine. The screen with holes is useless. Replacement is a must and not so difficult although the number of screen frames may be a lot depending upon home you live.

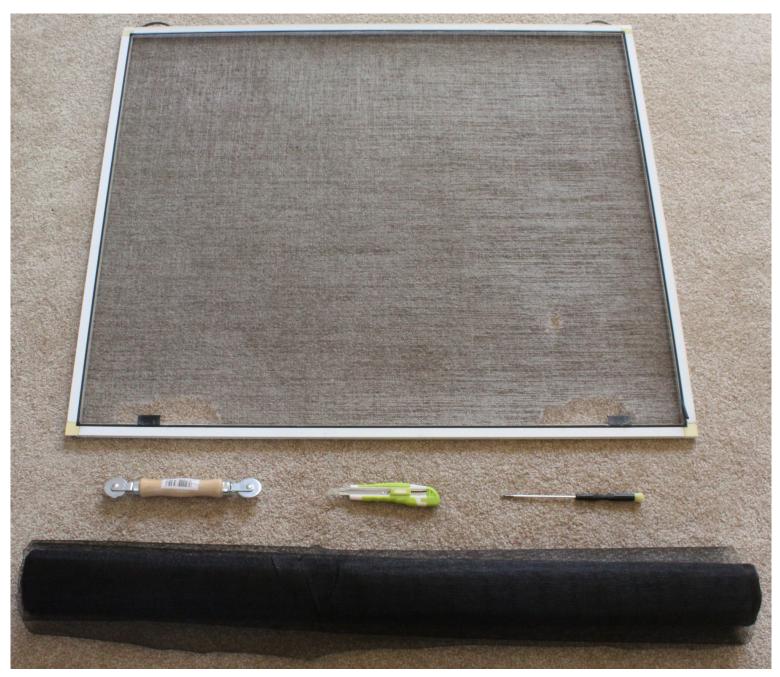
Window Screen to be Replaced, Spline Roller, Knife, Driver, Roll of New Screen (Old Spline still under Use)

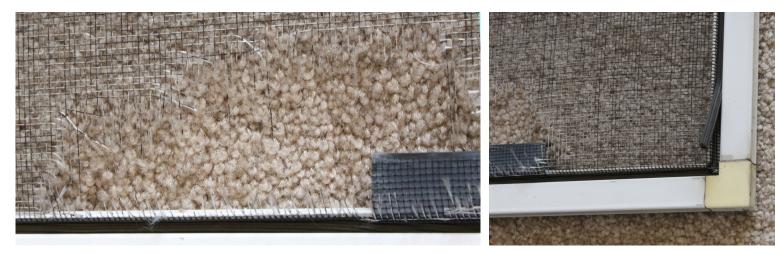
Screen Hole

Start from here (Pull up Spline at End)

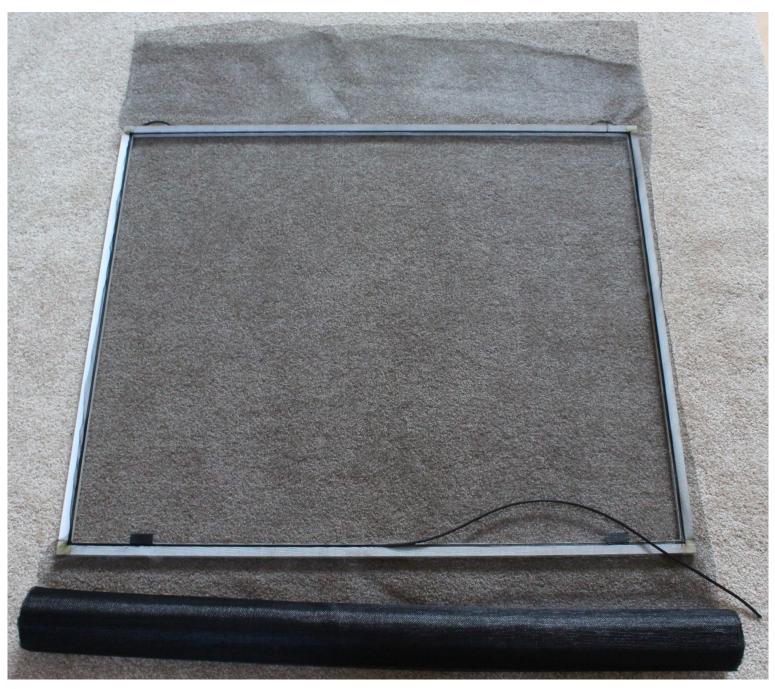
Final Stage of Pushing down Spline by Spline Roller over the New Screen

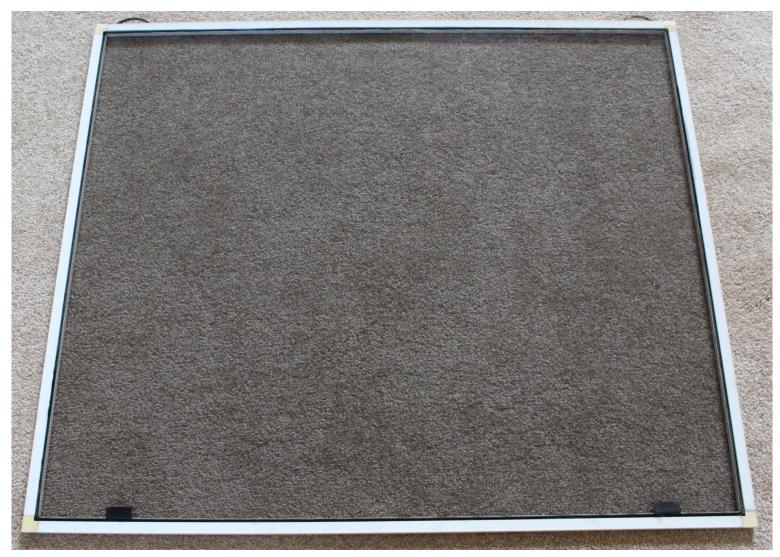
Done (Screen Tension Looks Good, Extra Spline Needs to be Cut)
