2007 Pontiac Vibe Drive Belt Replacement

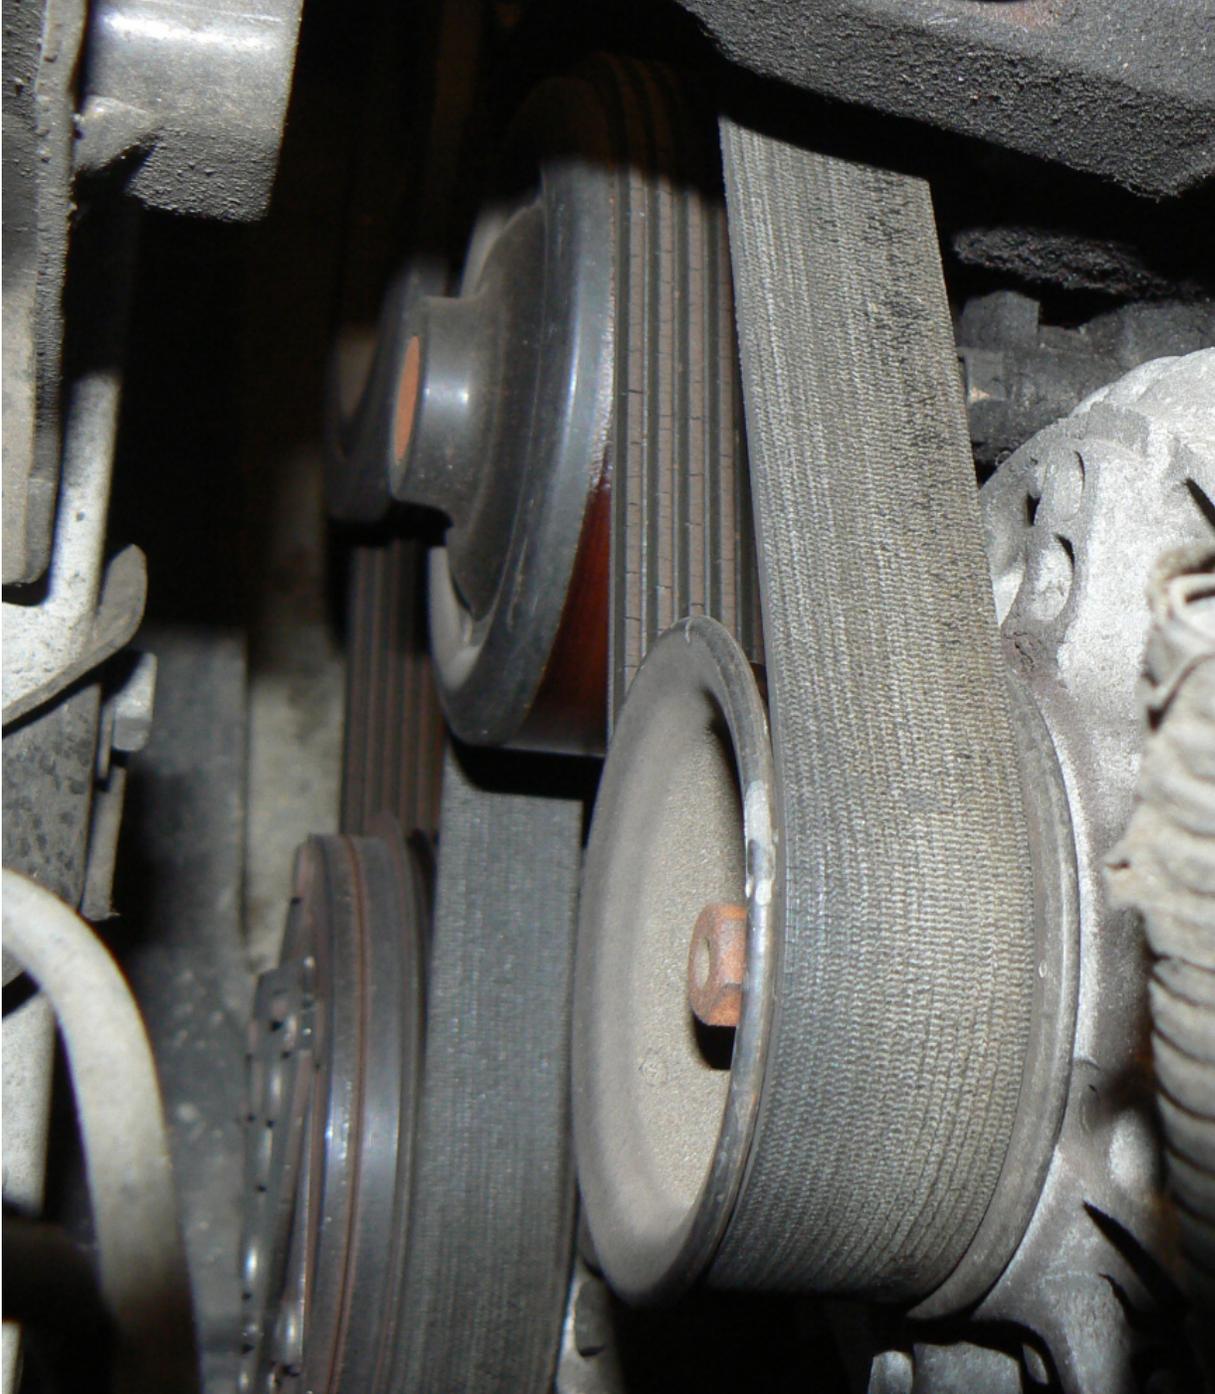
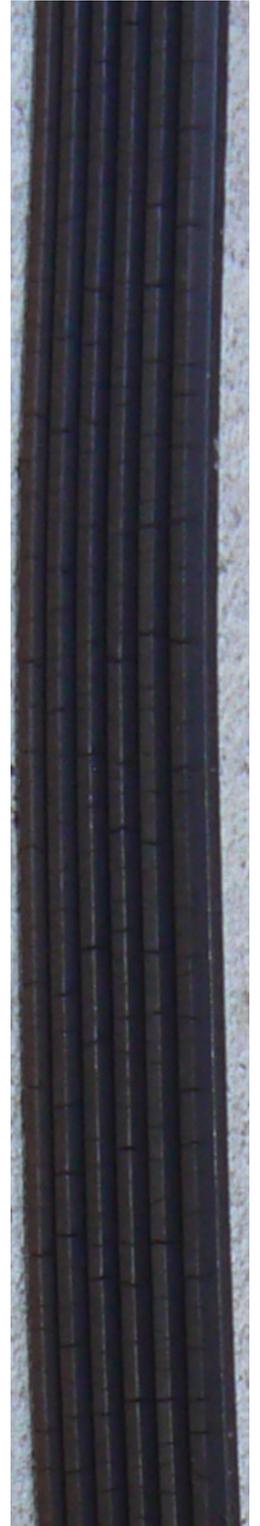
Cracked Drive Belt

Old drive belt exhibited a lot of cracks due to deterioration. The situation was under fracture, nearly break down.

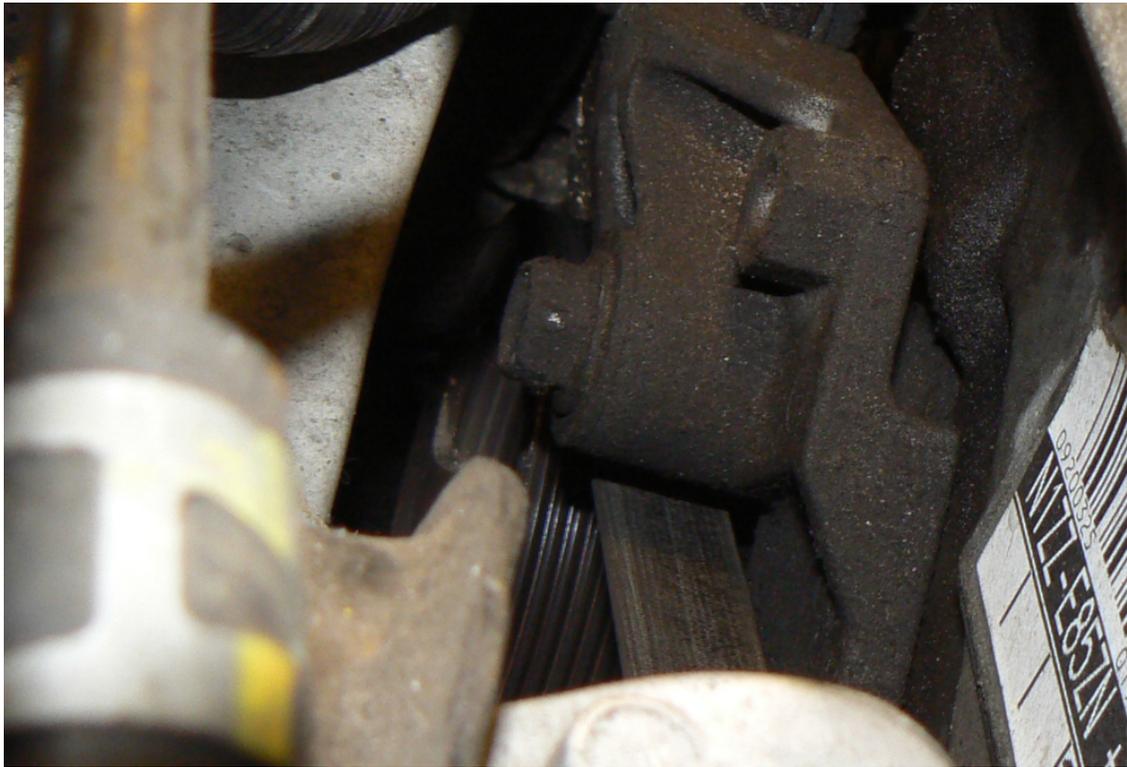
Tension Arm Bolt

By handling tension arm bolt, the drive belt wound firmly can be released or attached.
