Repair DVD Recorder

Toshiba DVD recorder (RD-XS32SU) installs a HDD (Hard Disk Drive) and a DVD-RAM/R/RW drive as multimedia recording equipment.

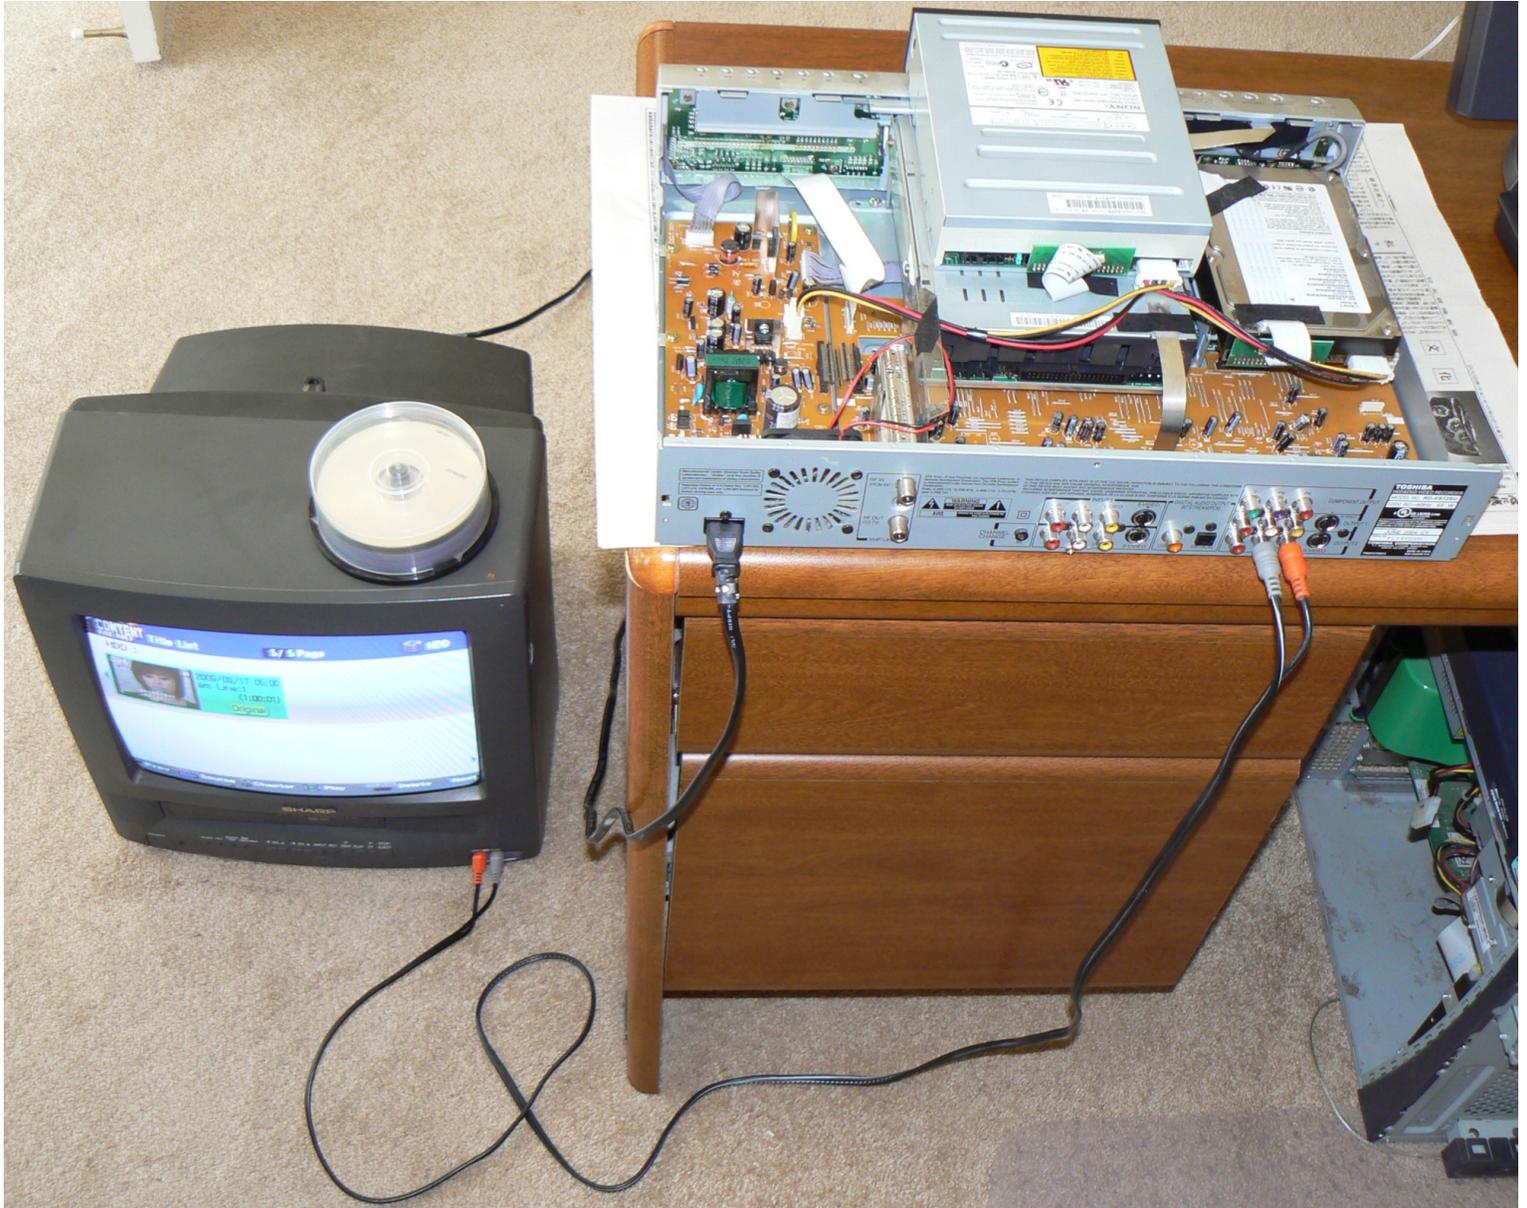
DVD-RW Drive with ATA Parallel Interface Piggy-backed, Analog TV Connected by Composite Video and Audio

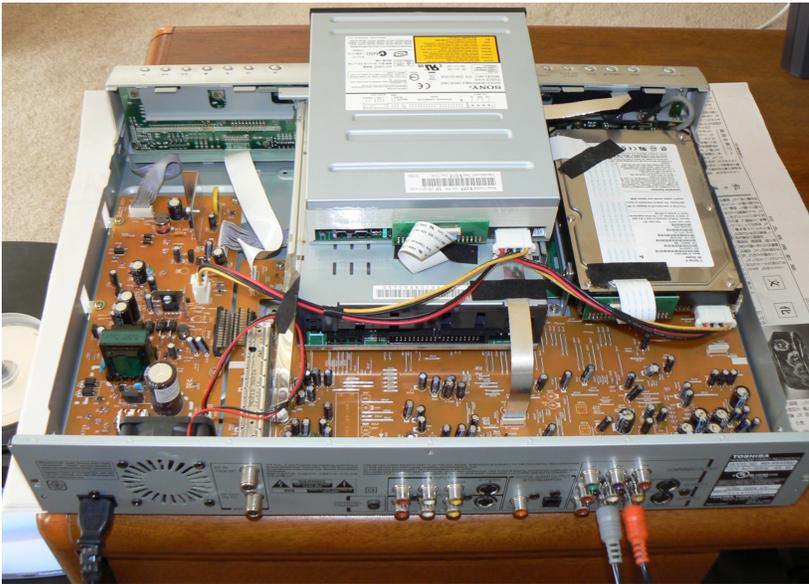
DVD Drive Piggy-backed (ATA Power & Data Connected)

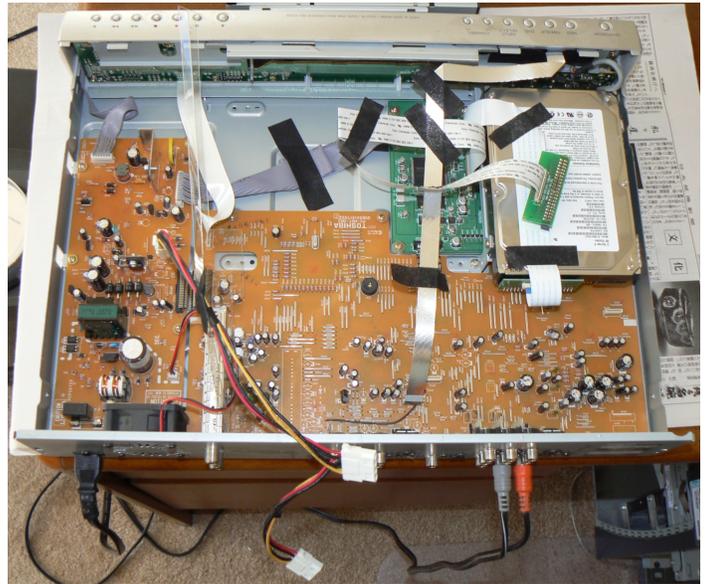
Removed Old DVD Drive

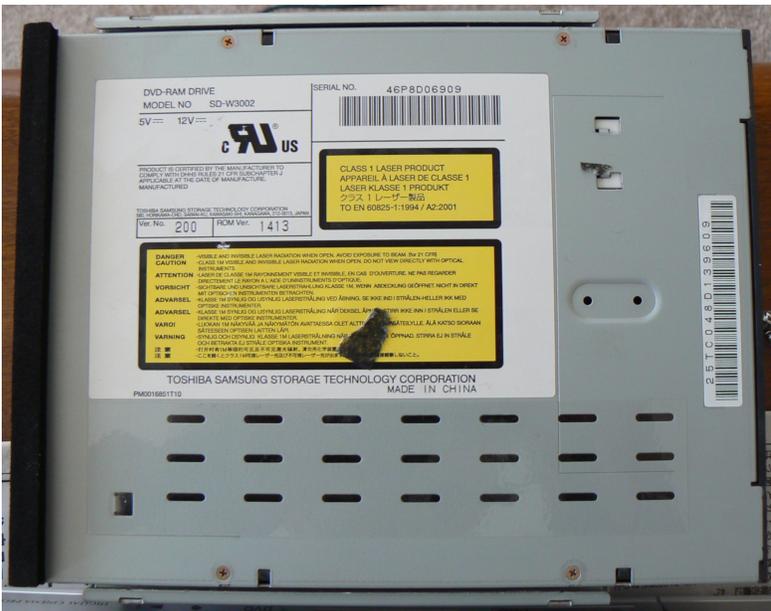
HDD was able to record multimedia programs but DVD-RAM/R/RW drive lost both playing and recording function. The DVD-RAM/R/RW drive installed on Toshiba DVD recorder was a regular DVD drive with ATA (AT Attachment) parallel interface that was installed in IBM PCs.

Broken DVD-RAM Drive (Toshiba Samsung)
